**Subject: Docket No. 468, Plumtree Substation to Brookfield Junction 115-kV Project  
Decision and Order Condition #4 – Independent Environmental Inspector Report**

**Docket No. 468– Development and Management Plan Inspection**

## Southwest Connecticut Reliability Project

### Plumtree To Brookfield Junction

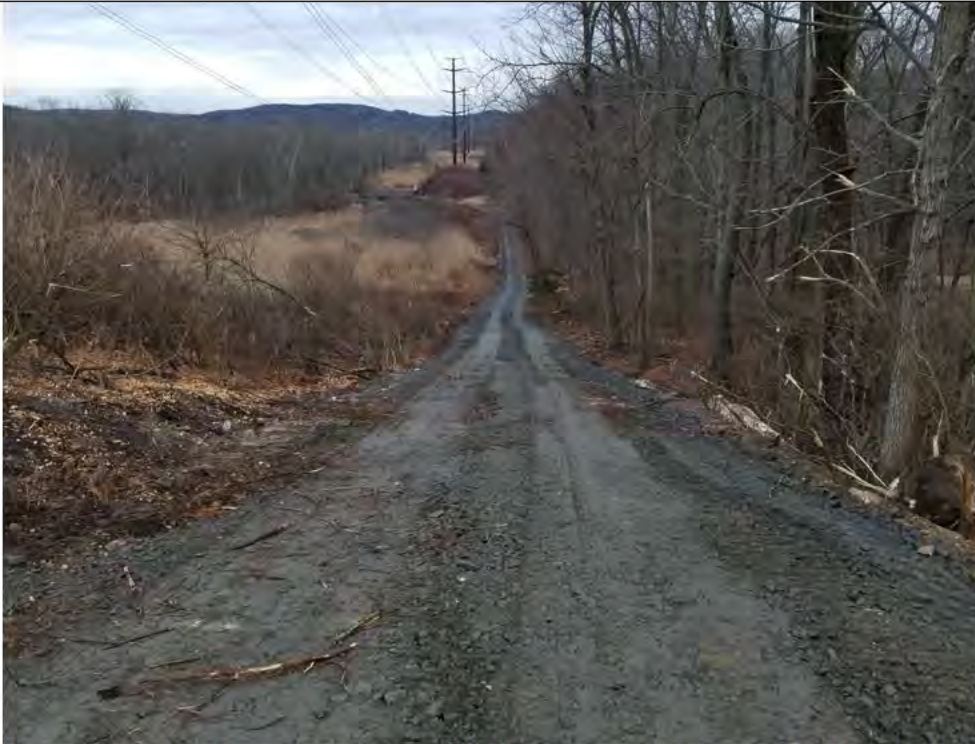
Photo 1: 02/22/2018, Danbury: Map 04, access road to Str1008, Wetland W1 primarily off to the left of the access road, photo taken facing south toward Str1008.

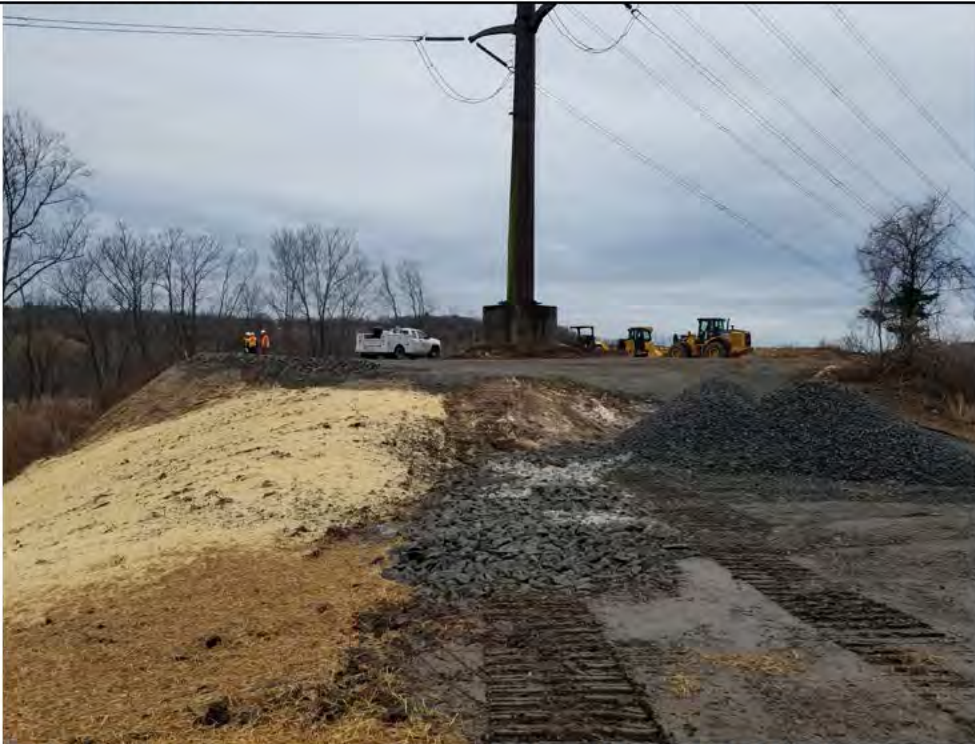
Photo 2: 02/22/2018, Danbury: Map 05, construction of pad at Str1009 and Str10263, photo taken facing southeast.

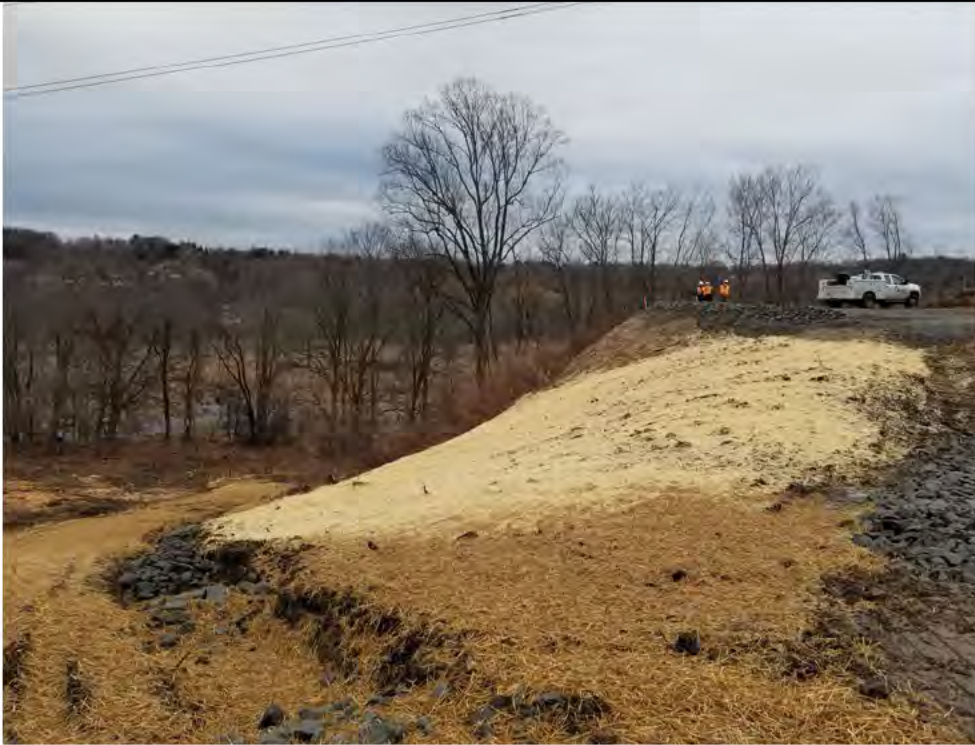
Photo 3: 02/22/2018, Danbury: Map 04, mulch placement for slope stabilization and stone filled swale at toe of slope for drainage, photo taken facing southeast.

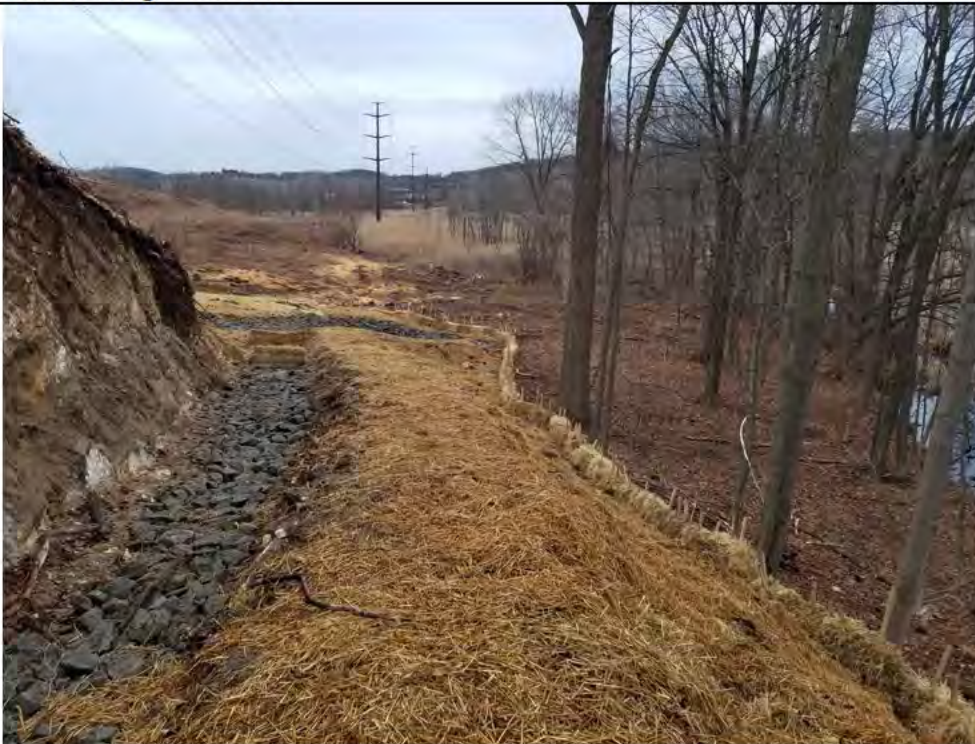
Photo 4: 02/22/2018, Danbury: Map 04, stone filled swale, mulch placement, and hay bales abutting Wetland W1 at bottom of slope east of Str1009, photo taken facing north towards Str1010.

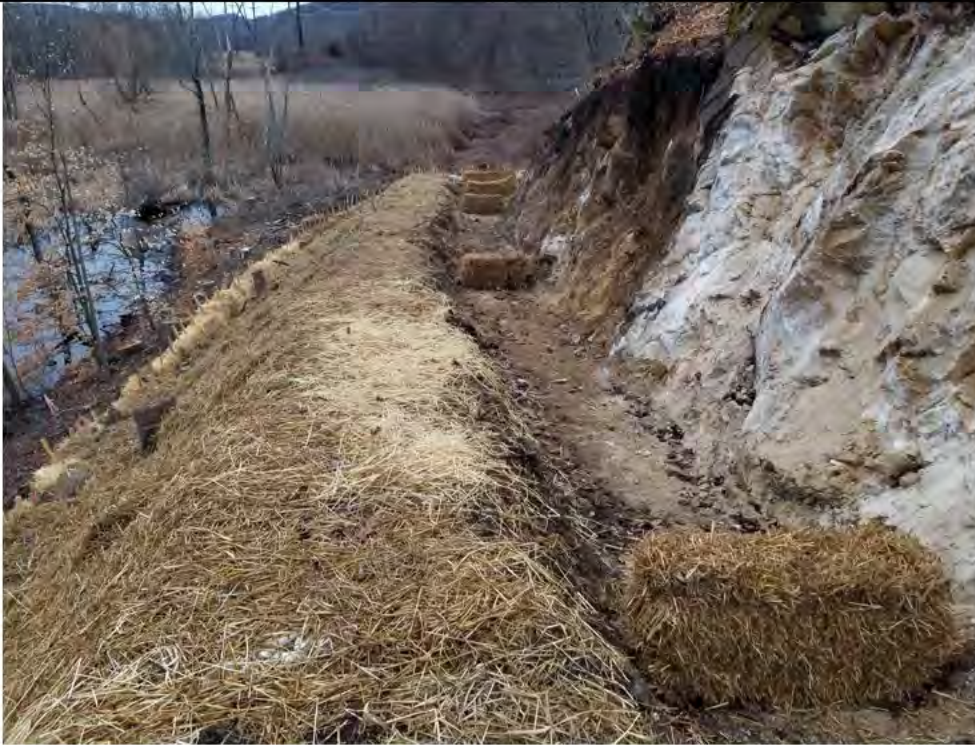
Photo 5: 02/22/2018, Danbury: Map 04, swale with check dams, mulch placement, and hay bales abutting Wetland W1 at bottom of slope east of Str1009, photo taken facing south towards Str1008.

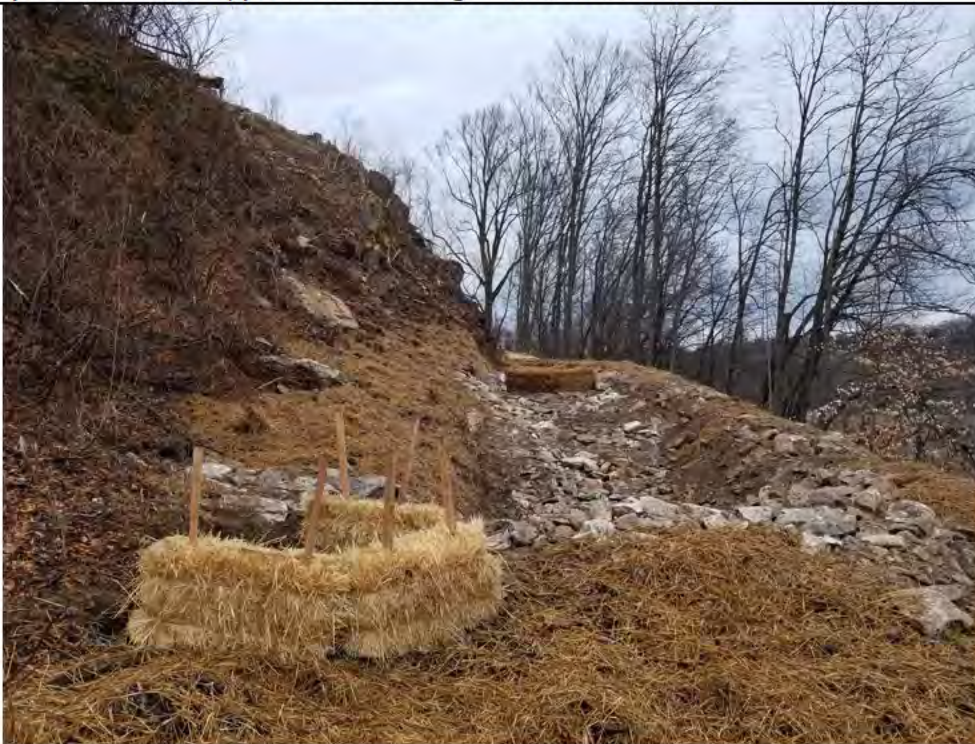
Photo 6: 02/22/2018, Danbury: Map 04, stone filled swale, mulch placement, and hay bales abutting Wetland W1 at bottom of slope southeast of Str1009, photo taken facing north towards Str1010.

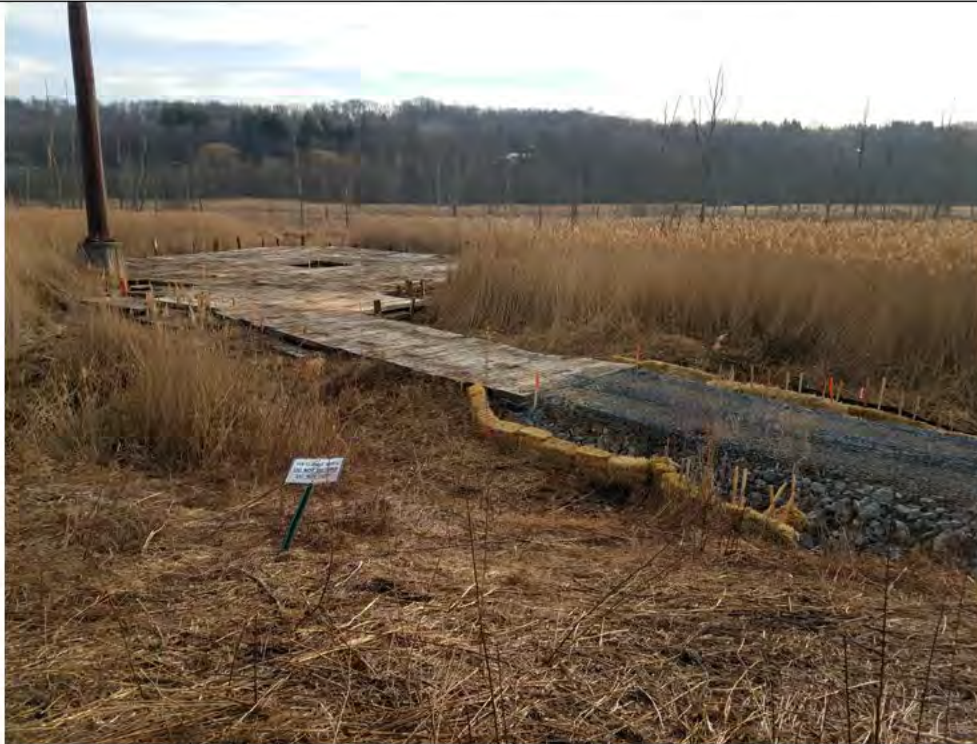
<b>Areas of Inspection</b>		<b>Observation:</b>	<b>Recommended Action/s:</b>	<b>Corrected Action/s:</b>
<b>Access Roads and Adjacent Roadways</b>	<b>Interim Week</b>	Access roads appear to be in good condition. No tire rutting or rills observed. No off ROW tracking of sediments observed.	N/A	
	<b>Bi-Week</b>	Access roads appear to be in good condition. No tire rutting or rills observed. No off ROW tracking of sediments observed.	N/A	
<b>Vegetative Clearing Limits (Including trees to save or danger trees noted.</b>	<b>Interim Week</b>	The limits of disturbance have been marked out with orange flagging in the areas of active vegetation and tree clearing. No out of bounds clearing was observed.	N/A	
	<b>Bi-Week</b>	Vegetation clearing at Str1010 in Wetland W1 was completed last week and timber mats installation was completed this week (see Photo 7).	N/A

<b>Water Crossings</b>	<b>Interim Week</b>	No changes in conditions since last inspection. No impacts to wetlands/watercourse at designated water crossings due to site activities.	N/A	
	<b>Bi-Week</b>	<p>No impacts were observed to wetlands/watercourse at designated water crossings as a result of site activities. Timber mat crossings and pads constructed within wetlands were clear of excess sediments. Supreme has equipment being delivered to the site tomorrow (pending potential weather delays) for removing excess sediments from the exposed top surfaces of the timber mats.</p> <p>Pad for Str1010 completed (see Photo 7).</p>	N/A

Photo 7: 03/01/2018, Danbury: Map 05, Str1010 pad completed, veg clearing completed and timber mats installed.

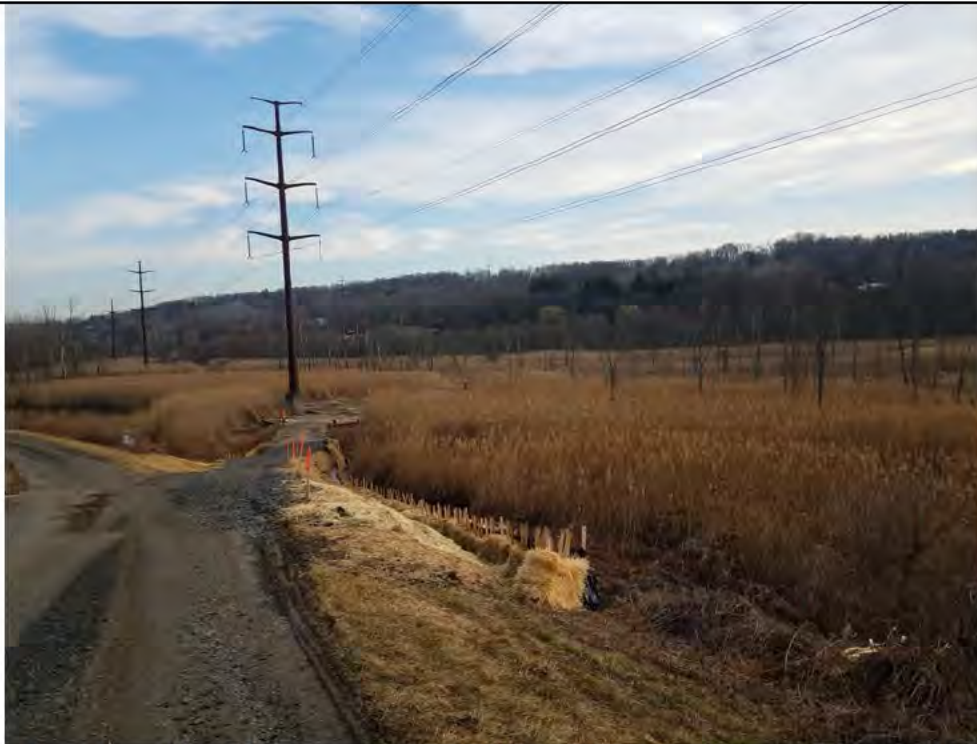
Photo 8: 03/01/2018, Danbury: Map 05, access road to Str1010, E&S installed between the gravel road and Wetland W1.
