Subject: Docket No. 468, Plumtree Substation to Brookfield Junction 115-kV Project

Decision and Order Condition #4 – Independent Environmental Inspector Report

Please find enclosed the Biweekly Independent Environmental Inspector Report, Report #13, for the March 23rd, and March 28th, 2018 inspection events for the construction of the Eversource Plumtree Substation to Brookfield Junction 115-kV Project.

Photograph Log Southwest Connecticut Reliability Project Plumtree To Brookfield Junction

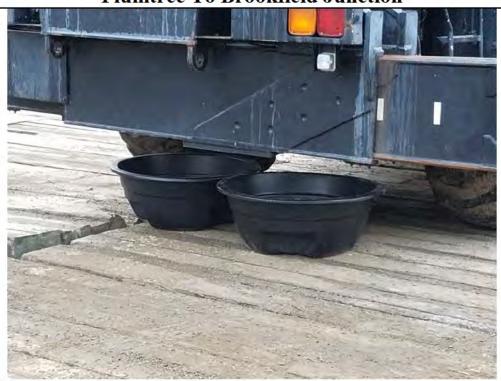
20	Interim Week	Water crossings are clear of excess sediments. No impacts to wetlands and/or watercourses was observed at the time of this inspection. Timber mats shown in Photos 1, 2, and 3.	N/A	
WaterCrossings	Bi-Week	Water crossings are clear of excess sediments. No impacts to wetlands and/or watercourses was observed at the time of this inspection.	N/A

Photo 1: 03/23/2018, Bethel: Map 02, Str1000-1006, photo of spill protection under operating equipment/staged equipment, over timber mats placed within wetland W1.

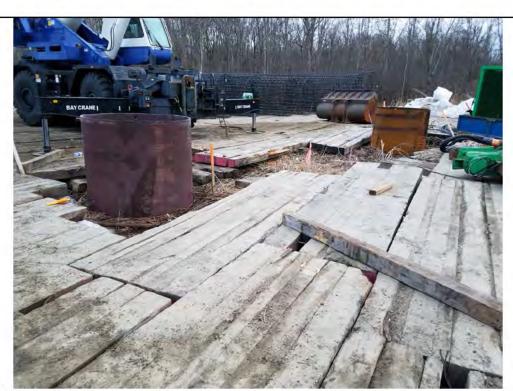
ntation Controls	Interim Week	E&S controls presently installed are maintained and functioning as designed.	N/A	
Erosion and Sedimentation Controls	Bi-Week	E&S controls presently installed are maintained and functioning as designed.	N/A	
Inland Wetland & Watercourse encroachment & mitigation	Interim Week	No visible impacts to wetlands or watercourses were observed in any of the work areas inspected today. Wetland W1 can be seen in Photos 2 and 3.	N/A

Photo 2: 03/23/2018, Bethel: Map 02, Str1002, drilling structure foundation holes.

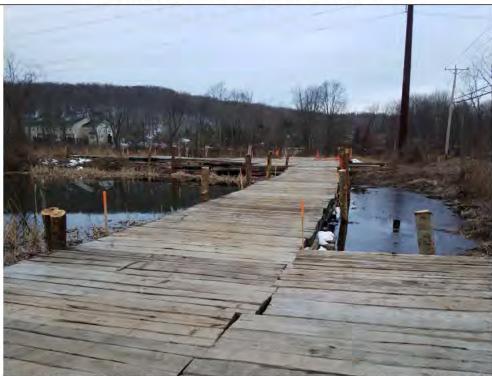
Photo 3: 03/23/2018, Bethel: Map 03, Str1007 timber mat access and work pad through Wetland W1.

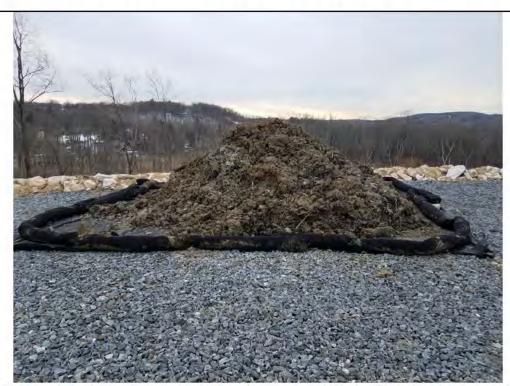
Photo 4: 03/23/2018, Danbury: Map 05, Str1009 work pad area, staged Wetland invasive species seed bank segregation material excavated from the top 4.5-feet of the landfill and to be disposed of off-site at an approved landfill.

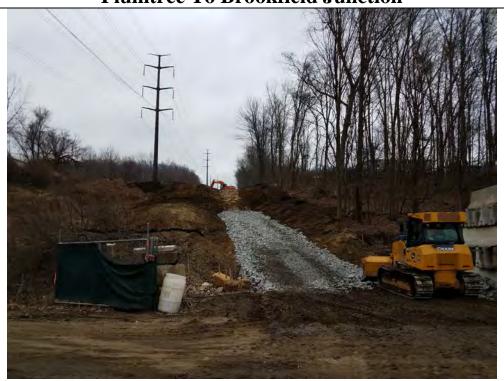
Observed Supreme constructing a gravel access road to Str1013 (see Photo 5). Supreme is on site this week continuing Civil work, Michel's is expected to return on Monday 4/2/18 and resume structure base/foundation drilling.

Photo 5: 03/28/2018, Danbury: Map 06, access road construction to Str1013.
