Subject: Docket No. 468, Plumtree Substation to Brookfield Junction 115-kV Project Decision and Order Condition #4 – Independent Environmental Inspector Report

Please find enclosed the Biweekly Independent Environmental Inspector Report, Report #15, for the **April 18th**, and **April 26th**, **2018** inspection events for the construction of the Eversource Plumtree Substation to Brookfield Junction 115-kV Project.

Docket No. 468- Development and Management Plan Inspection

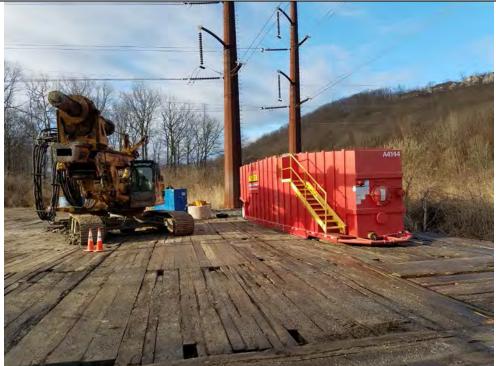
-Frac tank staged in the area of Str1005 for dewatering of structure foundation holes (Photo 1).

Photo 1: 04/18/2018, Bethel: Map 02, Frac tank staged on the work/pull pad, north side of Str1005. Photo taken facing south towards Str1005.

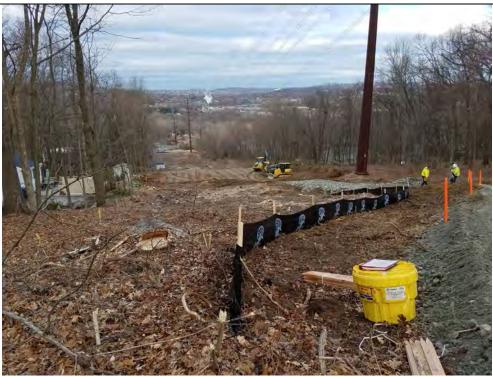
-Supreme resuming access road and work pad construction at Str1014 (Photo 2).

Photo 2: 04/18/2018, Bethel: Map 07, access road and pad construction at Str1014. Photo taken facing west towards Str1014 from Hearthstone Drive.

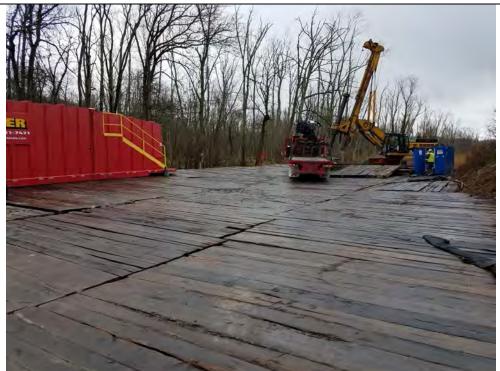
Photo 3: 04/26/2018, Danbury, Map 04, Frac tank and drilling equipment staged on the work pad, photo taken facing south toward Str1008.

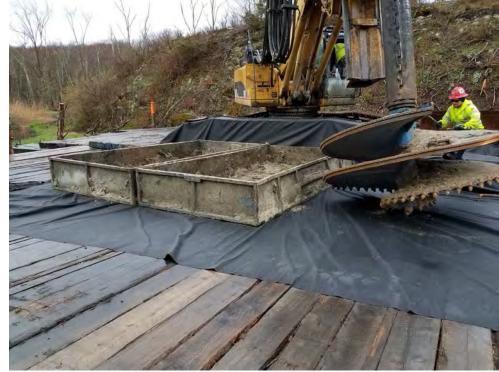
Supreme has finished civil work and is off site. Michels continues drilling and installing structure foundations. Michels was observed setting up to drill at Str1008 (See Photos 3 and 4).

Photo 4: 04/26/2018, Danbury, Map 04, drilling equipment staged on the work pad, photo taken at Str1008.

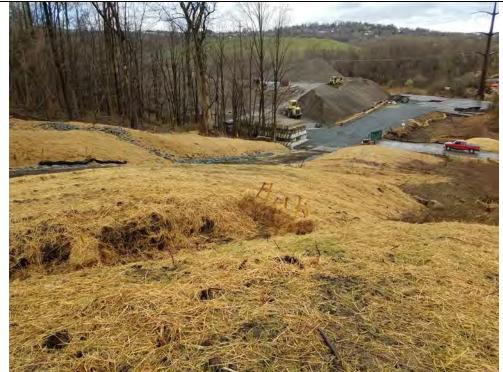
Areas of Inspection		Observation:	Recommended Action/s:	Corrected Action/s:
icent Roadways	Interim Week	Clean and clear of excess sediments and/or debris. No off ROW tracking of sediments was observed on public access roads.	N/A	
Access Roads and Adjacent Roadways	Bi-Week	Clean and clear of excess sediments and/or debris. No off ROW tracking of sediments was observed on public access roads.	N/A	
Vegetative Clearing Limits (Including trees to save or danger trees noted.	Interim Week	Temporary soil stabilization BMPs are being implemented. Exposed ground surfaces are stabilized with straw mulch and E&S controls to reduce the potential of soil erosion during site activities.	N/A	
Vegetative Clearing Limits (Bi-Week	Temporary soil stabilization BMPs are being implemented. Exposed ground surfaces are stabilized with straw mulch and E&S controls to reduce the potential of soil erosion during site activities (See Photos 5 and 6).	N/A

Photo 5: 04/26/2018, Danbury, Map 06, slope and exposed soil stabilization and various E&S controls implemented west of Str1013 down to Old Sherman Turnpike and the access road to Str1012-Str1011, photo taken facing west from Str1013.

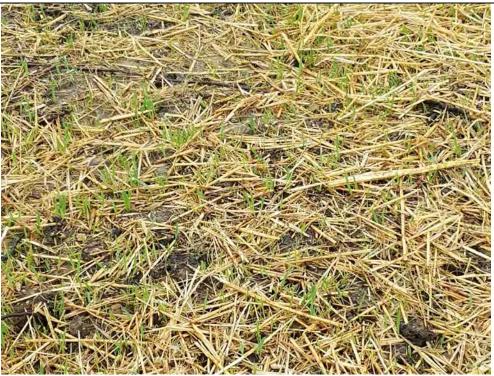
Photo 6: 04/26/2018, Danbury, Map 06, slope and exposed soil stabilization, new grass growth at the area shown in Photo 3.

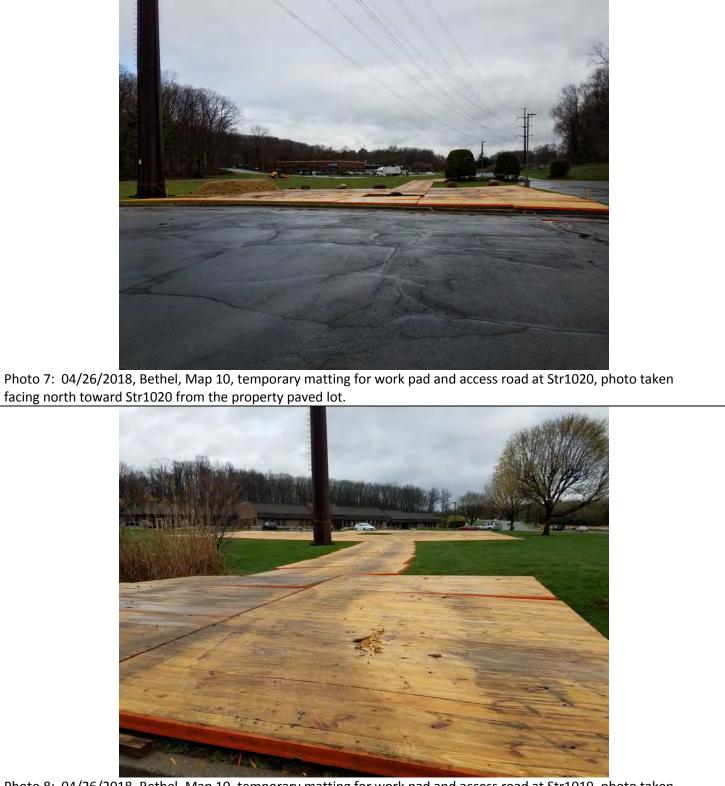
Photo 8: 04/26/2018, Bethel, Map 10, temporary matting for work pad and access road at Str1019, photo taken facing south toward Str1019 from the property paved lot.
