**Subject: Docket No. 468, Plumtree Substation to Brookfield Junction 115-kV Project
Decision and Order Condition #4 – Independent Environmental Inspector Report**

Please find enclosed the Biweekly Independent Environmental Inspector Report, Report #16, for the **May 4th**, and **May 10th, 2018** inspection events for the construction of the Eversource Plumtree Substation to Brookfield Junction 115-kV Project.

Docket No. 468– Development and Management Plan Inspection

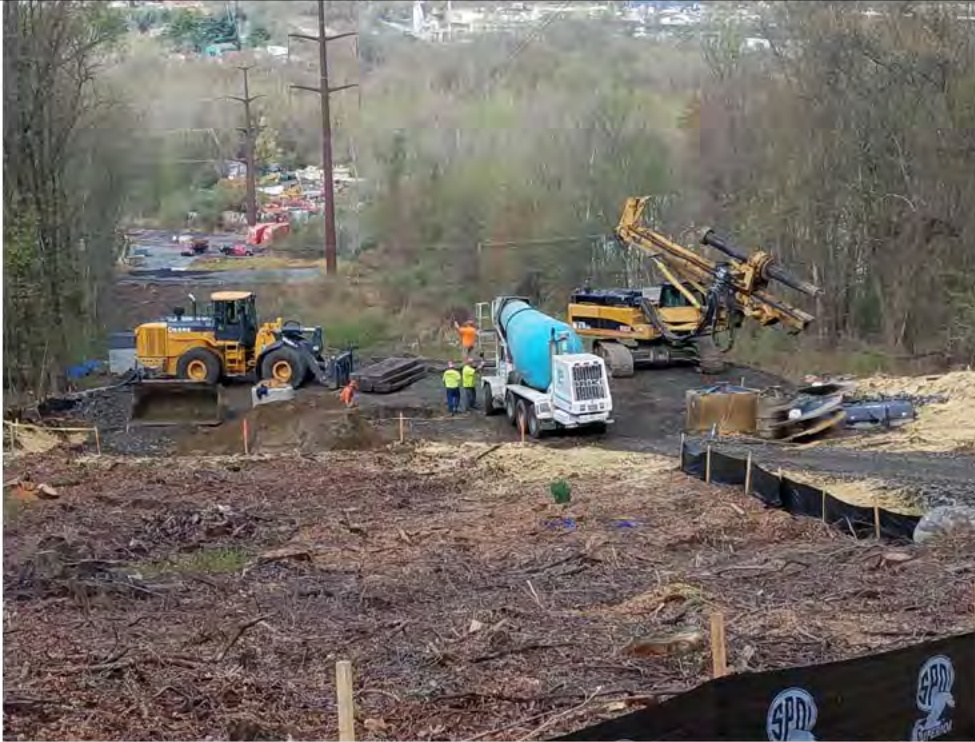
Michels was observed setting up to resume drilling a direct embed foundation at Str1014.

- Michels working at Str1014 (Photo 1).
- Structures erected at Str1000-1006 (Photos 2 and 3).
- Structure assembled and staged at Str1007 (Photo 4).

Photo 1: 05/04/2018, Bethel: Map 07, Michels drilling direct embed foundation at Str1014. Photo taken facing west toward Str1014 from Hearthstone Drive.

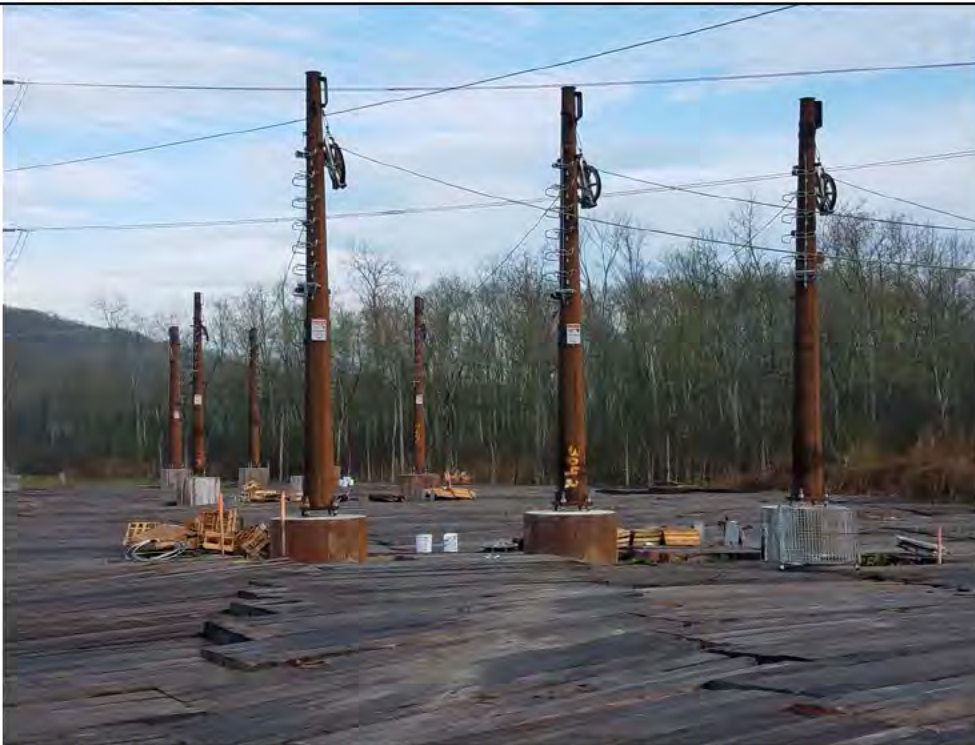
Photo 2: 05/04/2018, Bethel: Map 01, Str1000 through Str1003, weathered steel structures installed. Photo taken facing northwest from Str1000 toward Str1003 in the distance.

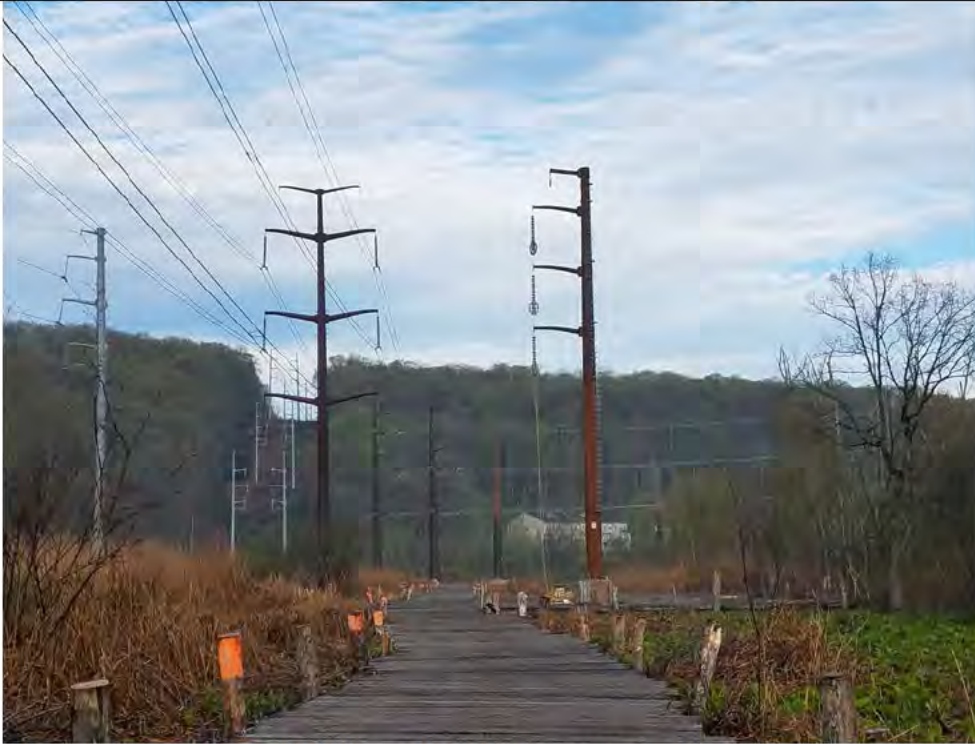
Photo 3: 05/04/2018, Bethel: Map 02, Str1004 through Str1005, weathered steel structures installed. Photo taken facing west from Str1003 toward Str1005 in the distance.

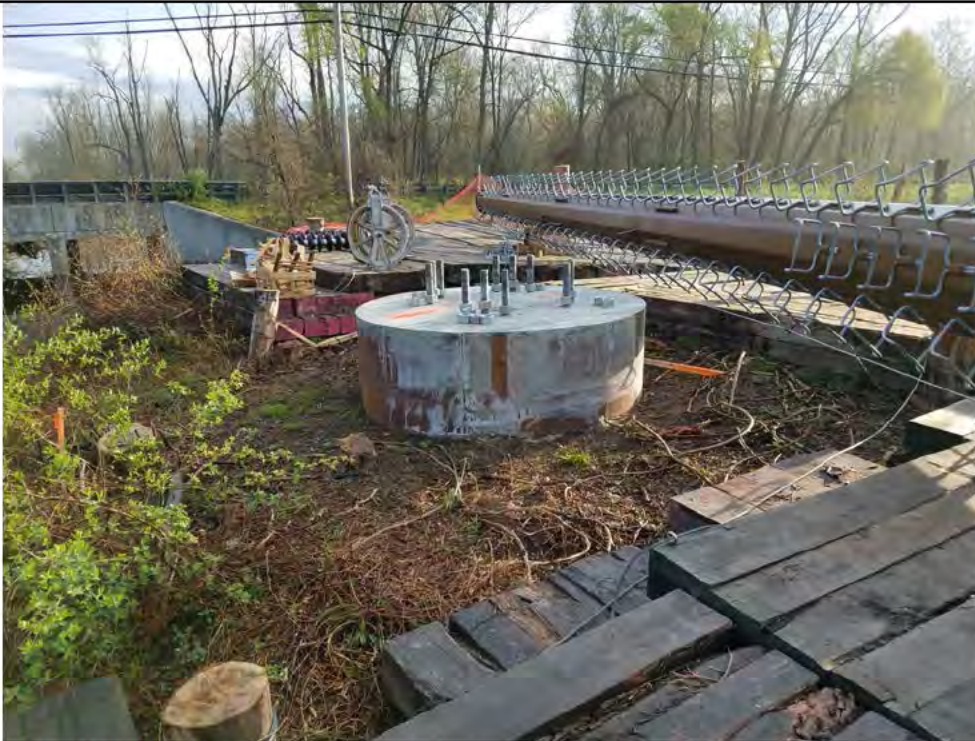
Photo 4: 05/04/2018, Bethel: Map 03, weather steel structure assembled and ready for installation. All drill cuttings removed from the area, little to no ground impacts outside of the foundation area within Wetland W-1. Photo taken facing north toward Shelter Rock Road.

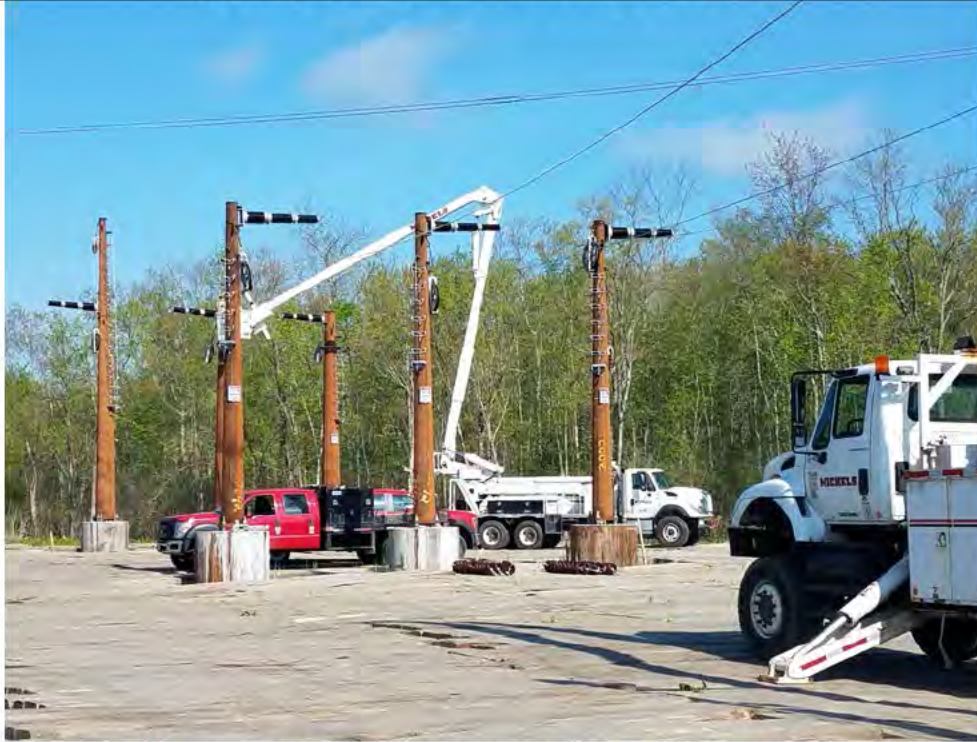
Michels observed setting up to pull line through 1000-1004 (Photo 5). Project Inspectors performing turtle sweeps.

- Structures erected at Str1000-1006, Michels set up to start pulling line through structures (Photo 5).

Photo 5: Bethel: Map 01, Str1002 through Str1003, set up to start pulling line, Str1000 through Str1005. Photo taken facing northwest.
