**Subject: Docket No. 468, Plumtree Substation to Brookfield Junction 115-kV Project  
Decision and Order Condition #4 – Independent Environmental Inspector Report**

Please find enclosed the Biweekly Independent Environmental Inspector Report, Report #17, for the **May 17<sup>th</sup>**, and **May 24<sup>th</sup>, 2018** inspection events for the construction of the Eversource Plumtree Substation to Brookfield Junction 115-kV Project.

**Docket No. 468– Development and Management Plan Inspection**

## Southwest Connecticut Reliability Project

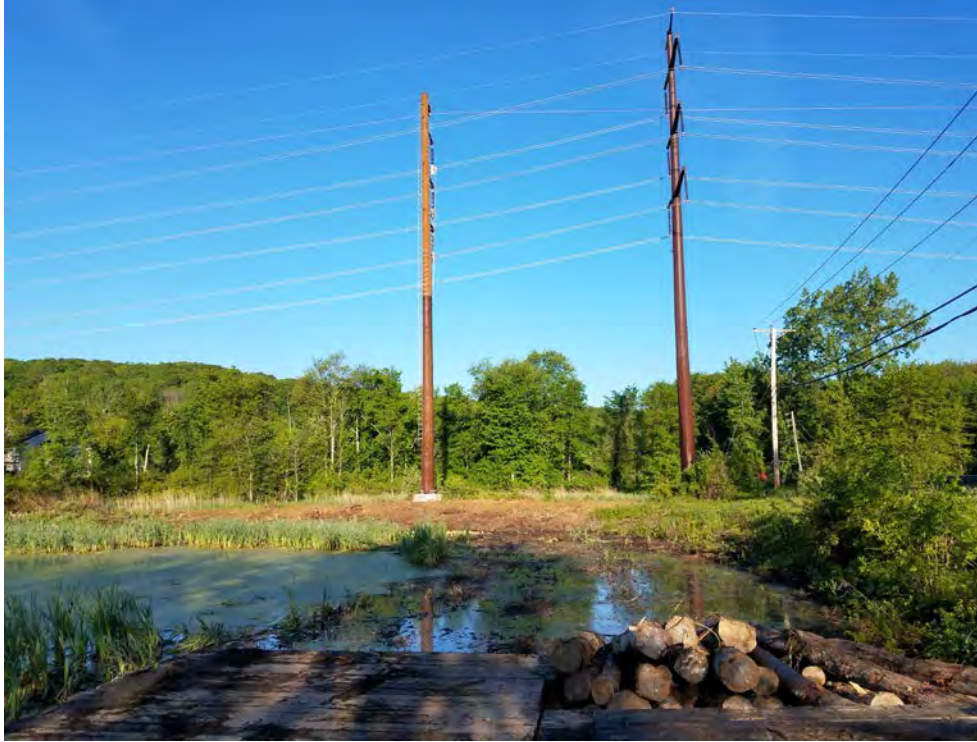
Photo 1: Bethel: Map 03, Str1007 and Wetland W1, Removal of timber mat access and work pad. Photo taken facing west, Structure Str1007 shown central in the photo.

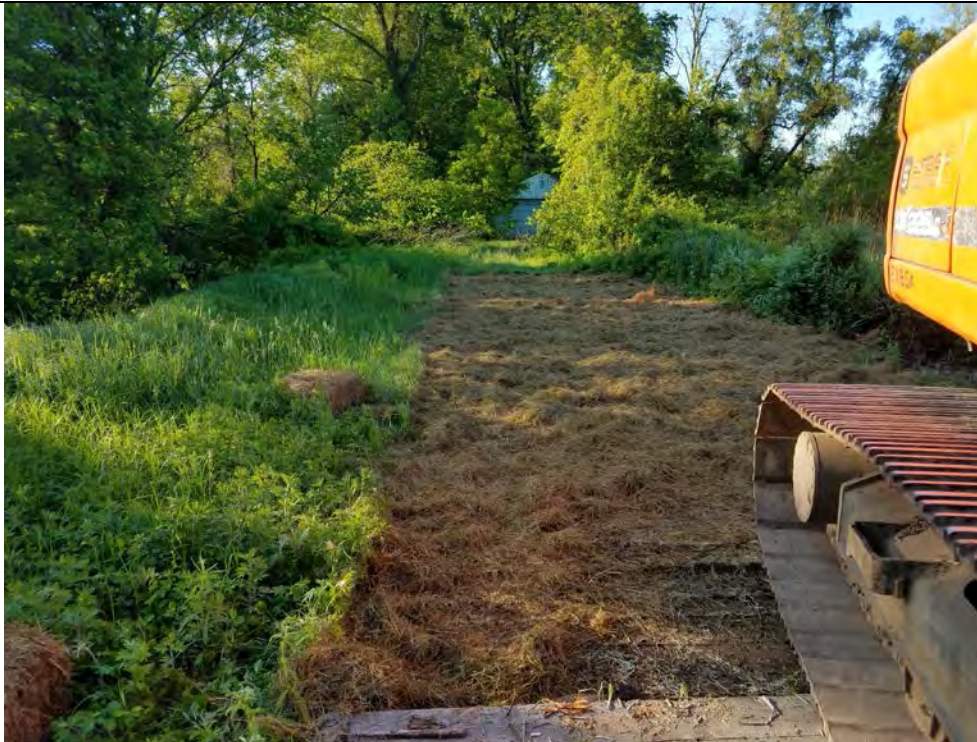
Photo 2: Bethel: Map 03, temporary equipment staging area for Str1007, removal of timber mat access and work pad. Photo taken facing south, town maintenance shed in the distance.
