**Subject: Docket No. 468, Plumtree to Brookfield Junction 115-kV Project
Decision and Order Condition #4 – Independent Environmental Inspector Report**

Please find enclosed the Biweekly Independent Environmental Inspector Report, Report #20, for the **June 28th** and **July 5th 2018** inspection events for the construction of the Eversource Plumtree to Brookfield Junction 115-kV Project.

Docket No. 468– Development and Management Plan Inspection

Southwest Connecticut Reliability Project

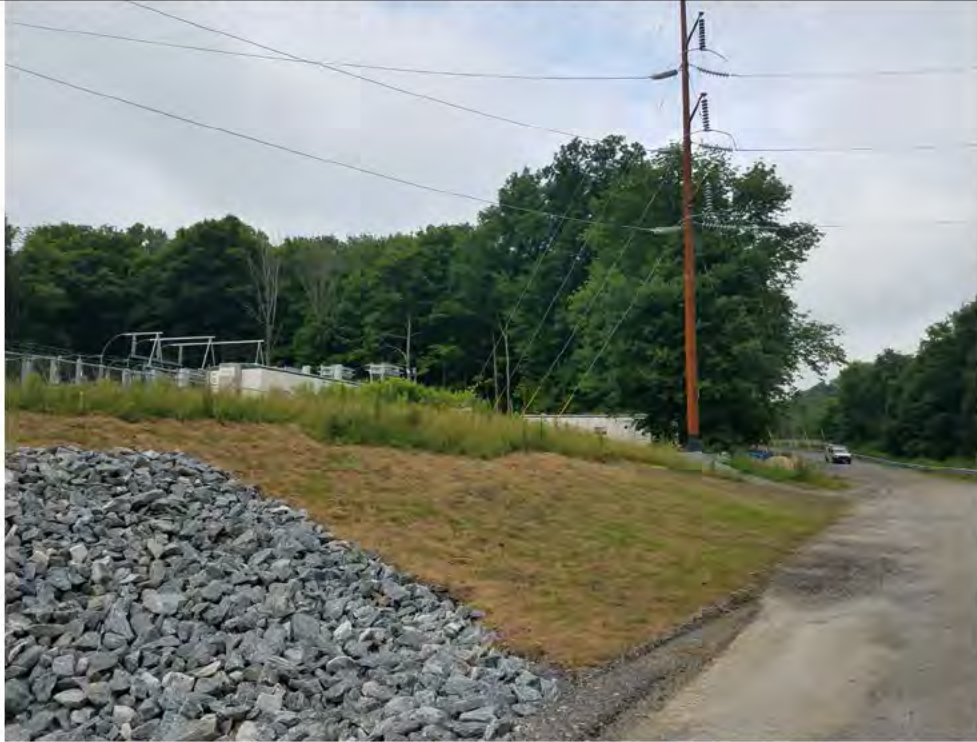
Photo 1: 07/05/18, Stony Hill Substation Str4648A stabilization of disturbed ground surfaces. Photo taken facing west along the Stony Hill Substation access road towards the Town of Brookfield Stony Hill Road.

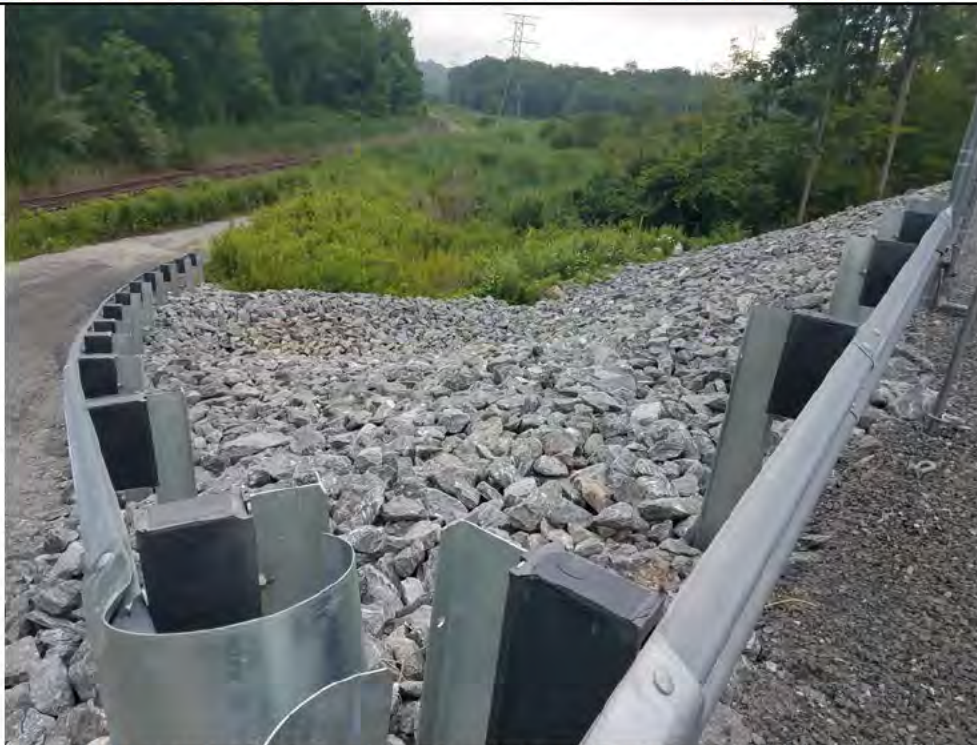
Photo 2: 07/05/18, Stony Hill Substation slope stabilization and site drainage feature abutting wetland W7. Photo taken facing northeast toward wetland W7.

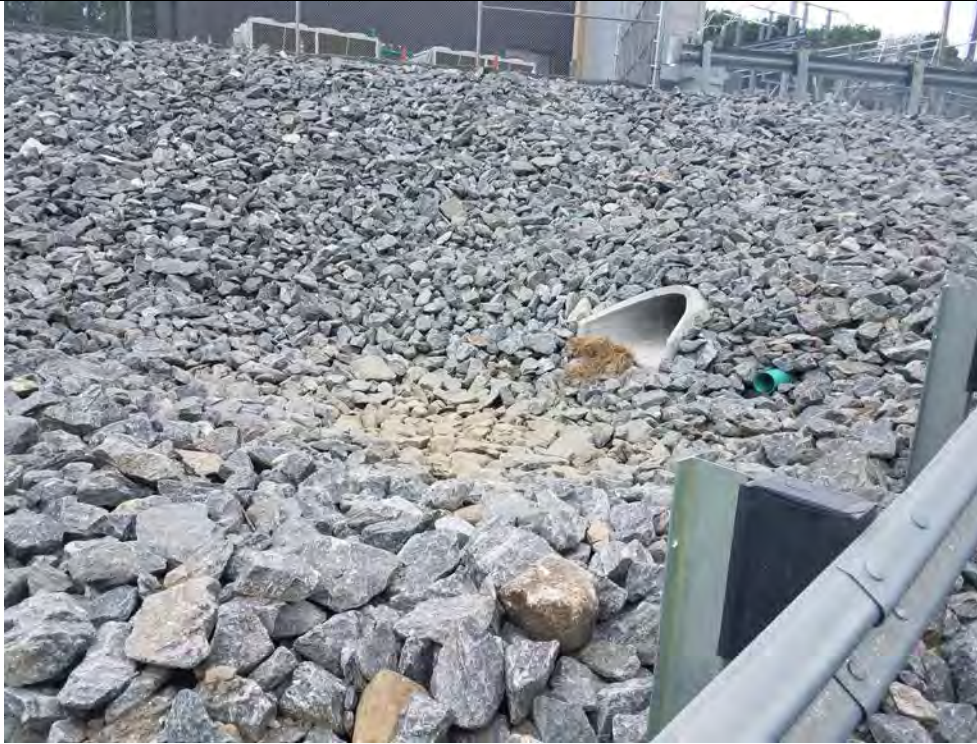
Photo 3: 07/05/18, Stony Hill Substation slope stabilization and site drainage feature abutting wetland W7. Photo taken facing southwest towards the substation from the access road shown in Photo 2.
