# Subject: Docket No. 468, Plumtree to Brookfield Junction 115-kV Project Decision and Order Condition #4 – Independent Environmental Inspector Report

Please find enclosed the biweekly Independent Environmental Inspector Report, Report #21, for the **July 13<sup>th</sup>** and **July 19<sup>th</sup> 2018** inspection events for the construction of the Eversource Plumtree to Brookfield Junction 115-kV Project.

# Photograph Log Southwest Connecticut Reliability Project Plumtree To Brookfield Junction

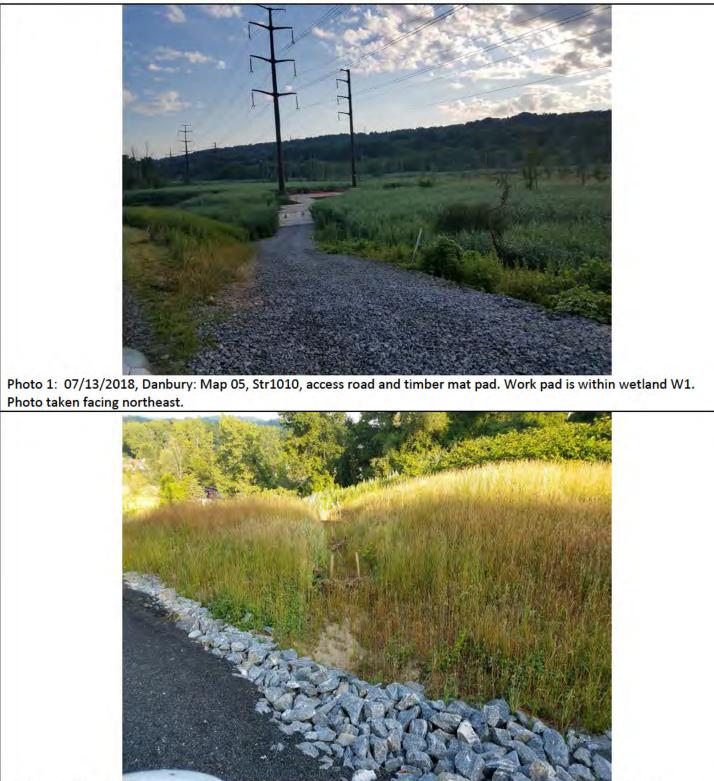
Photo 2: 07/13/2018, Danbury: Map 06, Str1013, slope stabilization (revegetation of disturbed area), drainage swale and temporary E&S controls (straw bale check dams) all appear to be in accordance with Eversource's BMP Manual. Photo taken facing north in the direction of Str1012.

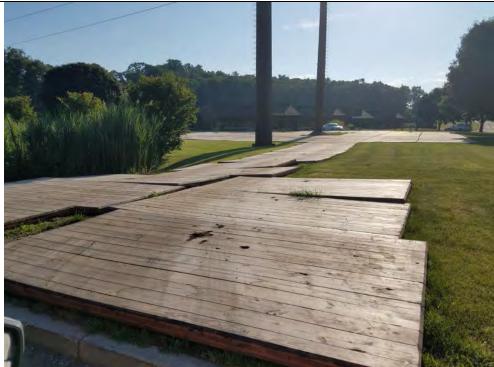
Photo 3: 07/13/2018, Bethel: Map 12, Str1022, access road to the structure area as well as the work pad is constructed with wood mats. Wetland W5 is abutting to the north. Photo taken facing east. All appears to be in accordance with Eversources's BMP Manual.
