**Subject: Docket No. 468, Plumtree to Brookfield Junction 115-kV Project
Decision and Order Condition #4 – Independent Environmental Inspector Report**

Please find enclosed the Biweekly Independent Environmental Inspector Report, Report #23, for the **August 9th** and **August 16th, 2018** inspection events for the construction of the Eversource Plumtree to Brookfield Junction 115-kV Project.

Southwest Connecticut Reliability Project

Plumtree To Brookfield Junction

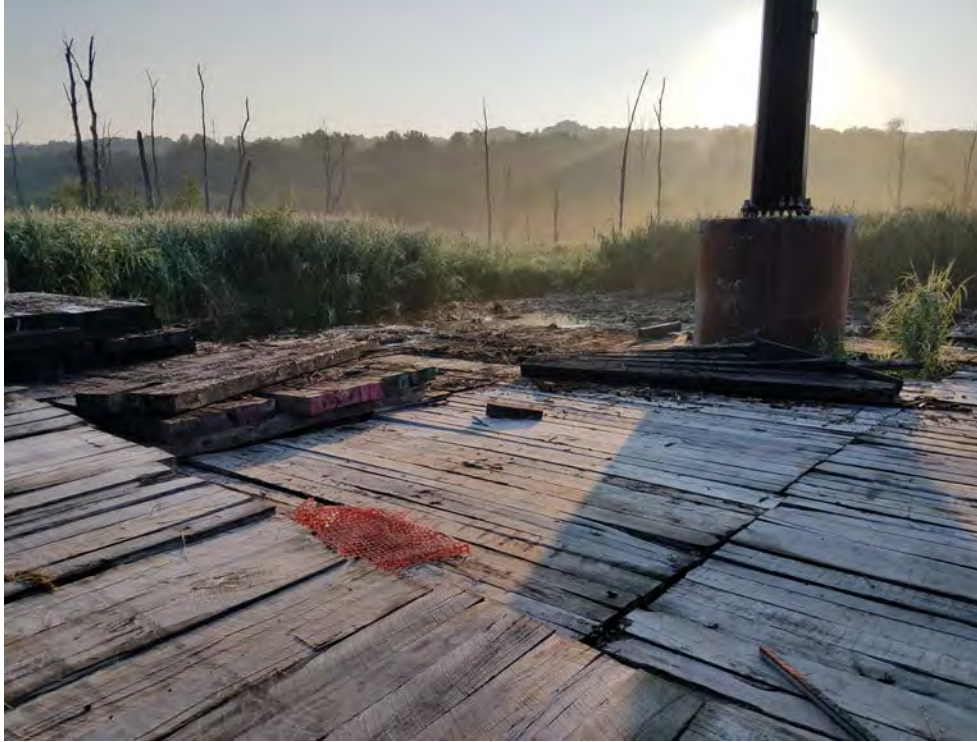
Photo 1: 08/09/2018, Danbury: Map 5, Str1010, timber mat pad and access road removal, and initial restoration being performed. Photo taken facing northeast.

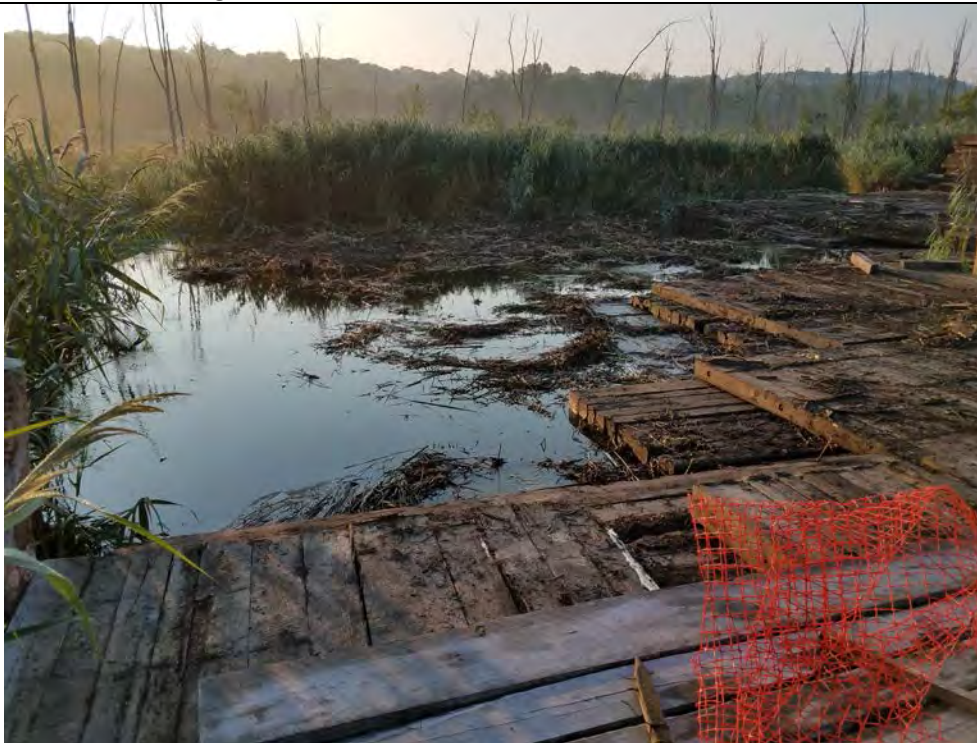
Photo 2: 08/09/2018, Danbury: Map 5, Str1010, timber mat pad and access road removal, and initial restoration being performed. Photo taken facing east.

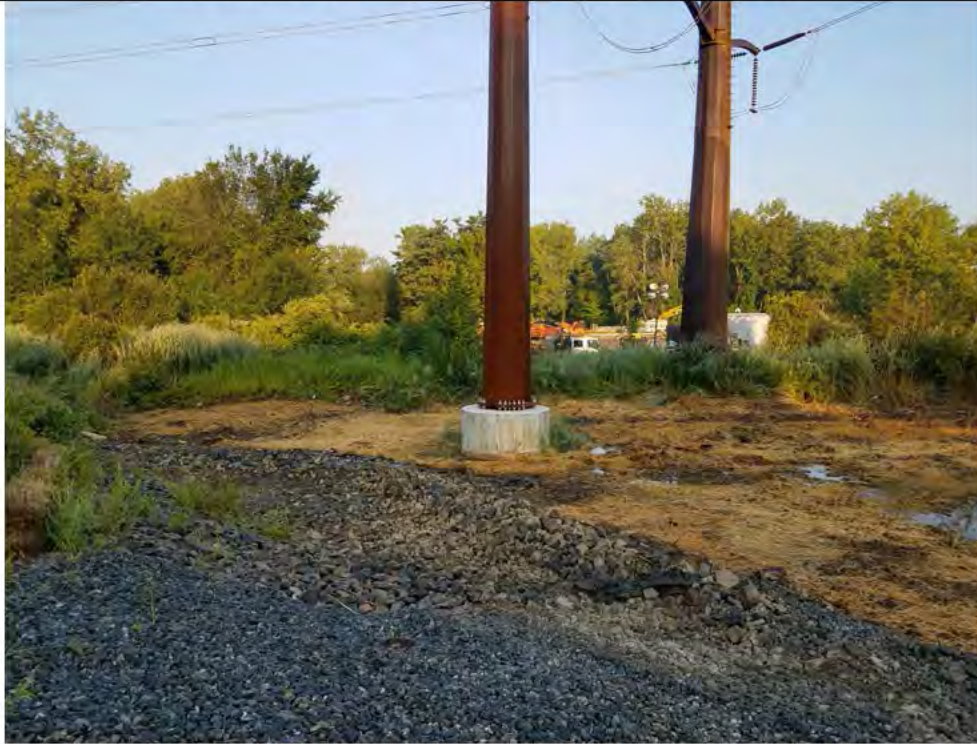
Photo 3: 08/09/2018, Danbury: Map 6, Str1011 and Str1012 (Str1012 shown in photo), timber mat pads and access road removed, and initial restoration performed. Photo taken facing northwest.

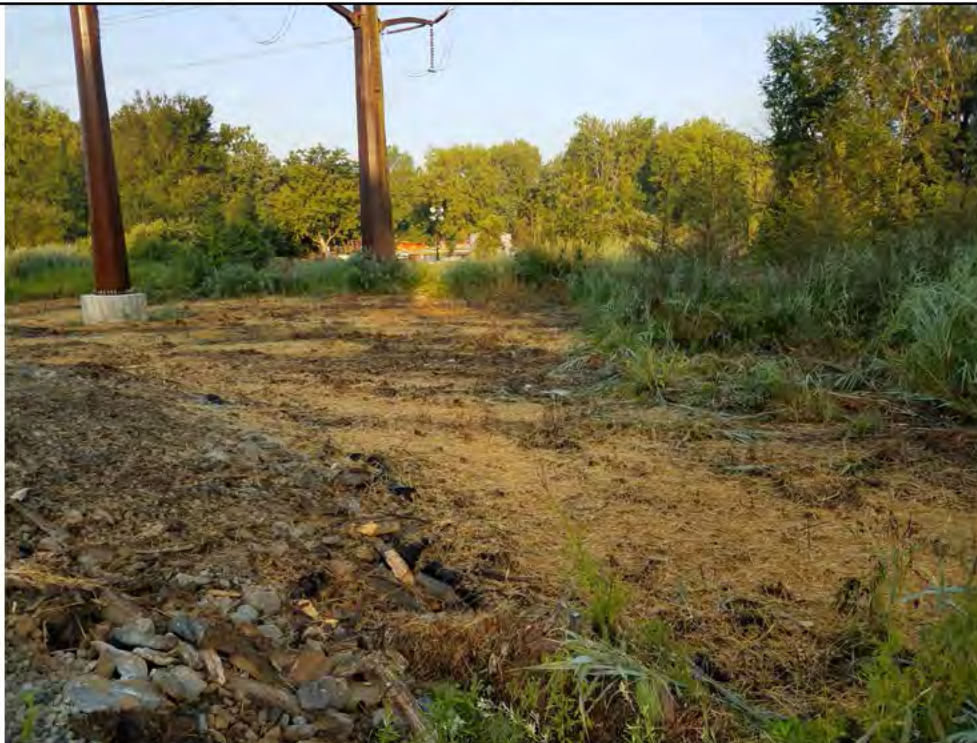
Photo 4: 08/09/2018, Danbury: Map 6, Str1011 and Str1012 (shown in photo), timber mat pads and access road removed, and initial restoration performed. Photo taken facing west.
