Subject: Docket No. 468, Plumtree to Brookfield Junction 115-kV Project

Decision and Order Condition #4 – Independent Environmental Inspector Report

Please find enclosed the Biweekly Independent Environmental Inspector Report, Report #24, for the **August 23rd** and **August 30th**, **2018** inspection events for the construction of the Eversource Plumtree to Brookfield Junction 115-kV Project.

Docket No. 468- Development and Management Plan Inspection

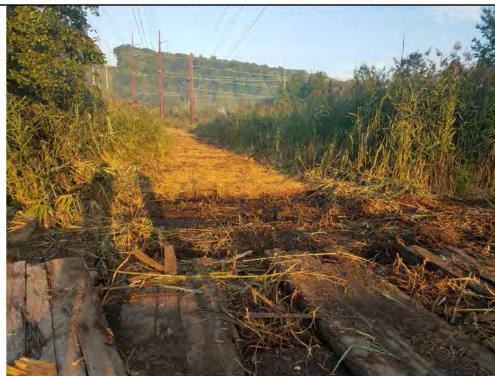
Photo 1: 08/30/2018, Danbury: Map 2, the timber mat access road and structure work pads west of Str1003 through to Str1006 have been removed. Initial stabilization/restoration has been performed. Photo taken facing west, west of Str1003.

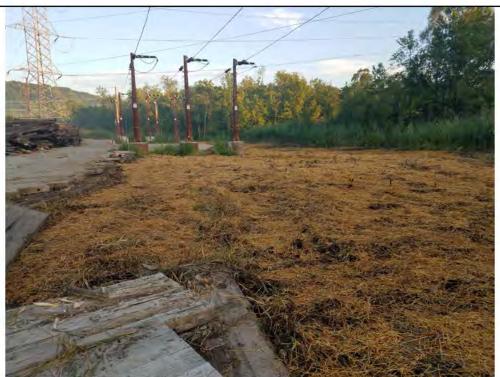
- -Supreme is on site setting up in the area of Str1000 Str1004 to resume timber mat removal and continue restoration following the completion of counterpoise activities between Str1000 and Str1003. Counterpoise has been completed, the trench areas backfilled and ground surfaces restored (see Photos 1 & 2).
- -Supreme has performed initial restoration in the areas between Str1004 Str1027 with the exception of the above discussed areas, Str1010 (partial timber mat pad still in place, see Photo 3), and at Str1023. No erosion has been observed (other than at Str1023), and at this time the areas appear to be stable with adequate vegetation growth (see Photo 4, existing conditions at Str1012).
- -The Flood Plain Compensation Area (Compensatory Floodplain Mitigation Area, Map Page 04) work is being scheduled at this time.

Photo 2: 08/30/2018, Danbury: Map 1, the timber mat work pad areas from Str1000 through to Str1003 have been removed and counterpoise completed. Initial stabilization/restoration has been performed. Photo taken facing west, west of Str1000.

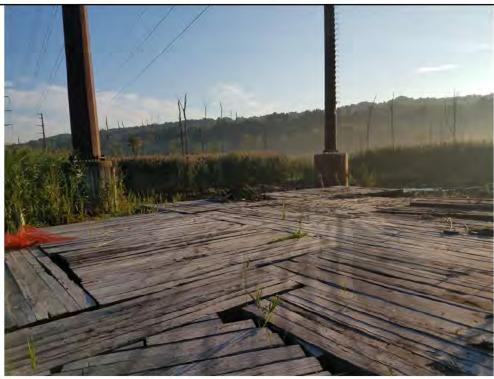
Photo 3: 08/30/2018, Danbury: Map 5, Str1010, partial timber mat pad and access road removal, and initial restoration being performed. Timber mats have been removed north and east of the structures. Photo taken facing northeast.

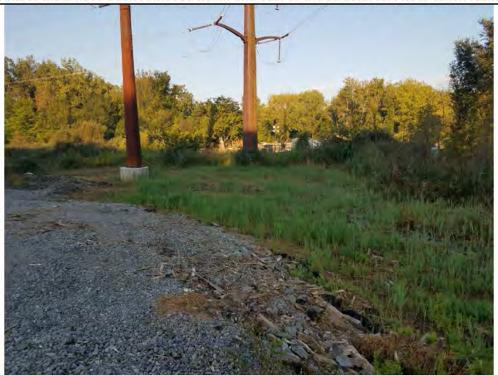
Photo 4: 08/30/2018, Danbury: Map 6, Str1012, stabilization in progress, natural regrowth of vegetation within wetland W1. Photo taken facing west from the gravel pull pad (to remain in place), west side of the north end of Old Sherman Turnpike.
