**Subject: Docket No. 468, Plumtree to Brookfield Junction 115-kV Project  
Decision and Order Condition #4 – Independent Environmental Inspector Report**

**Docket No. 466– Development and Management Plan Inspection**

**Final Inspection:**

**Date:** 09/20/2018 & 09/27/2018

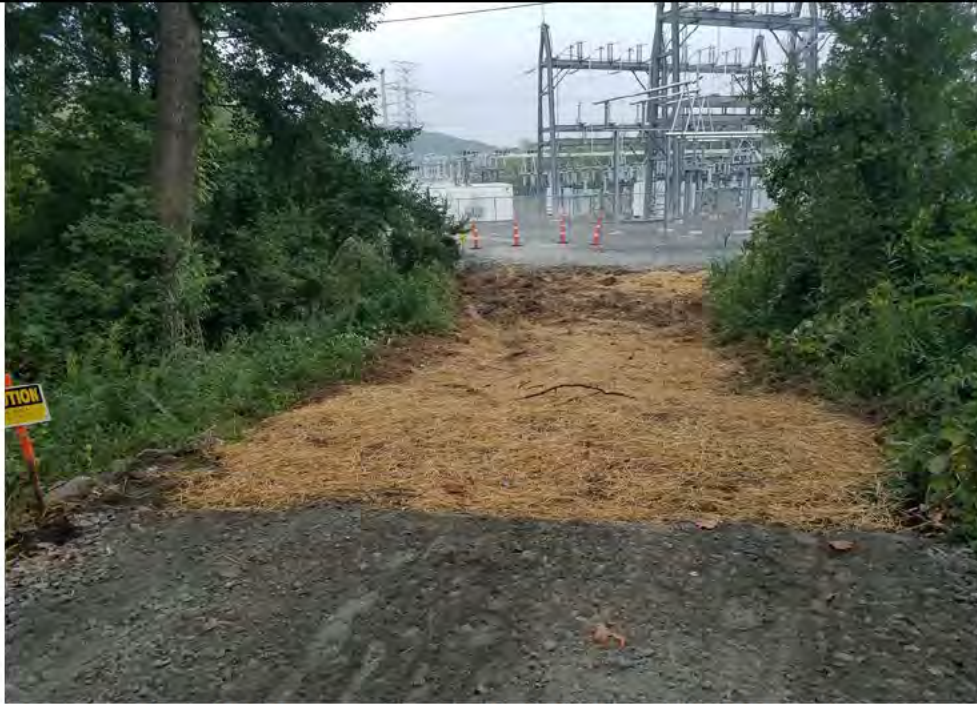
Photo 1: 09/20/2018, Bethel: Maps 01A-01, access road to Str1000 through Str1006 at the culvert crossing of Wetland W1 outside of the southeast fence line of the Plumtree Substation. Timber mats removed and initial restoration performed. Photo taken facing northwest from the southeast side of the culvert area towards the Plumtree Substation in the distance.

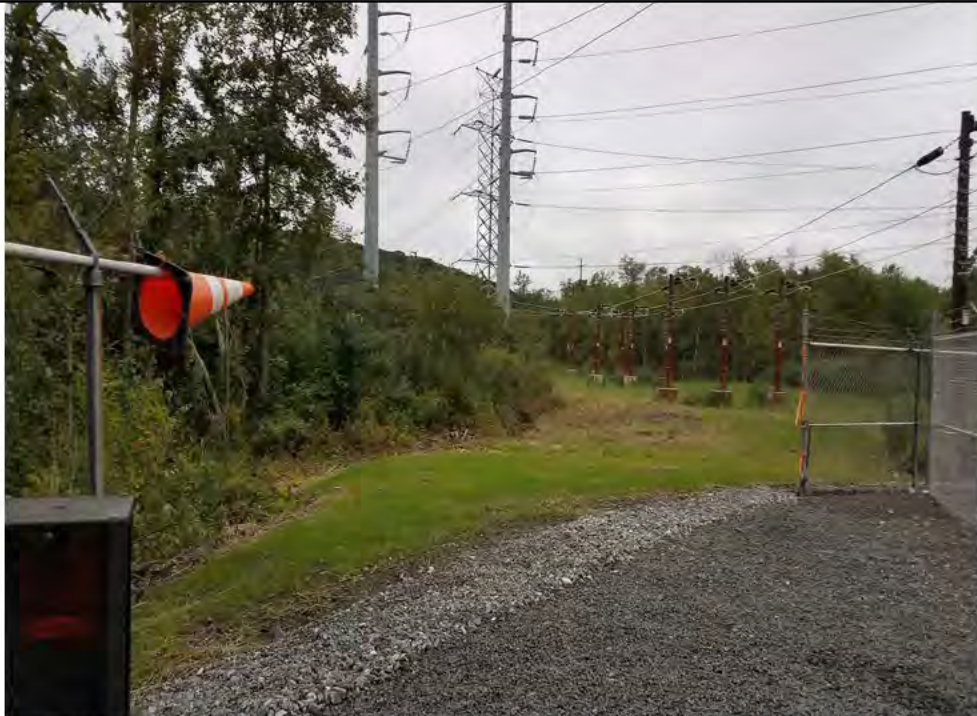
Photo 2: 09/20/2018, Bethel: Maps 01A-02, access road to Str1000 through Str1006, all timber mats removed from within Wetland W1 and initial restoration has been performed. Photo taken facing northwest from the southwest corner of the Plumtree Substation towards Str1003 in the distance.

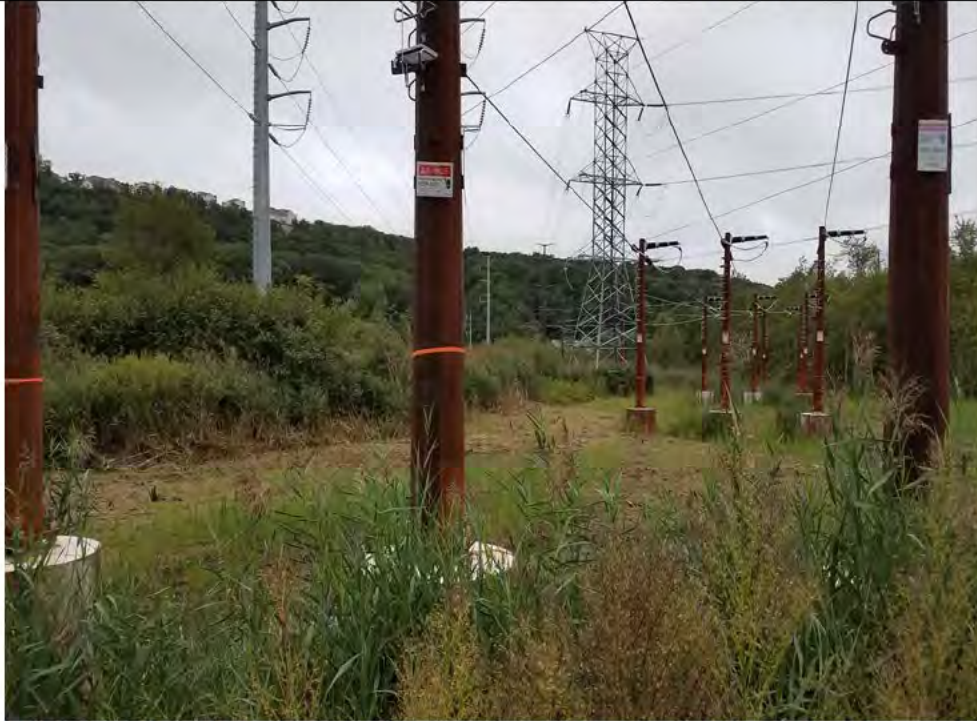
Photo 3: 09/20/2018, Bethel: Maps 01A-02, view of structures Str1000 through Str1003 within wetland W1. All timber mats removed and initial restoration performed. Photo taken facing northwest from Str1000 to Str1003 in the distance.

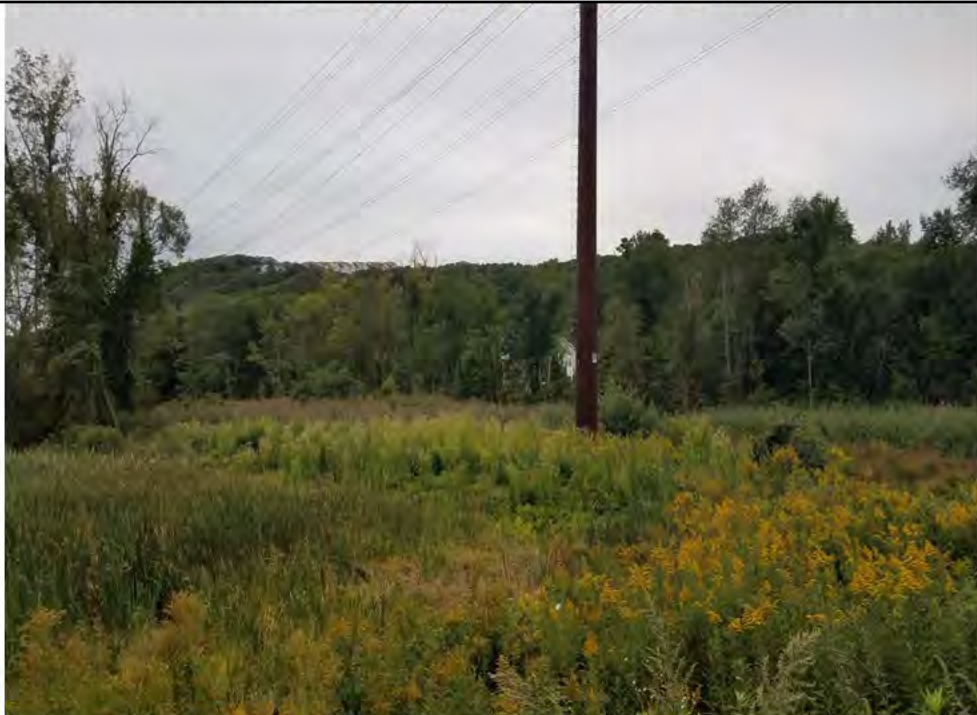
Photo 4: 09/20/2018, Bethel: Map 03, view of structure Str1007 located within wetland W1 off of Shelter Rock Road in a Rare Species Designated Area. All timber mats have been removed, all temporary anchor points were removed and initial restoration has been performed. Photo taken facing southwest.

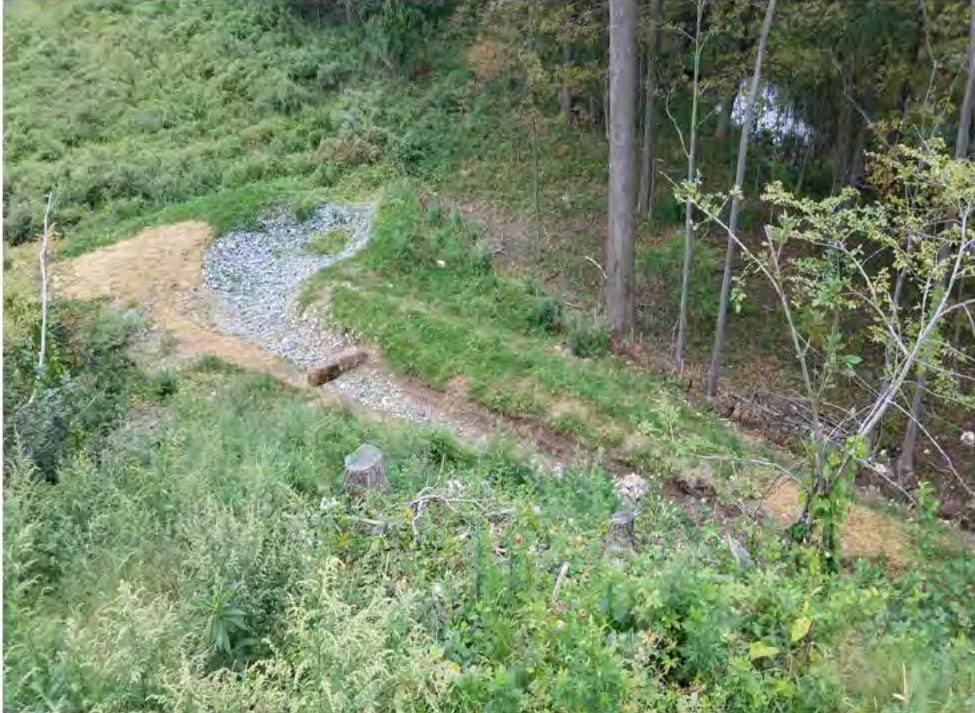
Str1007	Yes				
04	Str1008	Yes	Wetland W1, East Swamp Brook S1, Limekiln Brook S2	All timber mats (and anchors), project related equipment, and project related debris, have been removed from the Project ROW.  The Compensatory Floodplain Mitigation Area (D&M Plan Map Detail Sheet 9), has been constructed.  Initial restoration has been performed and vegetation regrowth is occurring. No erosion was observed in the area of the Project ROW between Str1007 through Str1008.	No permanent BMPs in the wetland area. Appears all non biodegradable E&S controls have been removed. Areas will be continue to be monitored by the project until full restoration has been established. Any remaining temporary E&S controls will be removed following full restoration.	Photo 13- Str1008 access road restoration and Compensatory Floodplain Mitigation Area.
05 & 5A	Str1009	Yes	Wetland W1, Limekiln Brook S2	All project related equipment and project related debris, have been removed from the Project ROW.  All temporary E&S controls have been removed. Permanant BMPs have been maintained, No erosion observed.	Drainage swale and riprap lined sediment basin, riprap check dams. Areas will continue to be monitored by the project until full restoration.	Photos 5 and 6- Str1009 down gradient Permanent BMPs.

Photo 5: 09/20/2018, Danbury: Map 05, view of rip rap filled sediment basin and soil drainage swale with straw bales and/or rip rap check dams (Permanent BMPs), constructed along the bottom of the east slope, parallel with Wetland W1. Photo taken facing northeast from the structure work pad.

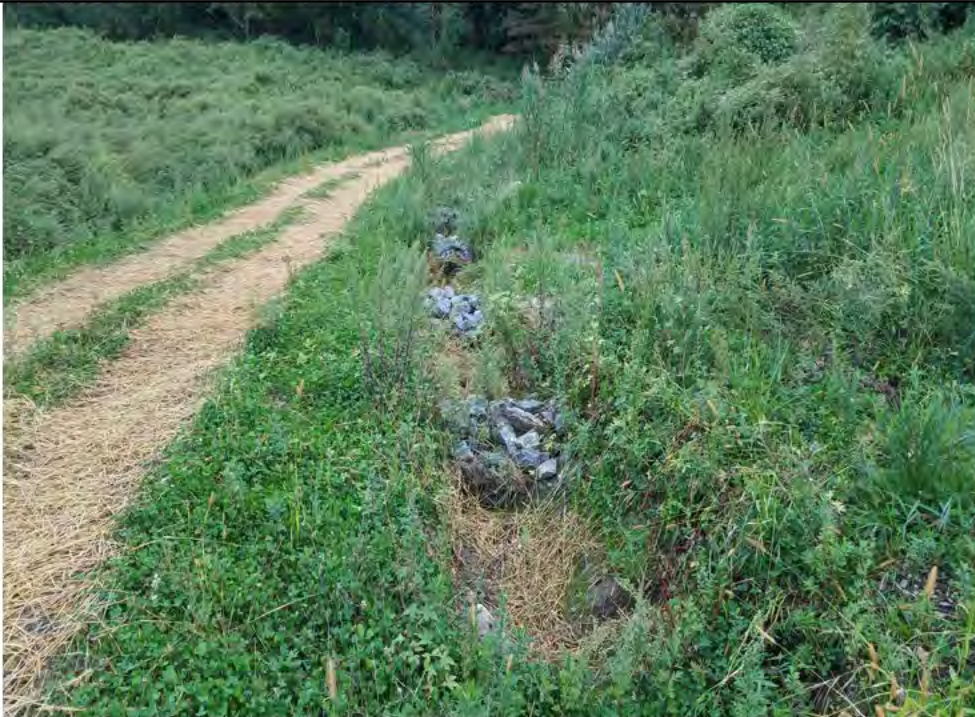
Photo 6: 09/20/2018, Danbury: Map 05, view of grass filled drainage swale with rip rap check dams (Permanent BMPs), constructed along the bottom edge of the north slope and connecting to the sediment basin shown in Photo 5 above, parallel with the pad and along the limits of disturbance as shown on Map Sheet 05. Photo taken facing east.

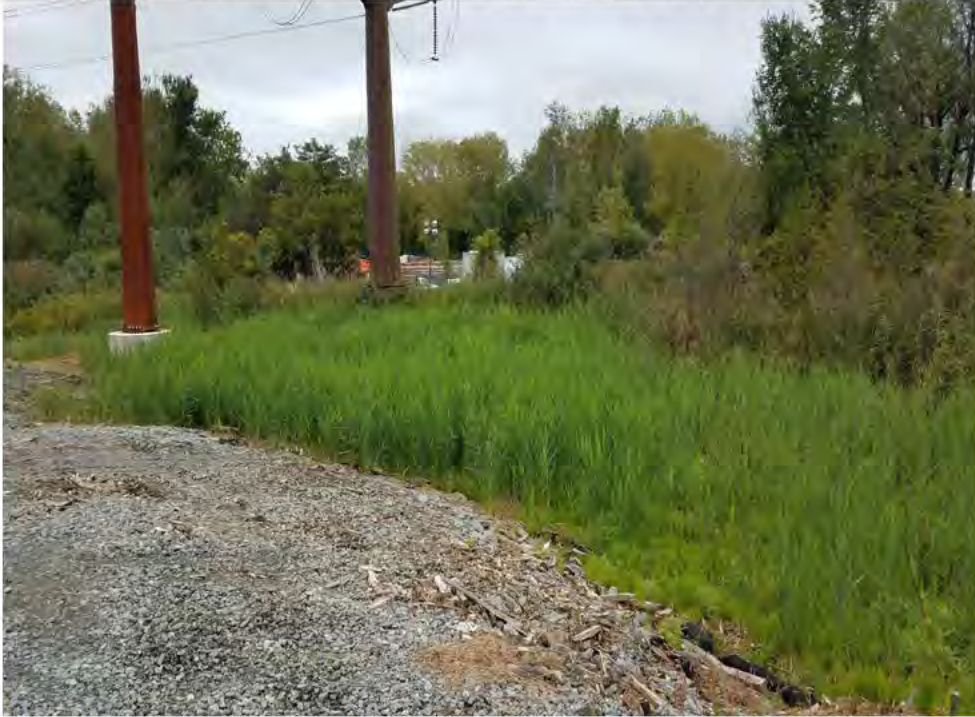
06	Str1011	Yes	Wetland W1, Wetland W2, Limekiln Brook S2, Unnamed Watercourse S3	All timber mats (and anchors), project related equipment, and project related debris, have been removed from the Project ROW.  Initial restoration has been performed and vegetation regrowth is occurring. No erosion or sedimentation was observed.	No permanent BMPs in the wetland area. Appears all non biodegradable E&S controls have been removed. Areas will be continue to be monitored by the project until full restoration has been established. Any remaining temporary E&S controls will be removed following full restoration.	
	Str1012	Yes		All timber mats (and anchors), project related equipment, and project related debris, have been removed from the Project ROW.  Initial restoration has been performed and vegetation regrowth is occurring. No erosion or sedimentation was observed.	Gravel pull pad remaining in place, riprap lined drainage feature in the north corner of the pull pad at Old Sherman Turnpike also remaining in place.	Photo 7- Str1012 restoration

Photo 7: 09/20/2018, Danbury: Map 06, view of Str1012 and access point to Str1012 and Str1011 (to the south, not shown in this view). Gravel pull pad to remain in place, timber mat access road and work pads removed. Initial restoration performed and natural revegetation visible. Photo taken facing west from the pull pad towards Str1012.

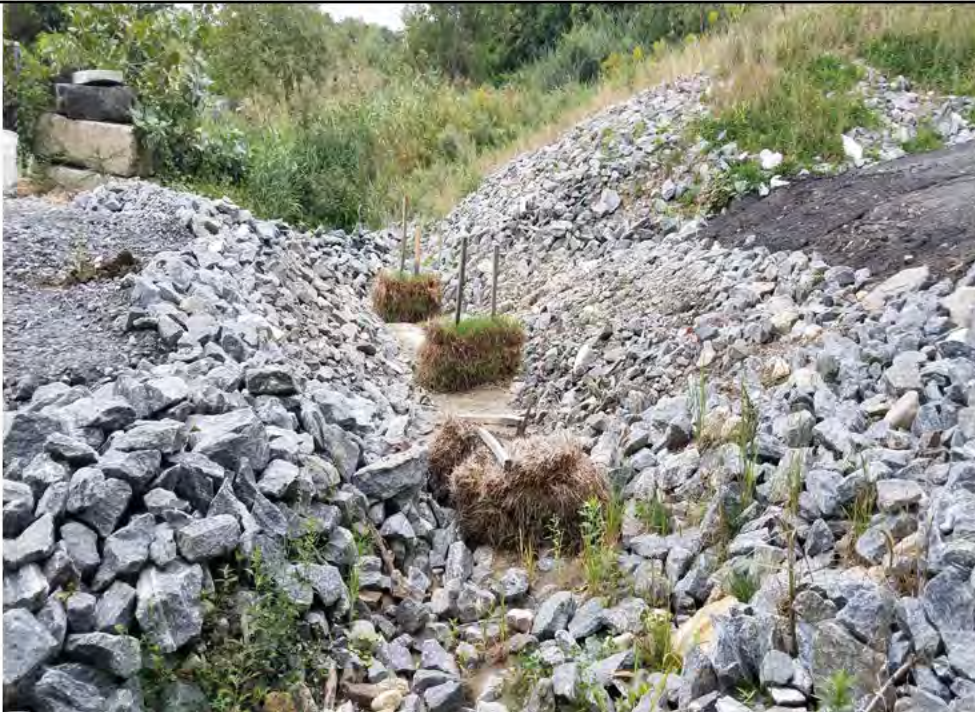
Photo 8: 09/20/2018, Danbury: Map 06, view of rip rap filled swale, sediment basin, and straw check dams constructed at the intersection of the Unnamed watercourse and the access road to Str1013, south end of Old Sherman Turnpike. A temporary rip rap filled hard bottom crossing has been removed and the final rip rap drainage swale and sediment basin is now in place (Permanent BMPs). Photo taken facing north parallel with Old Sherman Turnpike.

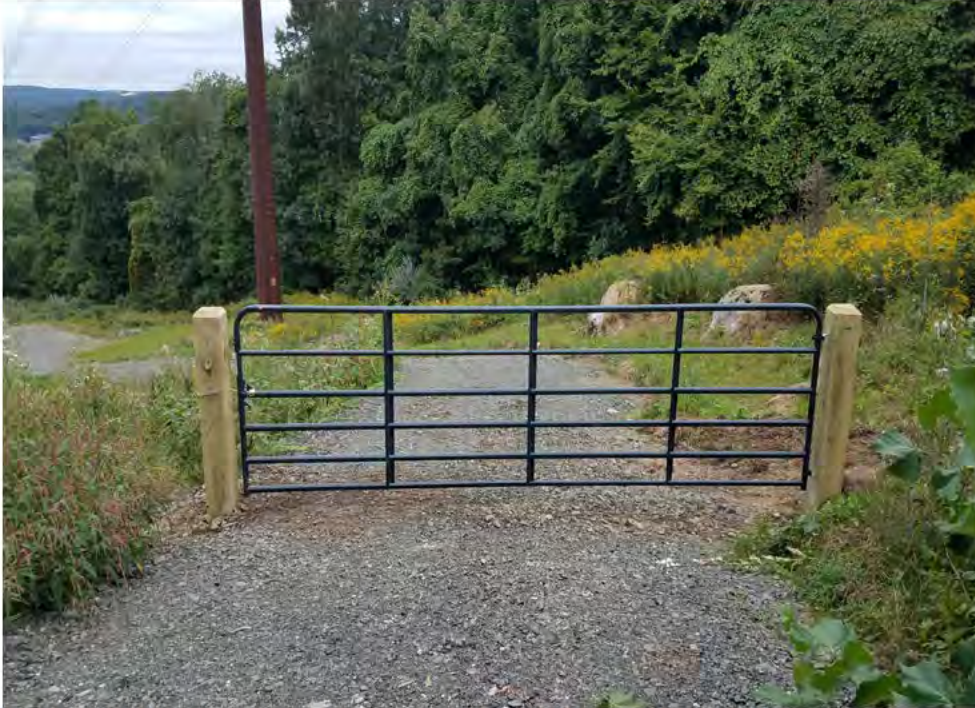
Photo 9: 09/20/2018, Bethel: Map 07, view of access road to Str1014 and installed security gate. Final grading (pad and access road) and initial restoration has been performed. Photo taken facing west from Hearthstone Drive towards Str1014 in the distance.

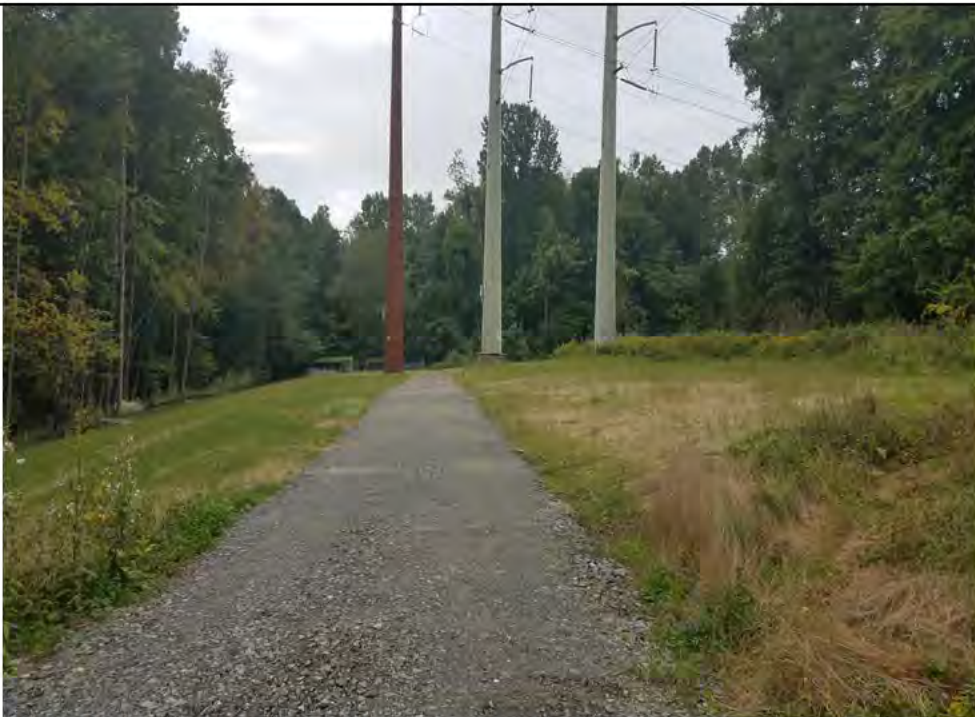
Str1013	Yes		All timber mats, project related equipment, and project related debris, have been removed from the Project ROW.  Initial restoration has been performed and vegetation regrowth is occurring. No erosion was observed at the time of this inspection	West end of access road removed and permanent drainage swale (constructed in a south-north orientation) with check dams constructed to divert stormwater run off from abutting property to the unnamed watercourse.	Photo 8- Str1013 access road restoration and Permanent BMPs
07	Str1014	Yes	Wetland W2, Unnamed Watercourse S4	Initial restoration has been performed and vegetation regrowth is occurring. No erosion was observed at the time of this inspection.	Soil berm constructed along the south and and part of the west side of the work pad. Access road gate installed at this location.	Photo 9- Str1014 access road gate installed.
	Str1015	Yes		Initial restoration has been performed and vegetation regrowth is occurring. No erosion was observed at the time of this inspection.	No permanent BMPs at this location. Access road gate installed at this location.	Photo 10- Access road and area restoration.

Photo 10: 09/20/2018, Bethel: Map 07-08, view of Structure Str1015 (Map 07) and the permanent access road off of Chimney Drive (Map 08). Final pad and access road grading, and initial restoration has been performed. Photo taken facing south from Chimney Drive towards Str1015 in the distance.

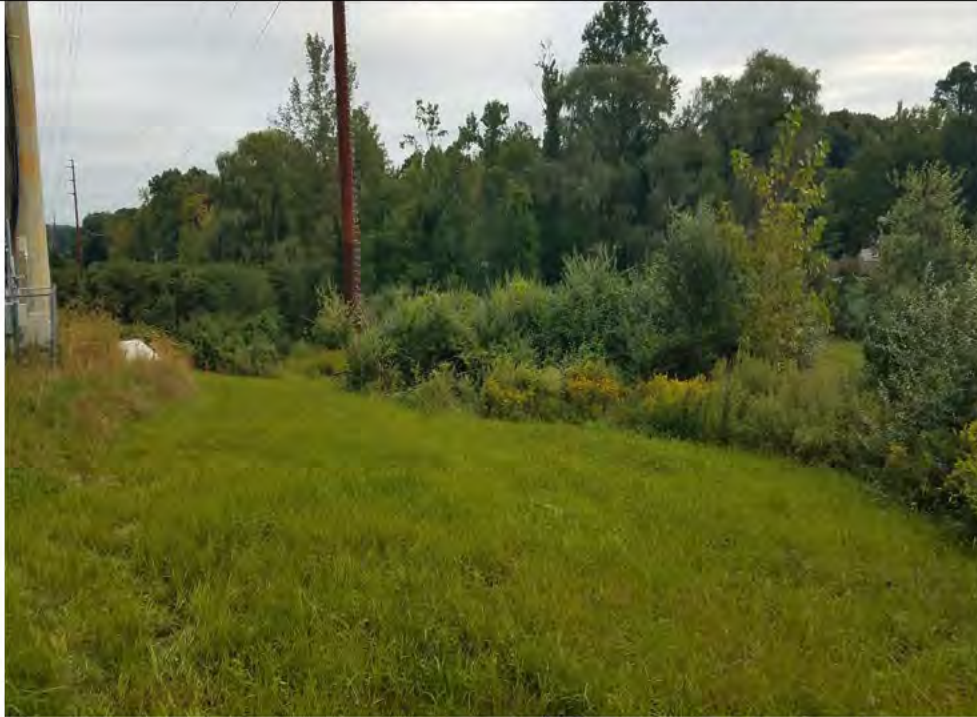
Photo 11: 09/20/2018, Bethel: Map 08, view of Structure Str1016 and access road, removal of timber mats, final grading, and initial restoration has been performed. Photo taken facing northeast from Chimney Drive towards Str1016 in the distance.

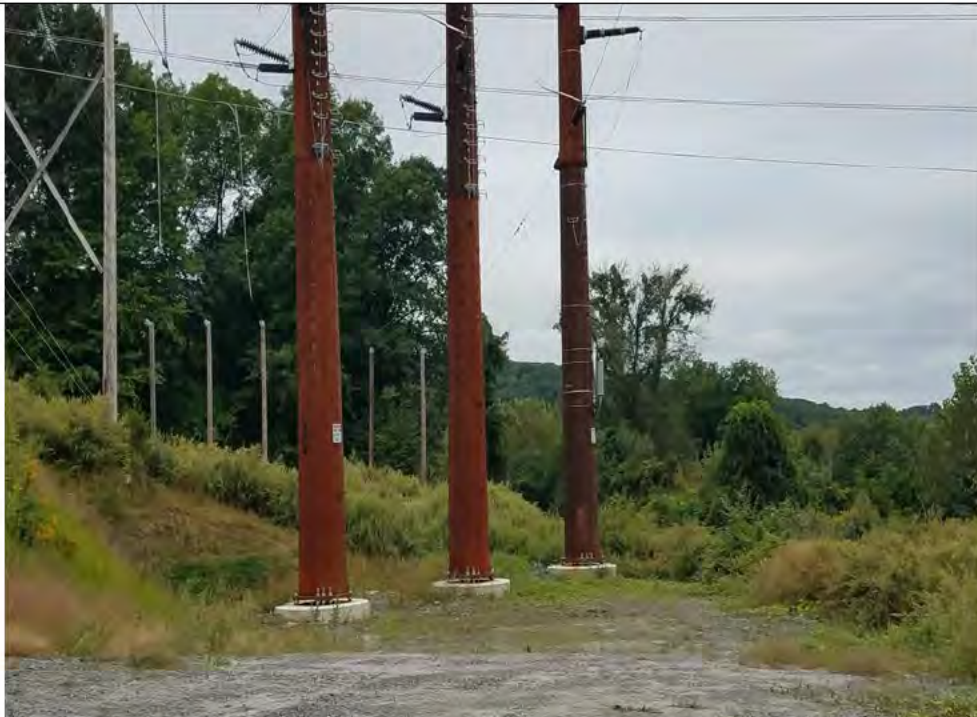
Photo 12: 09/20/2018, Bethel: Map 07, view of Str1027, Final grading and initial restoration has been performed. Stone work pad is staying in place, natural revegetation is occurring. No soil erosion observed, upland slope and pad appears to be stable at this time. Photo taken facing west towards Str1027.

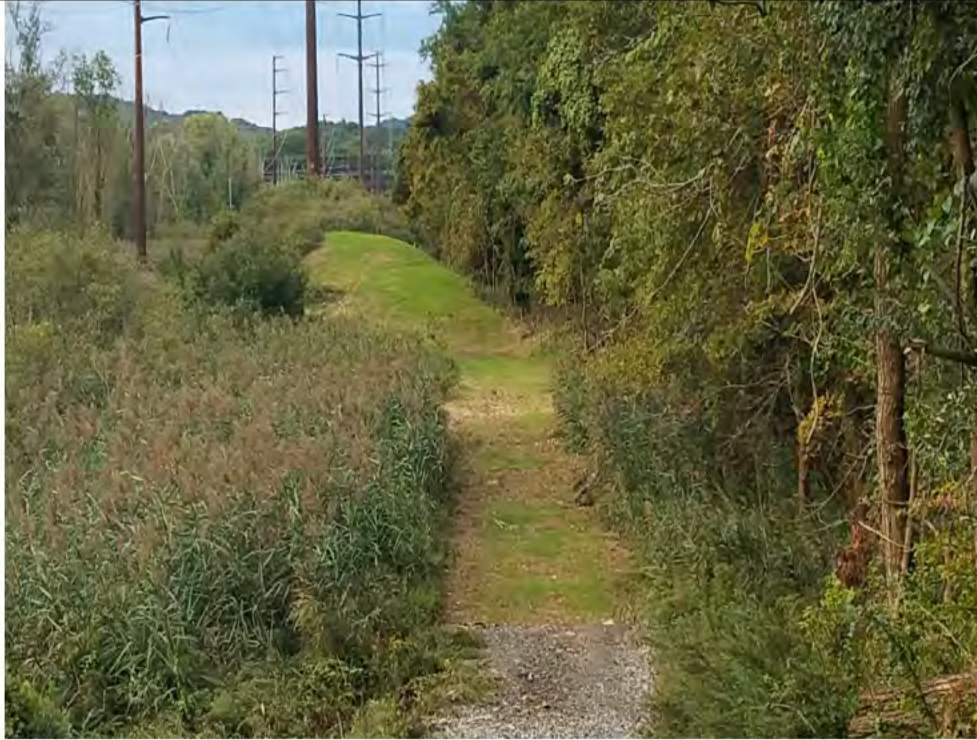
Photo 13: 09/27/2018, Danbury: Map 4, view of the compensatory Floodplain Mitigation Area, north of Str1008 (Detail Sheet 9).

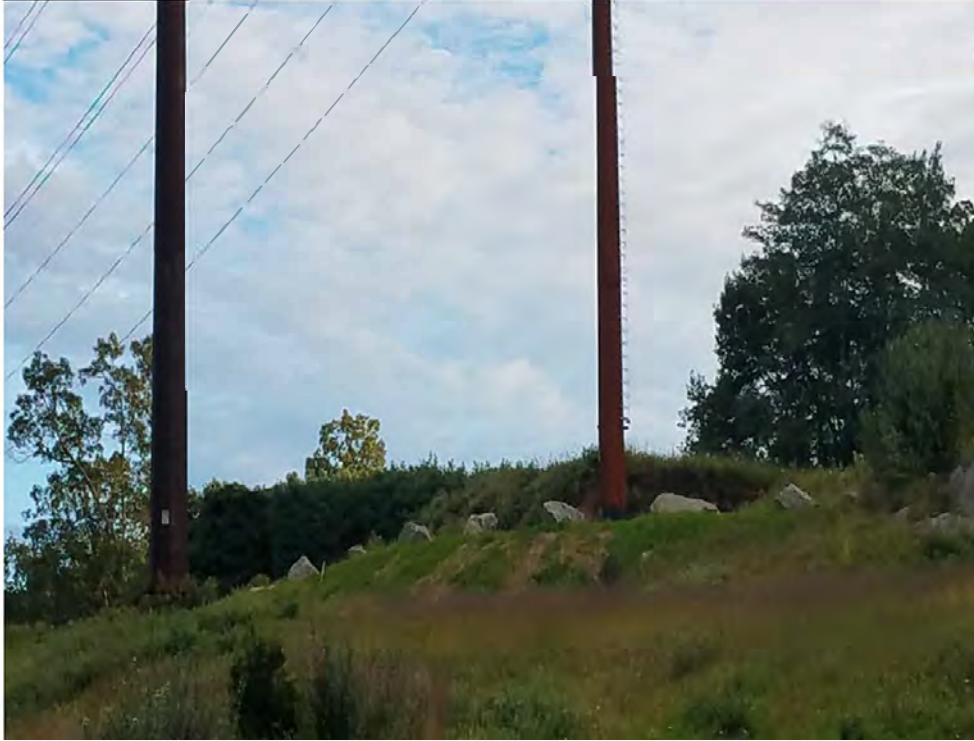
Photo 15: 09/27/2018, Bethel/Brookfield: Map 12, Str1023, view of west slope of work pad where previous erosion occurred. Area has been stabilized with seed and straw mulch. At the time of this inspection grass was growing and no erosion was observed.

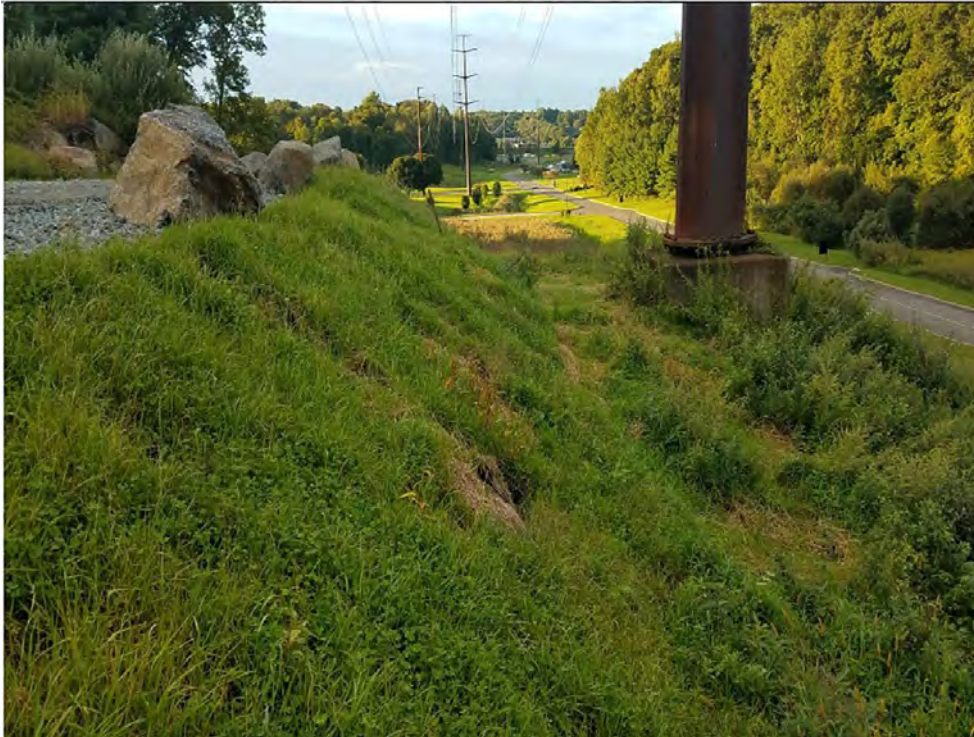
Photo 16: 09/27/2018, Bethel/Brookfield: Map 12, Str1023, north-south view of west slope of work pad where previous erosion occurred. Area has been stabilized with seed and straw mulch. At the time of this inspection grass was growing and no erosion was observed.
