ENVIRONMENTAL MONITORING DAILY SITE OBSERVATION FORM

Report Nos. 9

Project: Verizon Wireless Canterbury South CT Facility Address: 46 Cemetery Road, Canterbury, Connecticut APT Project No: CT1418090

Dates of Inspection: 7/23/20	Weather: sunny, mid, 80's		
Times of Inspection: 3:00 PM	Latest Precipitation Event > 1/4" (NOAA): 0.22" on 7/18/2020		
Compliance Monitor:	Matthew Gustafson, Wetland Scientist		
Regulatory Compliance Permitting Agency & Permit ID:			
ACOE NED 🛛 : NAE-2018-02520, dated November 13, 2018			
CT Siting Council 🗵: Docket No.477			
CTDEEP IWRD			
CTDEEP NDDB			
Resource Protection Program:			
•	Species Name: N/A		
Wetland Protection			
Wetland Restoration			
Workers Environmental Awareness Program Training Completed: Yes 🛛 No 🗆			
Date of Training: 2/5/2020			
Signage Installed Date: 2/5/2020			
Compliance Species Observed During Inspection: Yes No No			
Species Name: N/A			
# Species: N/A			
Progress of Construction:			
Pre-Construction			
Initial Exclusion Fencing Inspect	tion		
Clearing & Grubbing			
Intermediate	\boxtimes		
Final Inspection

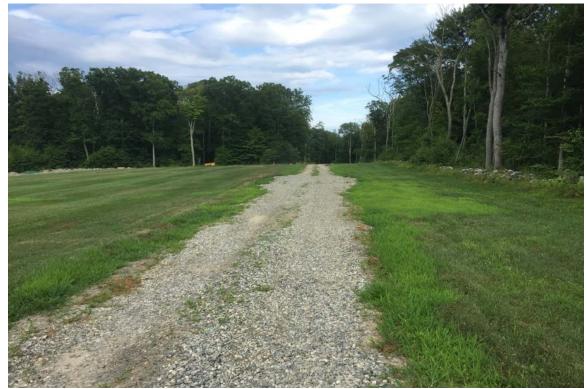
Photo 1: View of access road leading to compound area.

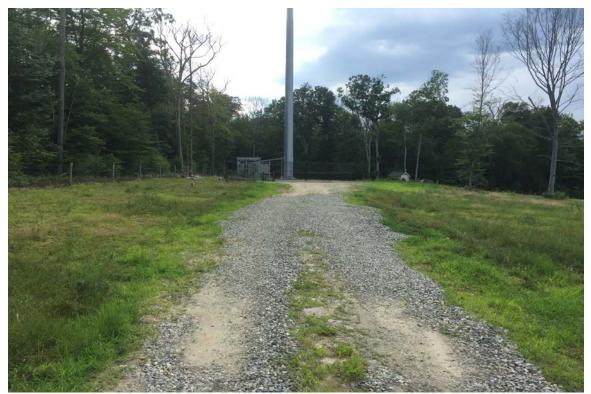
Photo 2: View of access road with compound area in background.

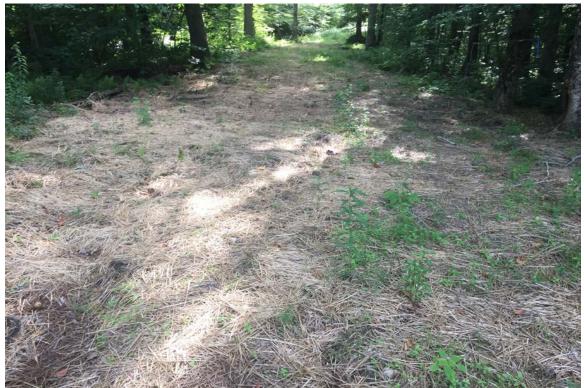
7/23/20 – All site grading and compound work is complete. Final electrical work still remains. Utility route crossing of wetland areas are approximately 50% stabilized with. All E&S controls remain in good working order.

Photo 3: View of utility route wetland crossing partially stabilized.

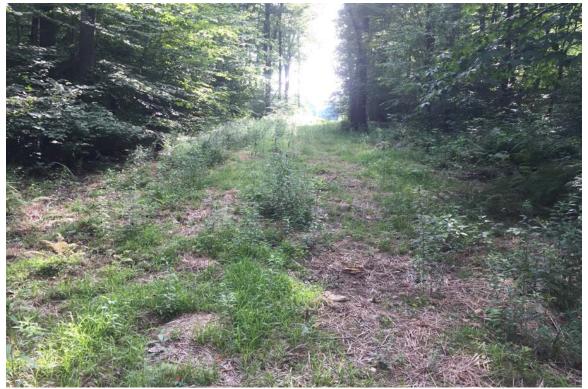
Photo 4: View of utility route wetland crossing stabilized with permanent vegetation.

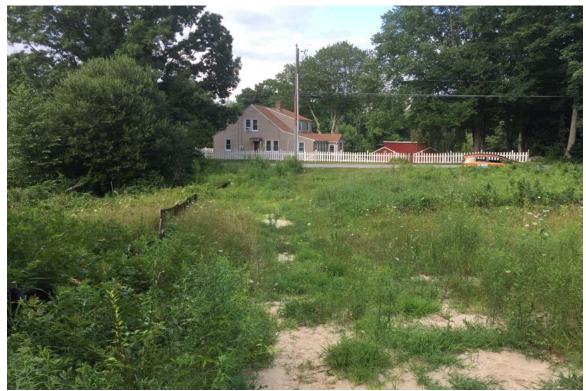
Photo 5: View of utility route entrance off Cemetery Road.

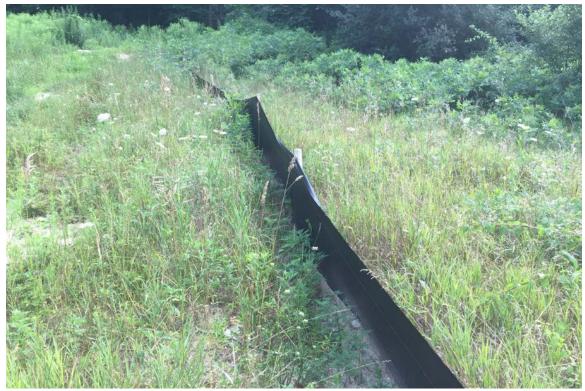
Photo 6: View of well-maintained silt fence.
