## ENVIRONMENTAL MONITORING DAILY SITE OBSERVATION FORM

**Report No. 6**

Project: Verizon Wireless Lebanon Center CT Facility  
Address: 917 Exeter Road, Lebanon, Connecticut

APT Project No: CT1417950

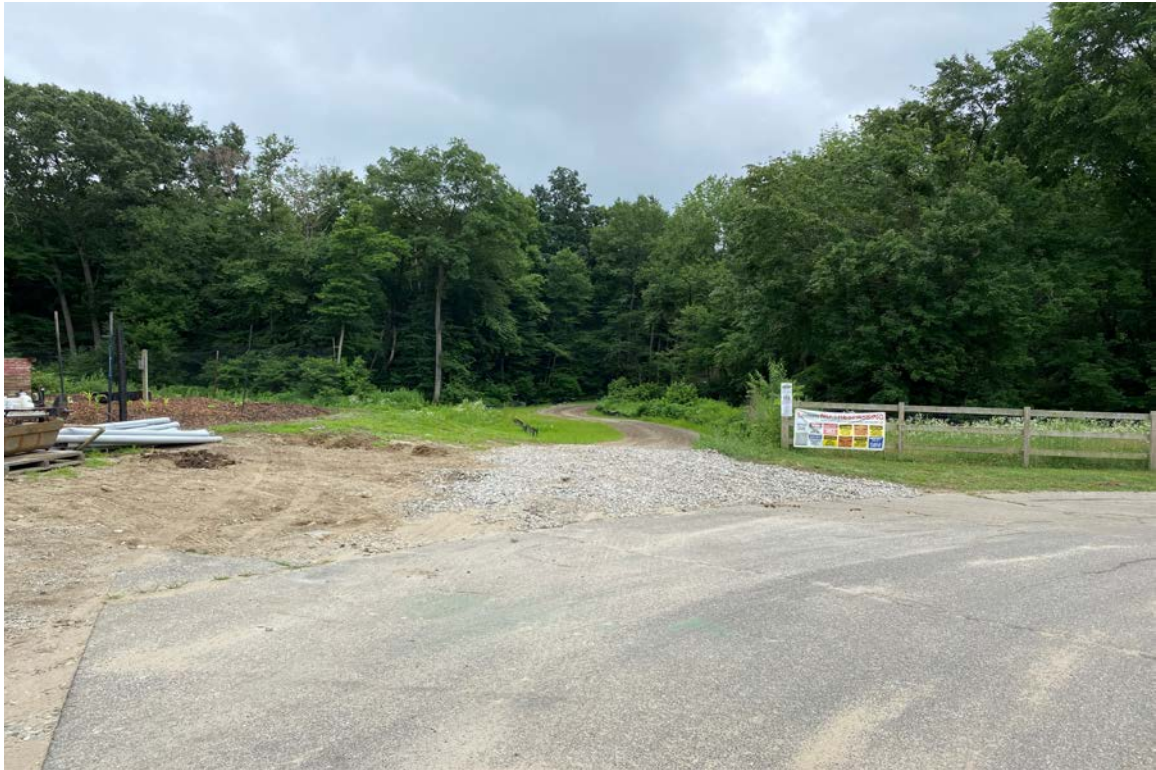
Photo 1: View of access road looking south from antitracking pad entrance.

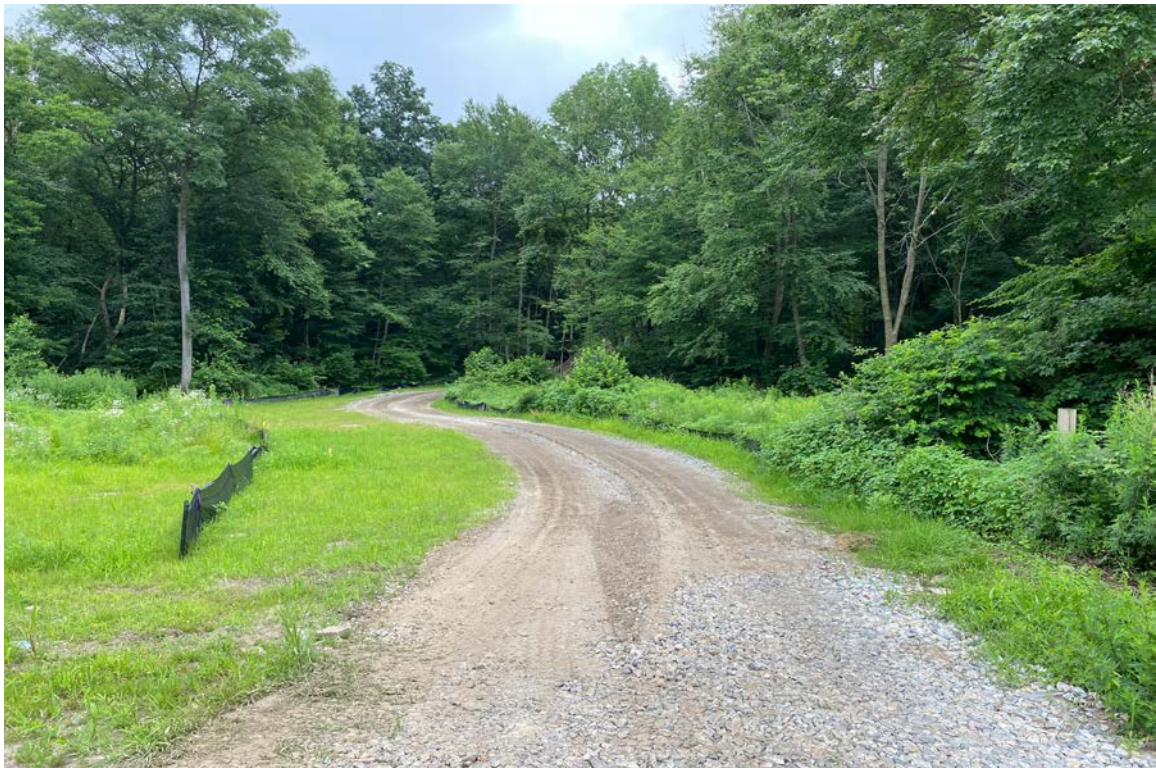
**7/7/20** – All erosion controls and isolation barriers were found to be in good condition. Seeding along the shoulder and side slopes of the access road have resulted in well-established vegetation that has permanently stabilized those areas. Access road construction completed and tower foundation excavation work currently underway.

Photo 2: View of access road looking south showing shoulder stabilized with well established permanent vegetation.

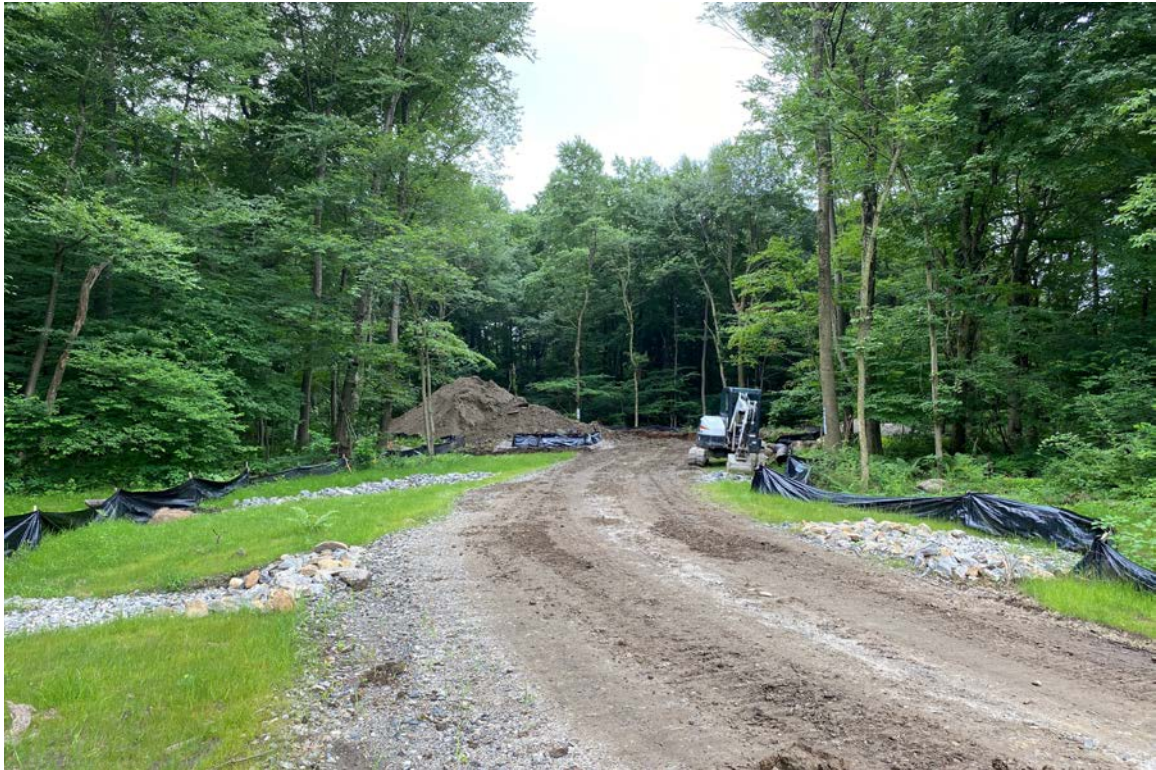
Photo 3: View of access road at French mattress and culverts crossing looking south with compound in background. Road shoulder and side slopes stabilized with well established permanent vegetation.

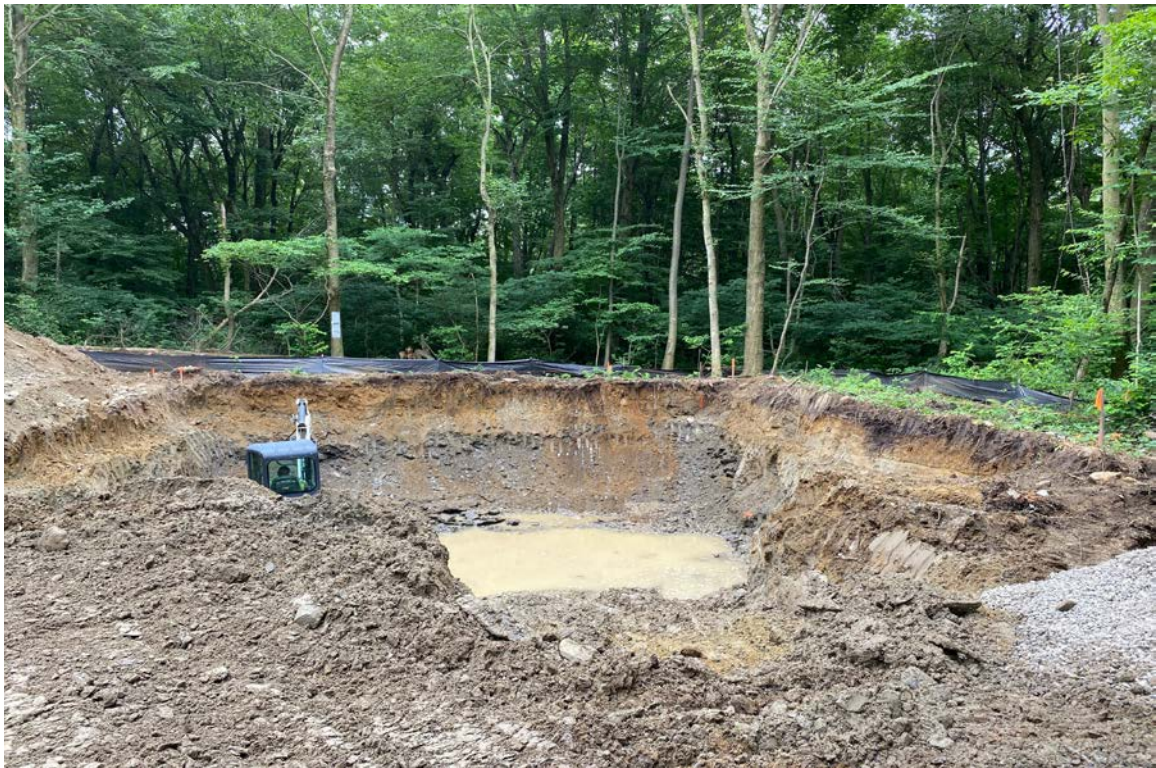
Photo 4: View of tower foundation excavation work underway looking east.

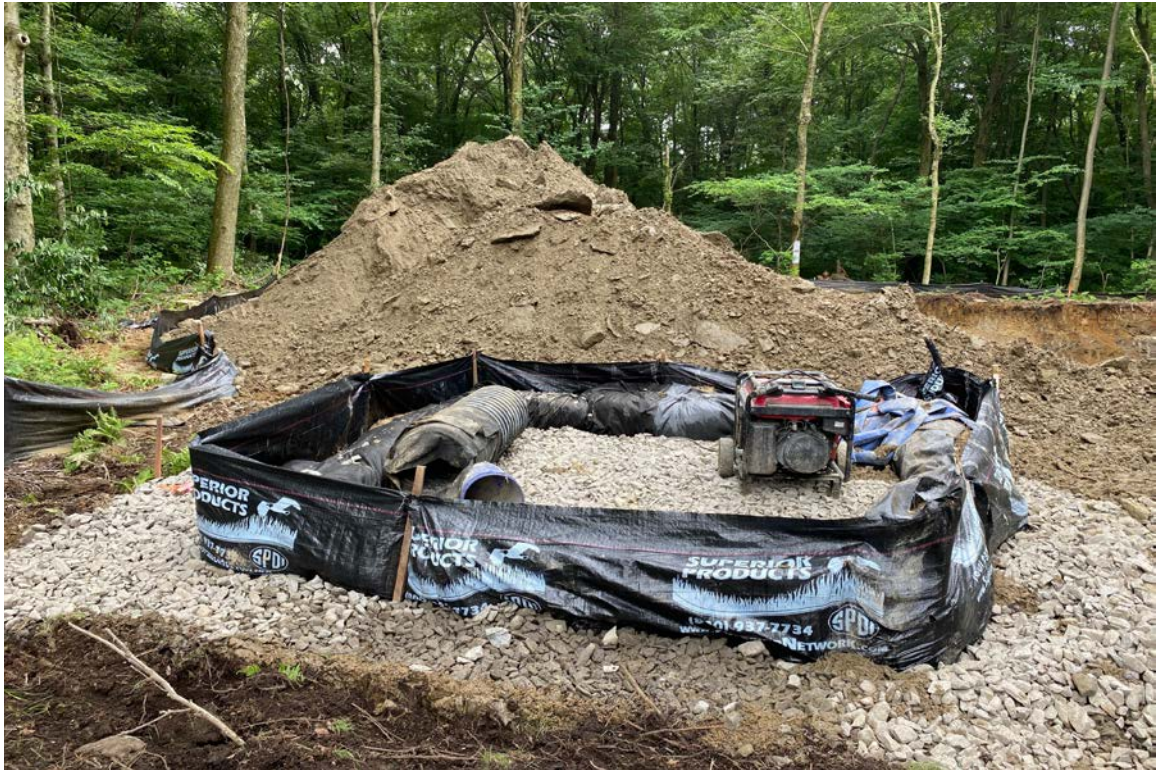
Photo 5: View of temporary dewatering basin to support foundation excavation work looking south.

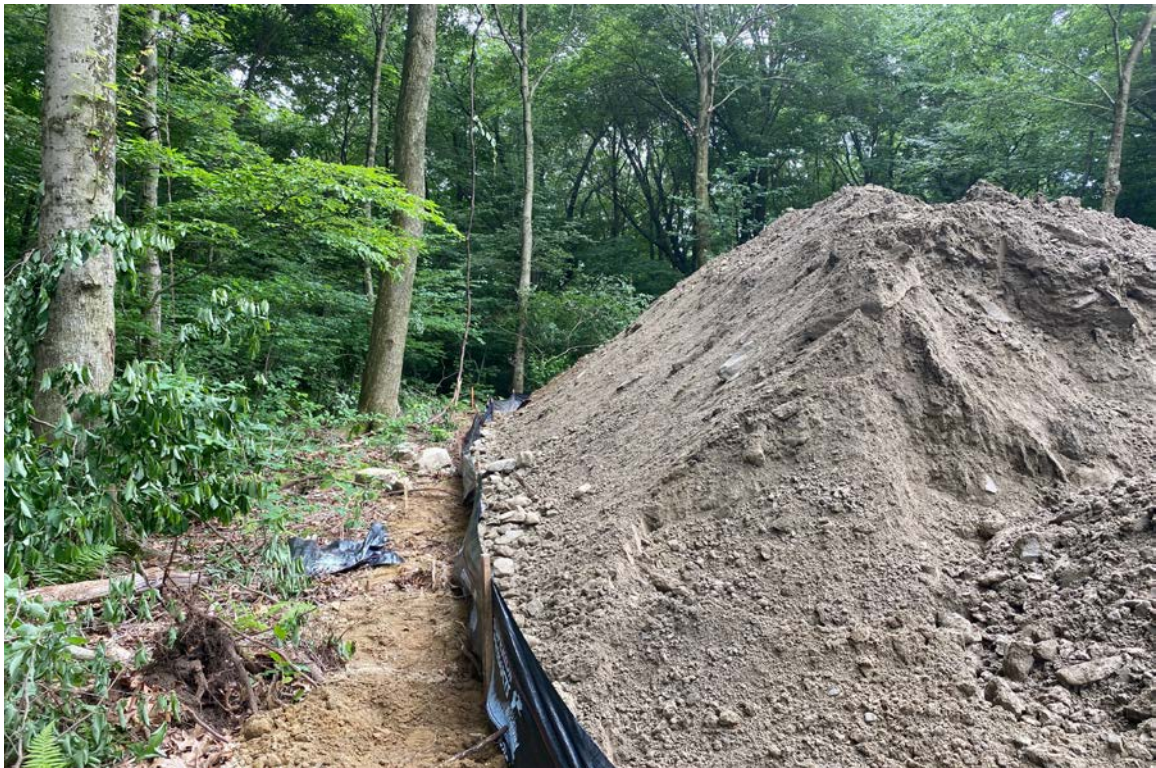
Photo 6: View of erosion controls in good condition looking south along eastern side of compound at foundation excavation spoil pile.

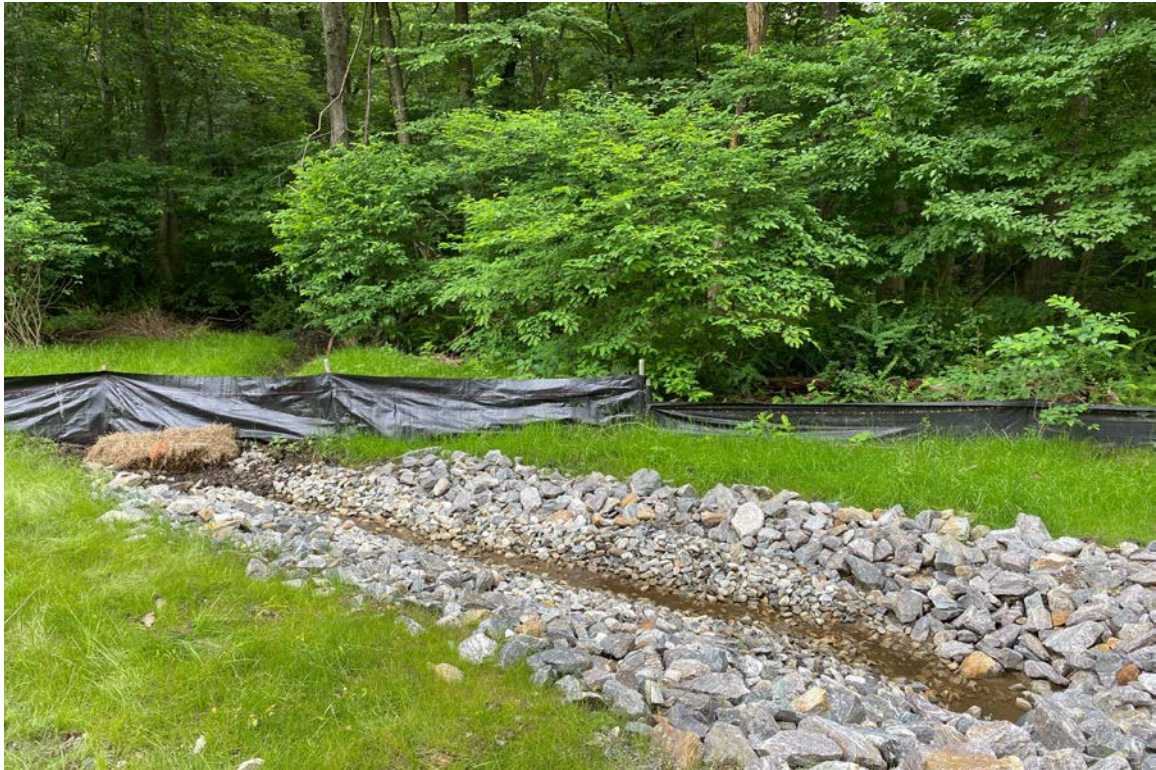
Photo 7: View of erosion controls along culvert crossing looking east; all controls found in good condition.

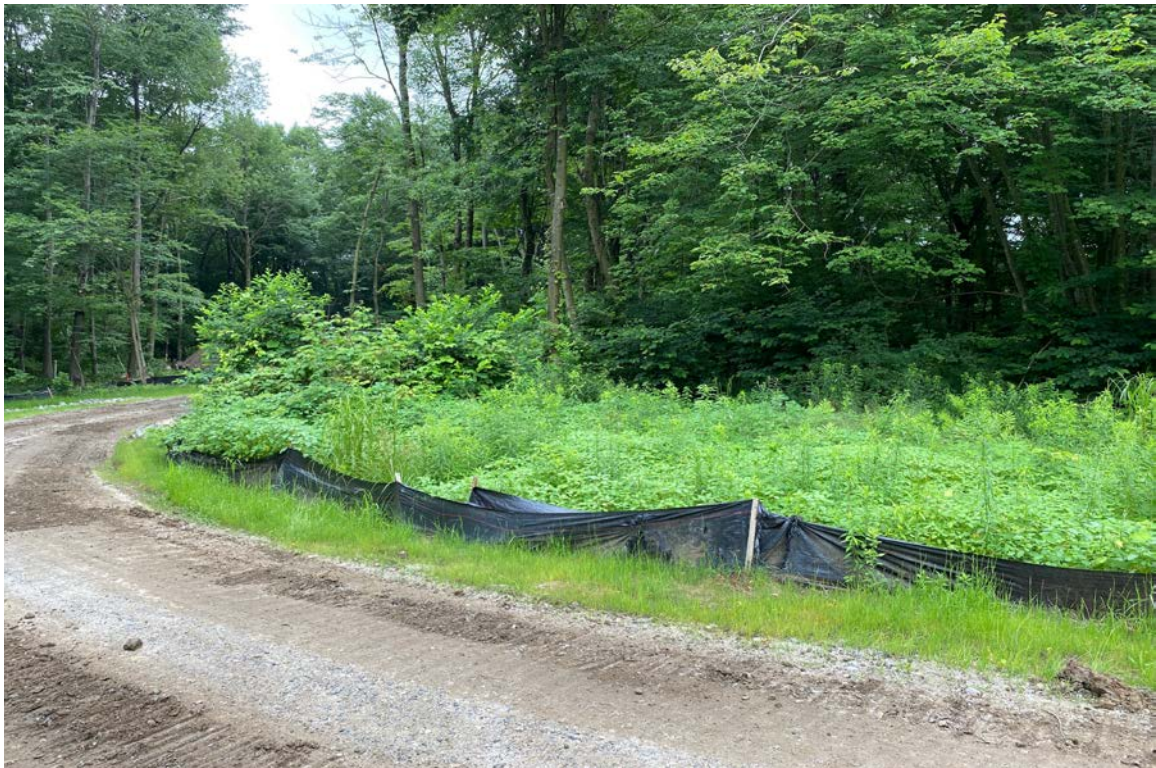
Photo 8: View of erosion controls in proximity to Wetland 1 looking south; all controls found in good condition.
