**Re: Petition 983 - BNE Energy Inc., Flagg Hill Road, Colebrook, CT**

**EXISTING CONDITION STUDY  
FLAGG HILL ROAD AND ROCK HALL ROAD  
FOR  
WIND FARM PROJECTS  
COLEBROOK, CT**

**GM2 Associates, Inc.  
115 Glastonbury Blvd  
Glastonbury, CT 06033**

**NOVEMBER 30, 2011**

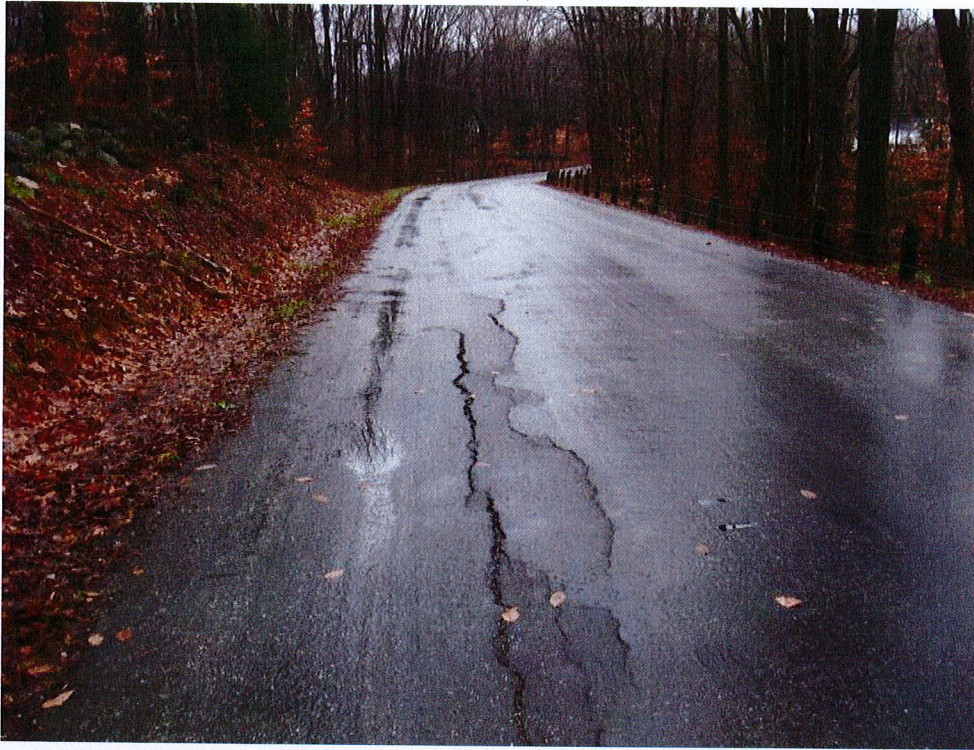
Flagg Hill Road – Longitudinal Cracking

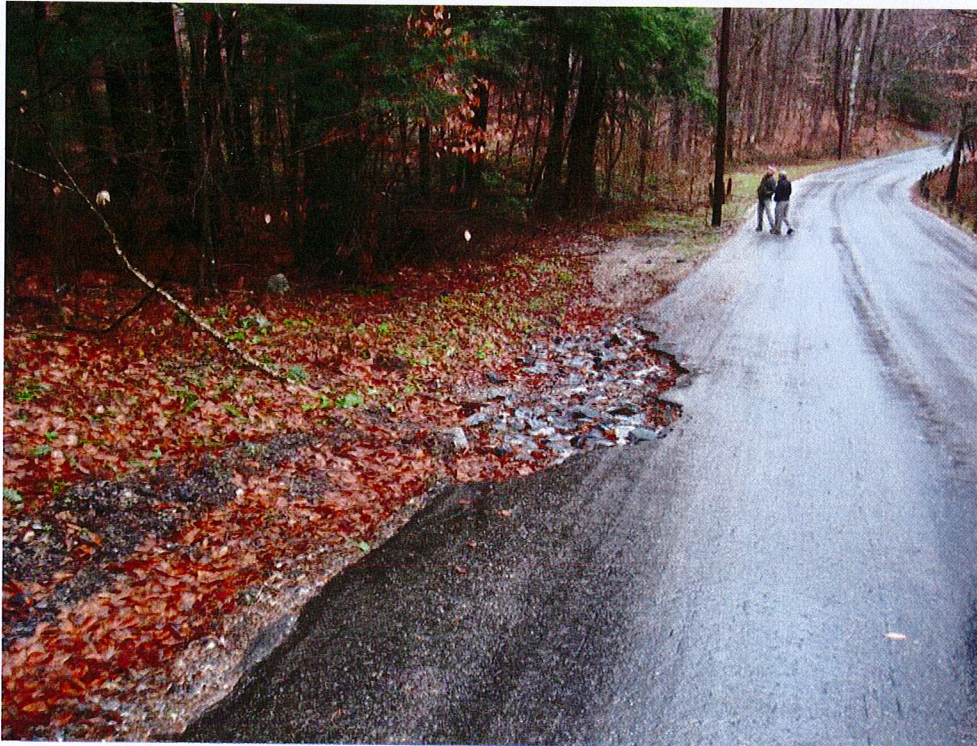
Flagg Hill Road – Area of Pavement Failure

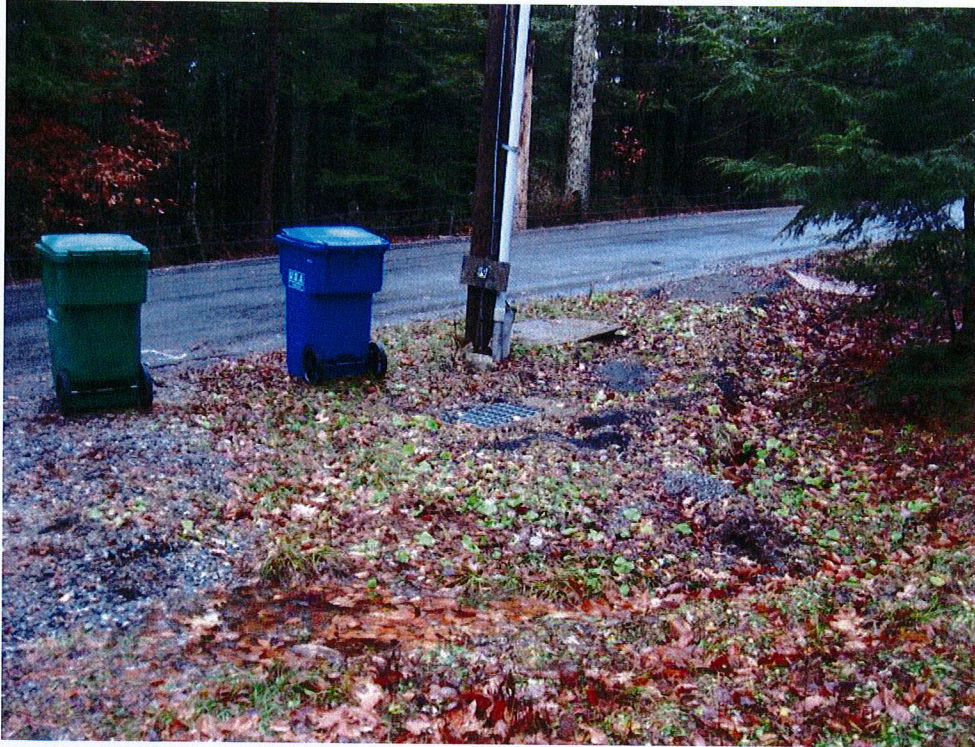
Flagg Hill Road is a local dead end road serving a handful of residential homes. To the north it intersects with Route 44 and to the south it is a dead end street with a gravel surface turnaround area. The overall condition of the roadway pavement is good, and according to the Town of Colebrook was resurfaced within the last 5 years. Existing asphalt thickness was measured at 3 inches. Intermittent longitudinal cracking was noted over the study area but the extents and severity of cracks was limited. The cracks were generally confined to the center and west side of the pavement. These cracks along the roadway edge could be attributed to the wet conditions with the shallow roadside ditch adjacent to the west side of the roadway and shoulder area. No rutting of the pavement was noted within the study area. An area of complete pavement failure was noted on the western edge of Flagg Hill Road, between the temporary access road and the permanent entrance to the South Site. This failure area was approximately 15 feet long and encroached into the roadway approximately 4 feet. The failure was the result of significant rainwater runoff flows which washed out the edge of the roadway. The gravel driveway at the southern limit of the study area, proposed to serve as temporary site access, showed evidence of repeated erosion due to water running across the bottom of the driveway close to Flagg Hill Road.

Gravel Driveway on Flagg Hill Road – Erosion due to poor drainage

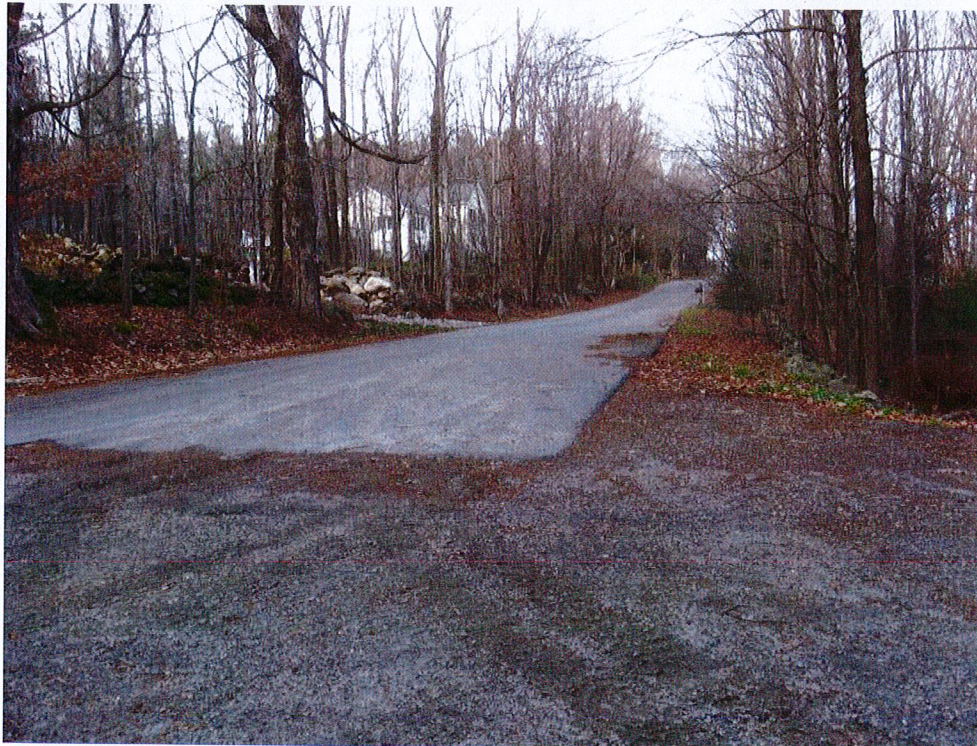
Flagg Hill Road – Gravel cul-de-sac at end of road

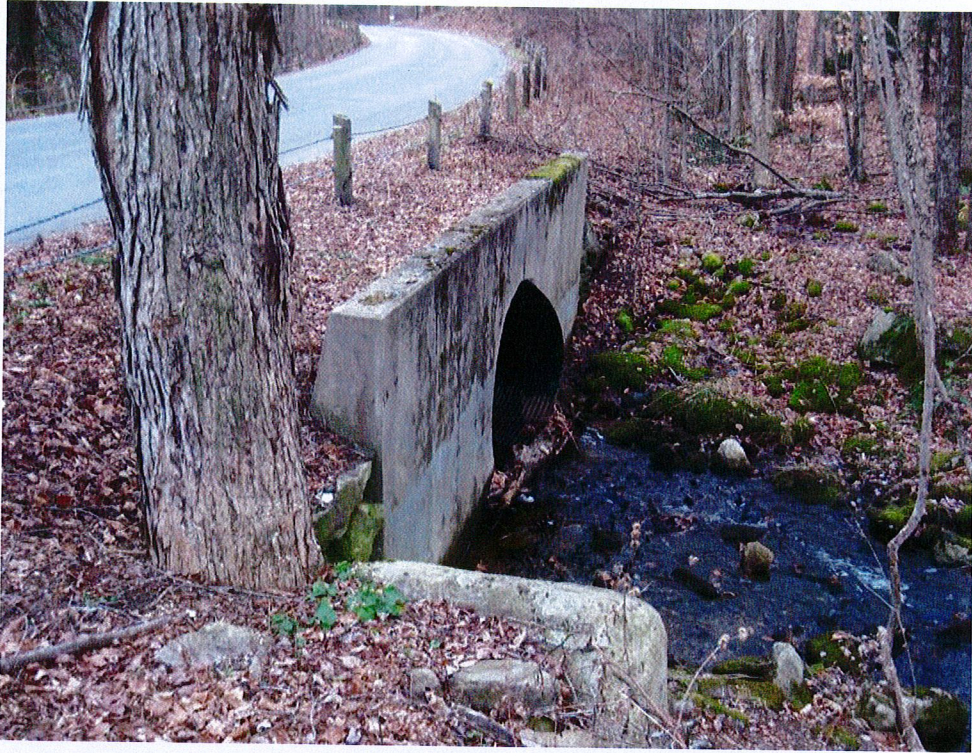
A large metal pipe culvert is located at the north end just south of Route 44 carrying a stream, which flows west to east. This culvert, approximately 4 foot in diameter appeared to be performing properly but the bottom condition could not be observed.

Flagg Hill Road – Culvert South of Route 44, West Side

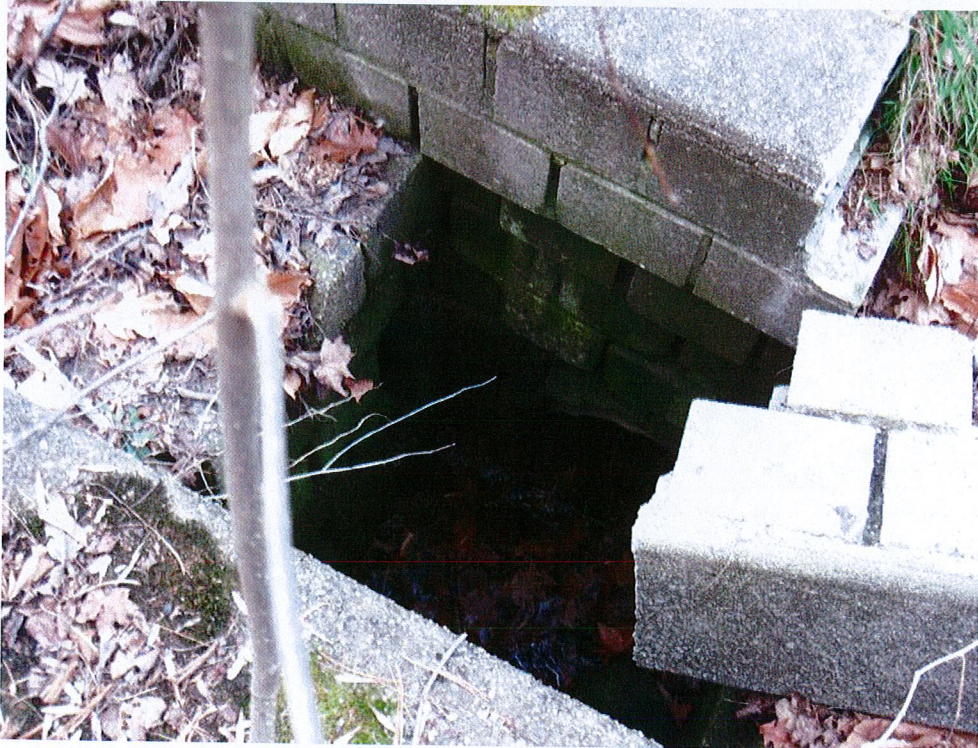
On the east side of the roadway, road drainage is by sheet flow due to the steep bank. West side drainage is through a combination of catch basins, shallow roadside ditches and cross culverts. On both visits the west side of the roadway was observed to be wet. The catch basin ditch system is drained by two cross culverts located between the proposed permanent entrance and temporary access driveway. The first and most southerly is a CMU headwall draining to the east side of the road. This culvert also picks up a pipe from an existing catch basin north of the temporary access driveway. The second culvert connects to a CMU catch basin structure draining the shallow roadside ditch on the west side which was observed to be in poor condition with no top and blocks dislodged. Both culverts appeared to be performing properly.

Flagg Hill Road – CMU catch basin structure and culvert, West Side

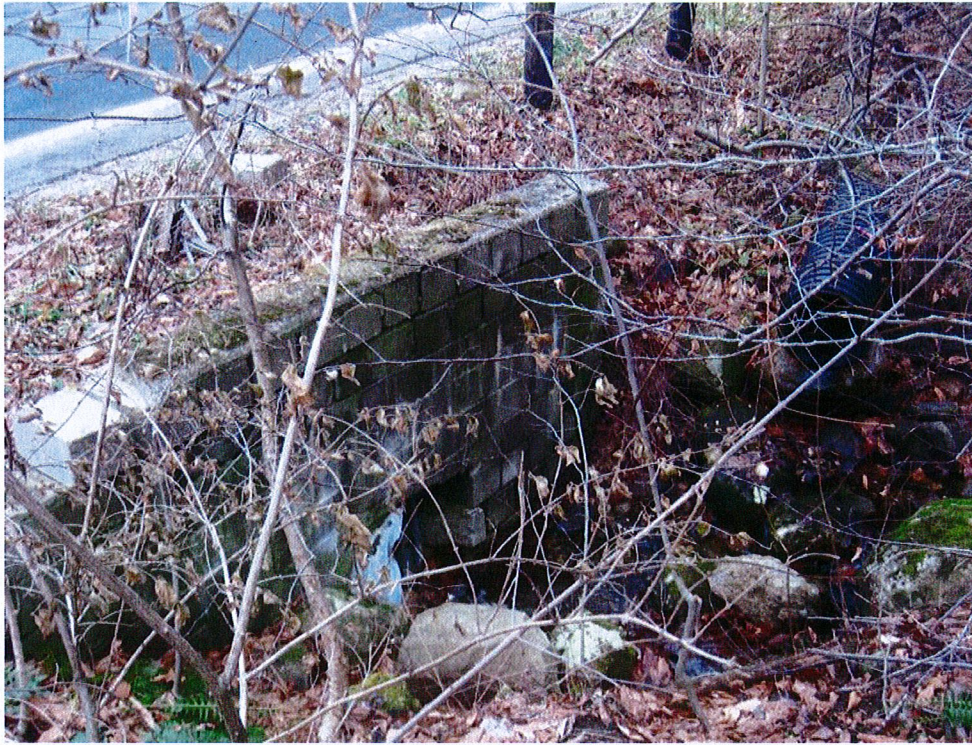
Flagg Hill Road – CMU Headwall and culvert with contributing pipe, West Side

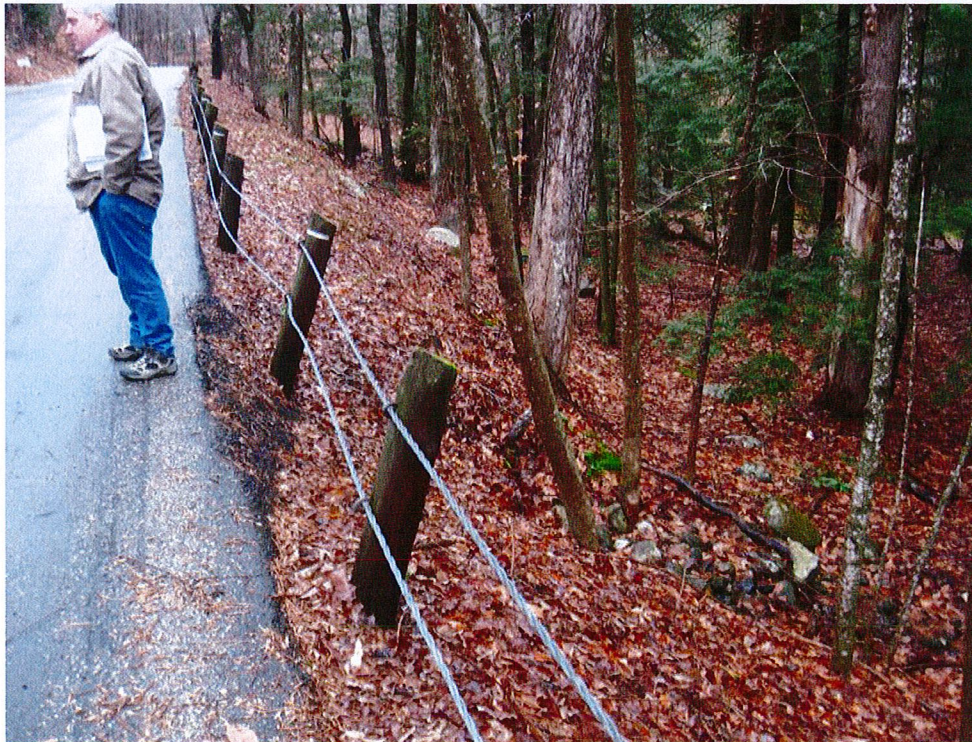
Flagg Hill Road – East Side, sheet flow and steep fill slope

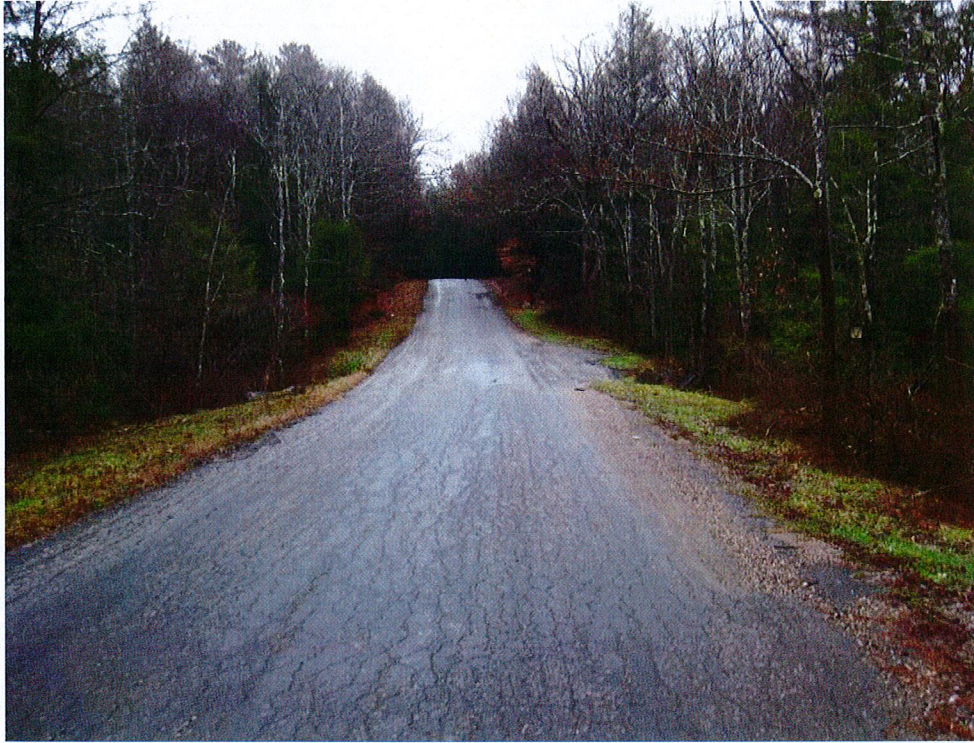
Rock Hall Road is a local connector road between Route 44 to the south and Route 182 to the north. The overall condition of Rock Hall Road is very poor. Extensive alligator cracking was noted along the entire length of road investigated by this study. Asphalt pavement thickness appeared to be less than 3 inches. Numerous potholes were present at the time of walk through, with a couple of potholes measuring more than 1 foot across. Pavement heaving was also observed in some areas.

Rock Hall Road – Alligator Cracking

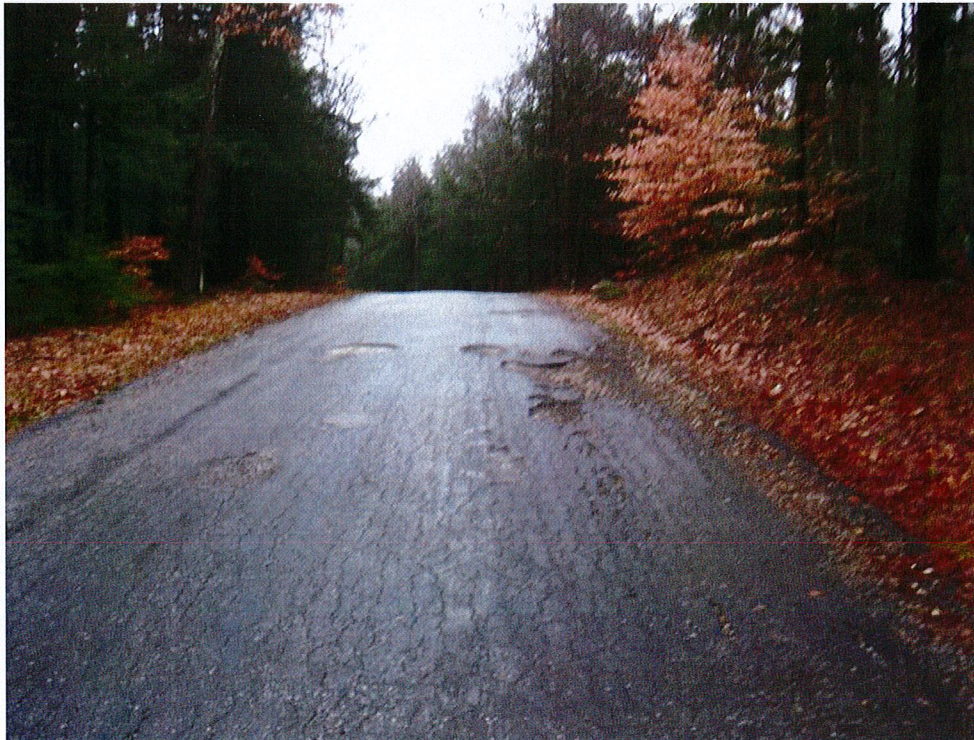
Rock Hall Road – Potholes and Pavement Cracking

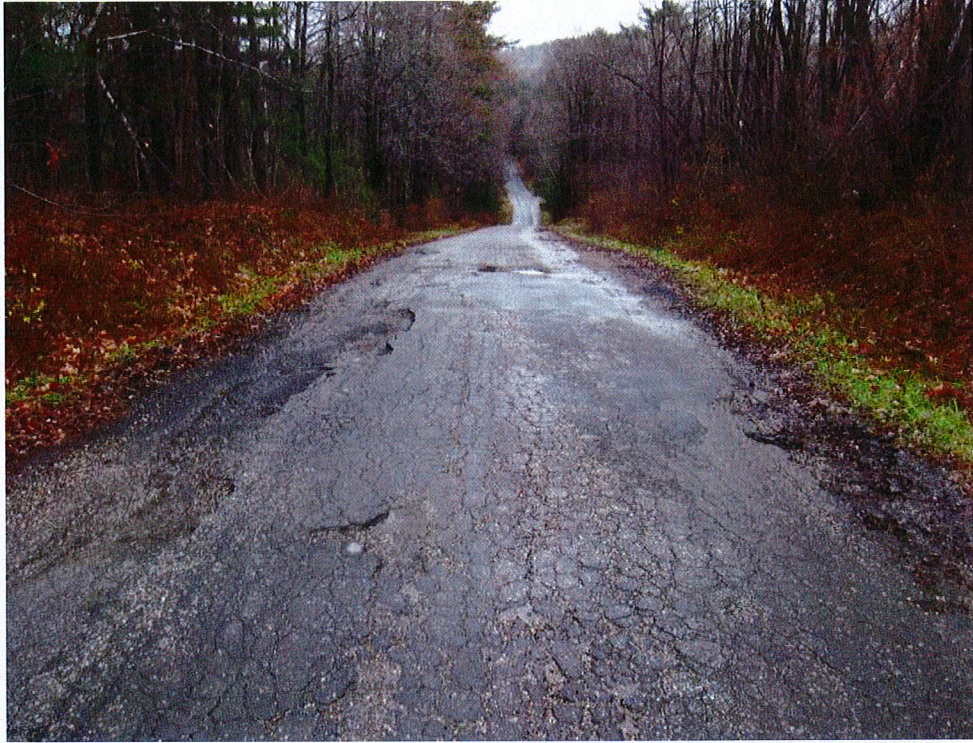
Rock Hall Road – Potholes, Pavement Failure Area, Pavement Cracking

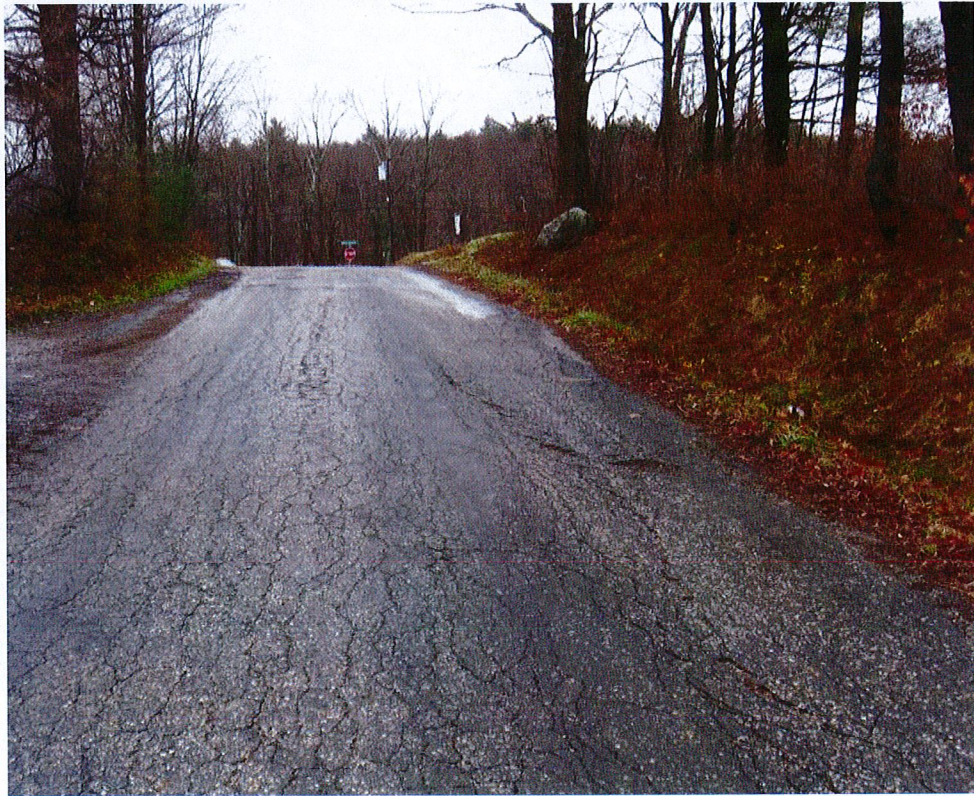
Rock Hall Road – Alligator Cracking, Rutting on Roadway Edge
