Memorandum

Re: Wind Colebrook South

Attached are environmental erosion and sediment control monitoring reports numbers 40 through 43 for the period July 27 through Aug 10, 2012.

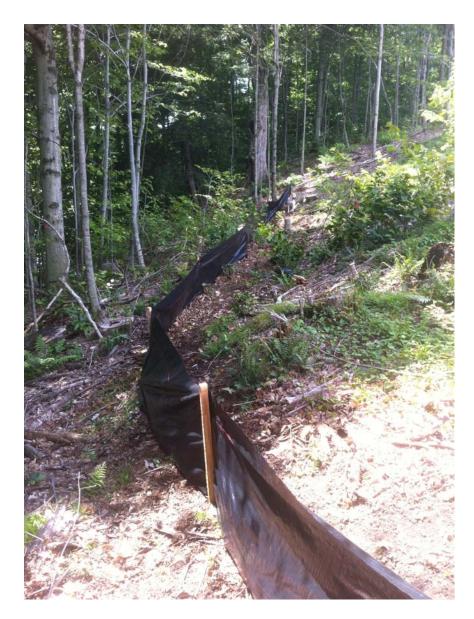
Silt Fence Installed 8/8/2012

No problems or discharges were observed. Greg Zupkus installed silt fence in the area noted in previous inspection reports

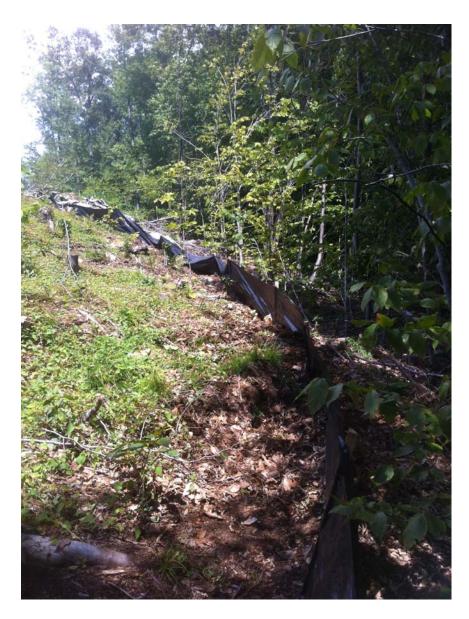
Silt Fence Installed 8/8/2012
