Memorandum

To: Dr. Michael Klemens
From: Roger Hurlbut *Roger Hurlbut*
Date: December 28, 2012
Re: BNE Wind Colebrook South

Attached are environmental erosion and sediment control monitoring reports numbers 66 thru 68 for the period Dec 115 through Dec 28, 2012.

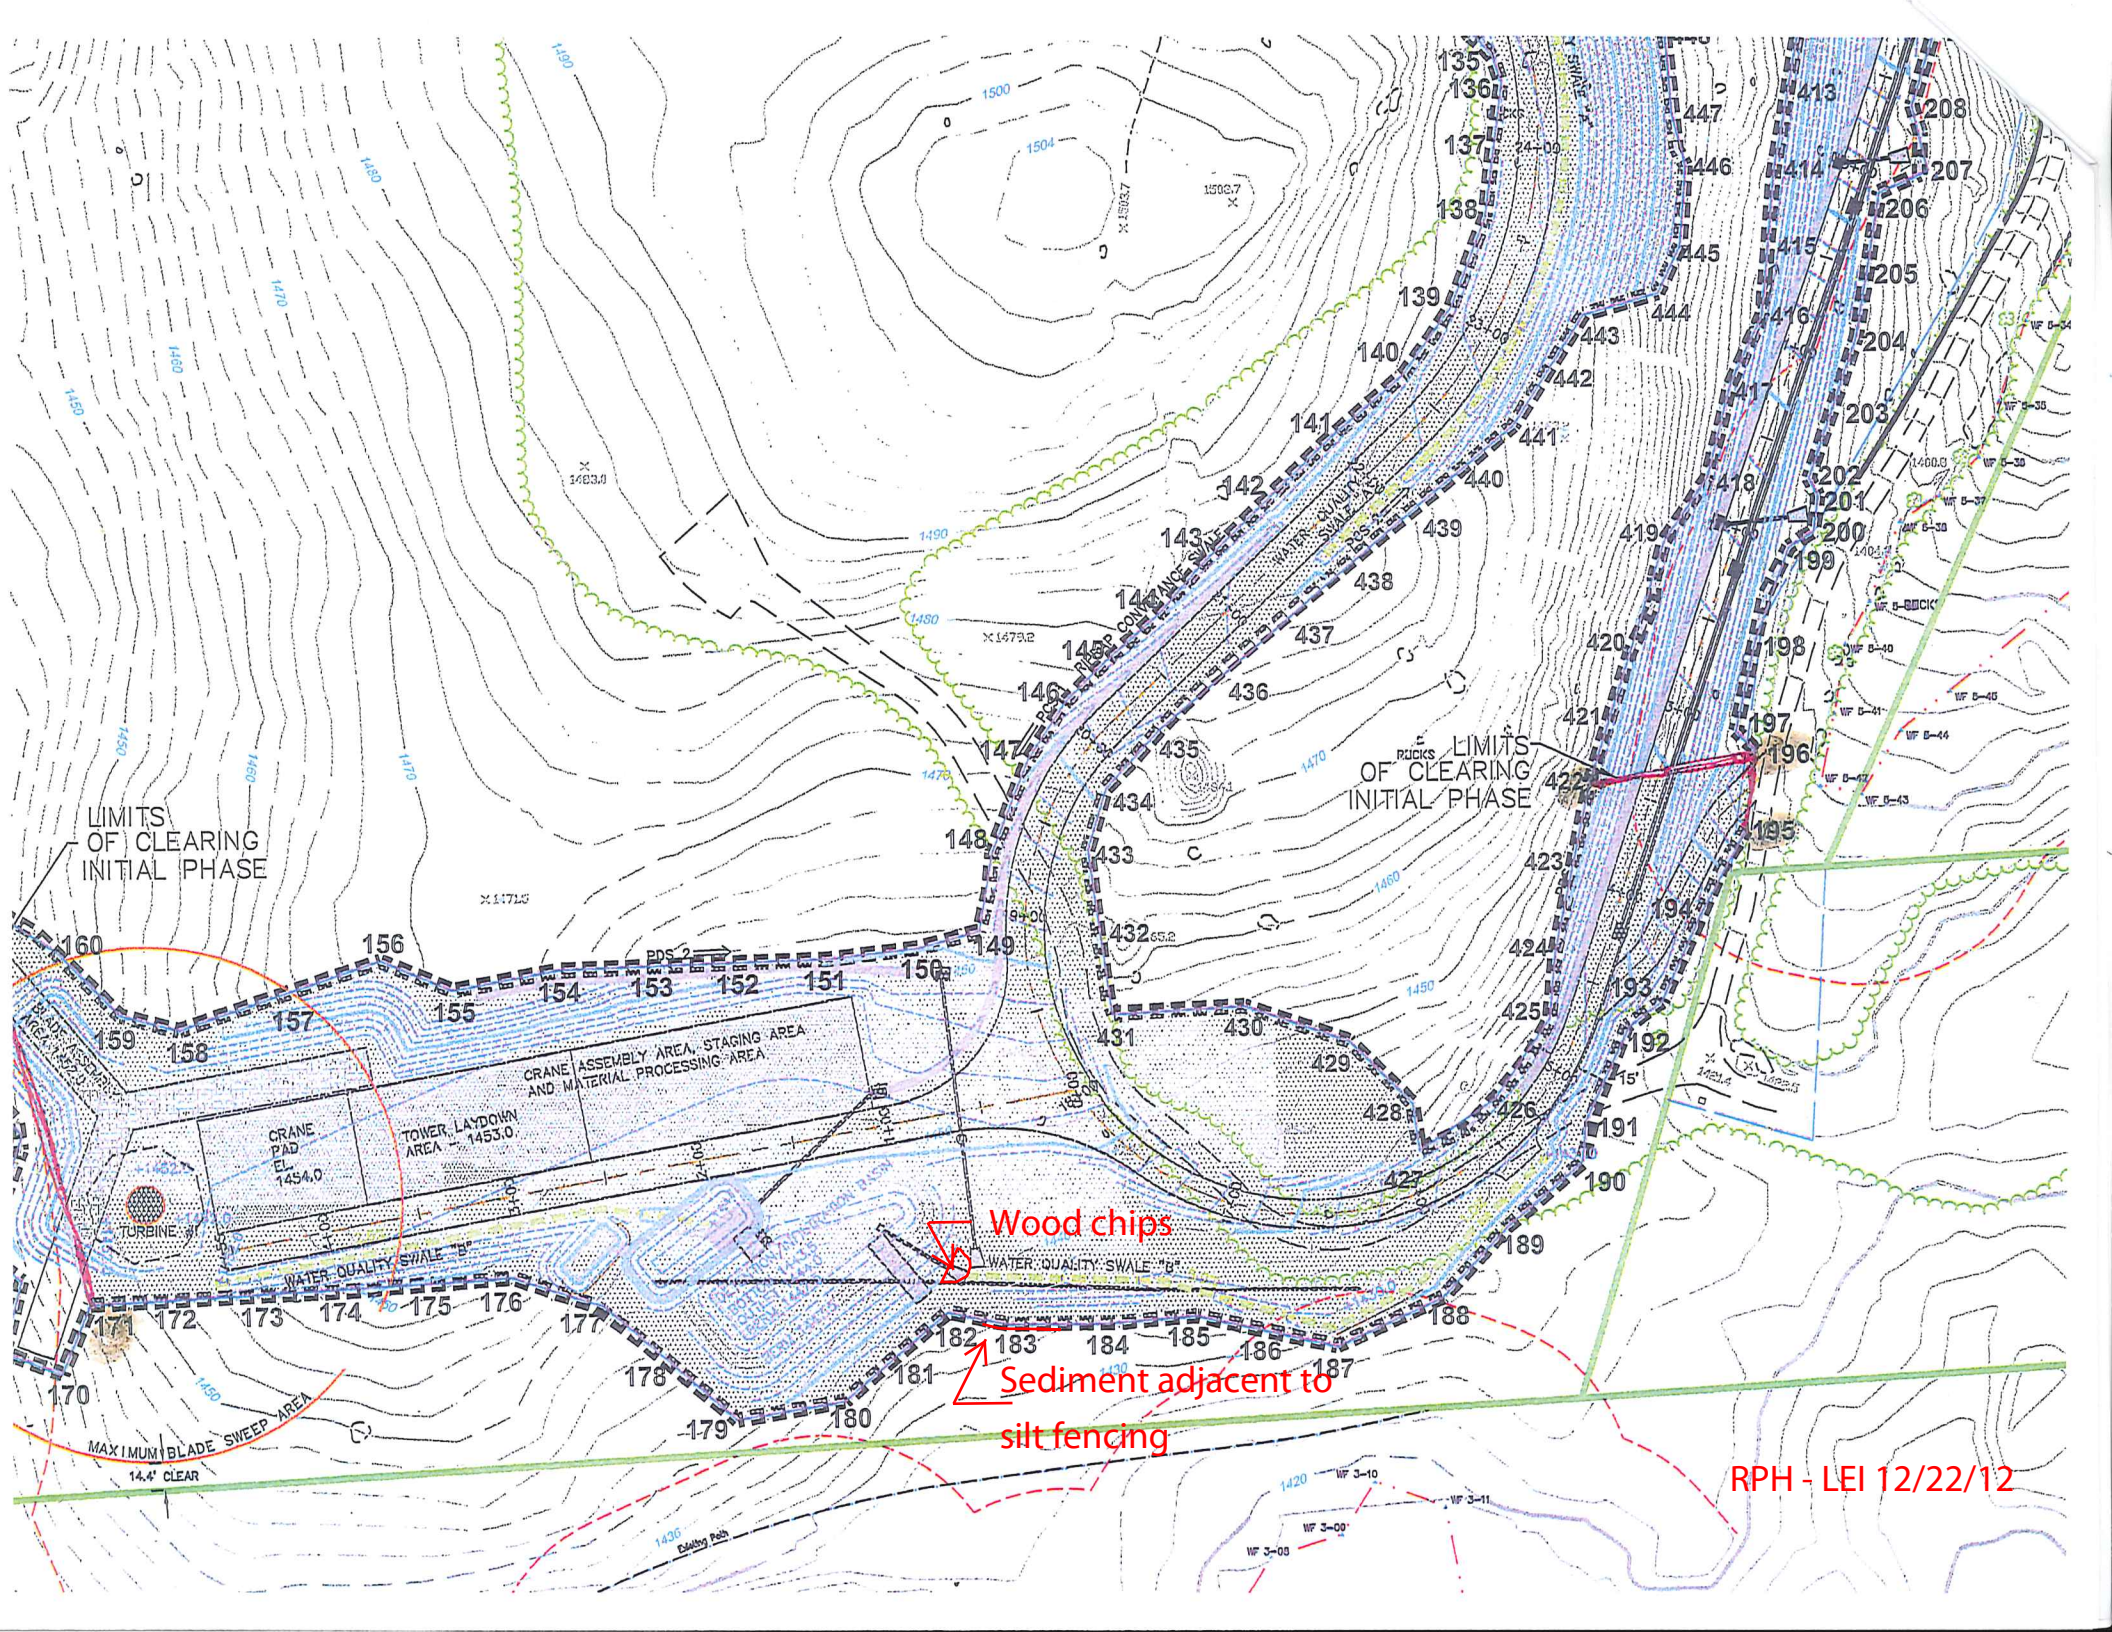
Inspections 66 and 67 were after rainfall events. Report # 67 was after a rain of around 1.75 inches on partially frozen ground and there was some sediment movement, there was no discharge from the site, however both sides of the silt fence in the vicinity of Clearing Limits flag # 183 had sediment on the ground. I have contacted BNE and they are going to get someone to refresh the woodchip barrier and restake the fence. As a result of yesterdays snow/rain event the site is now snow covered.

Sediment adjacent to silt fencing
