Memorandum

Re: BNE Wind Colebrook South

Attached are CT Siting Council environmental erosion and sediment control monitoring reports numbers 216 and 217 for the period June 27, 2015 thru July 10, 2015.

General Information			
Project Name:	Wind Colebrook South		
Location:	Winsted- Norfolk Road Colebrook, Connecticut		
CT DEP Tracking No.	CSC Petition 983 CT GSN 002270	Report No.	216
Date of Inspection:	July 1, 2015	Start / End Time:	7:00AM to 8:30AM
Inspector's Name(s):	Roger Hurlbut		
Inspector's Title(s):	Project Engineer		
Inspector's Contact Information:	LENARD ENGINEERING INC 860 379-6669 office		
Describe present phase of construction:	<p>Contractor constructing roadway & tower bases</p> <p>Sediment and Erosion controls in place and functioning properly.</p> <p>No discharges to west (vicinity of pond & vernal pools)</p> <p>Minor discharge of sediment onto Town road. Grassed road side swale prevented sediment from getting to stream. Per discussion with S McGriff, Additional stone & woodchip controls will be installed.</p> <p>Erosion along swale on uphill side of access road. Per discussion with S McGriff, haybale check dams will be installed.</p>

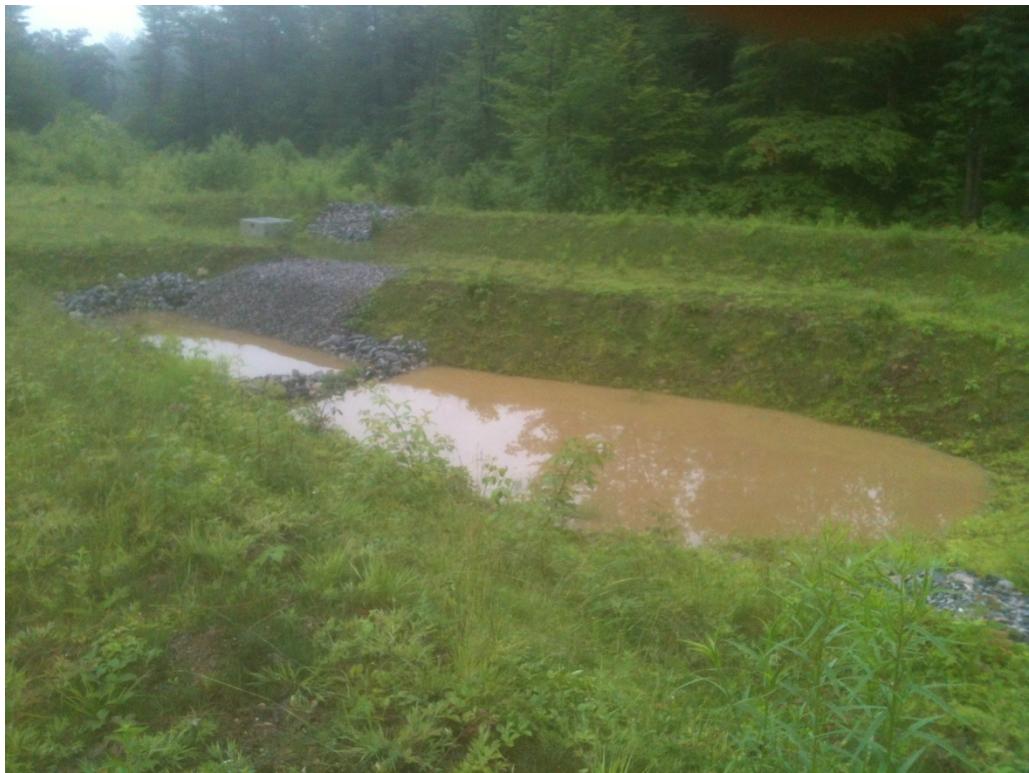
Temporary Sediment basin# 2, functioning as designed
