Re: Modification Inspection Report
623 Pine Street
Bridgeport, CT 06605
Site ID: CT1382S (Bridgeport, CT)
KM Project No. 230807.00

Bolted Connection Inspection Report

Client:	KM Consulting Engineers, Inc.	Project No.:	5988
Project:	AT&T Tower, 623 Pine St. – Bridgeport, CT	Report No.:	001
Inspector:	Greg Aiudi	Date:	8/15/2023
Subject:	AT&T Cell Tower Bolted Connection Inspection	Page:	1 of 6

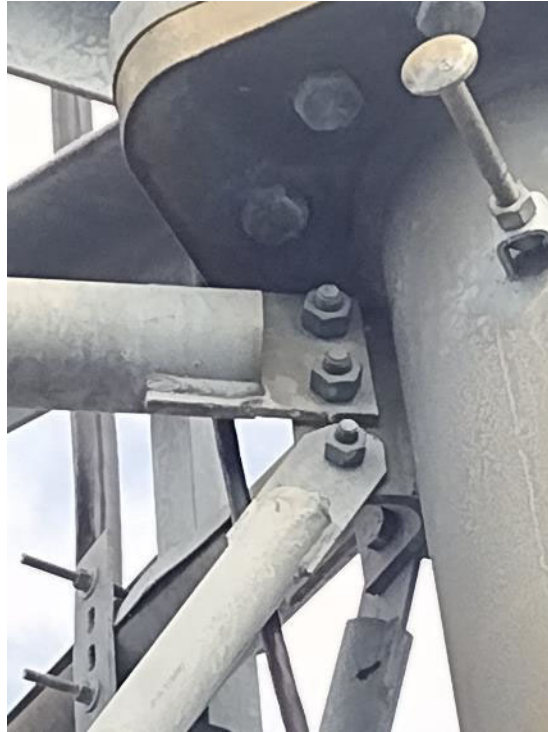
1. Photo provided by CSB to show (2) bolts are installed at horizontal specified needing larger bolts installed based on only (1) bolt at each end of the horizontal and used in the structural analyses (reference date 8/10/23).
