RE: **SUB-PETITION NO. 1293 - BMM-01 (Berlin, Middletown and Middlefield)** – Eversource Energy declaratory ruling that no Certificate of Environmental Compatibility and Public Need is required for all transmission facility asset condition maintenance improvements statewide to comply with the updated National Electrical Safety Code clearance requirements.

RE: Eversource R.O.W.  
97 Poplar Road, Middletown, CT

**RE: Founders Ridge – Phase 2 – Ridgewood Road – Middletown, CT  
P&R Job No. 143038**

RE: POND REHABILITATION/MAINTENANCE  
97 Poplar Road, Middletown, CT  
*REMA Job #15-1787-MID19*

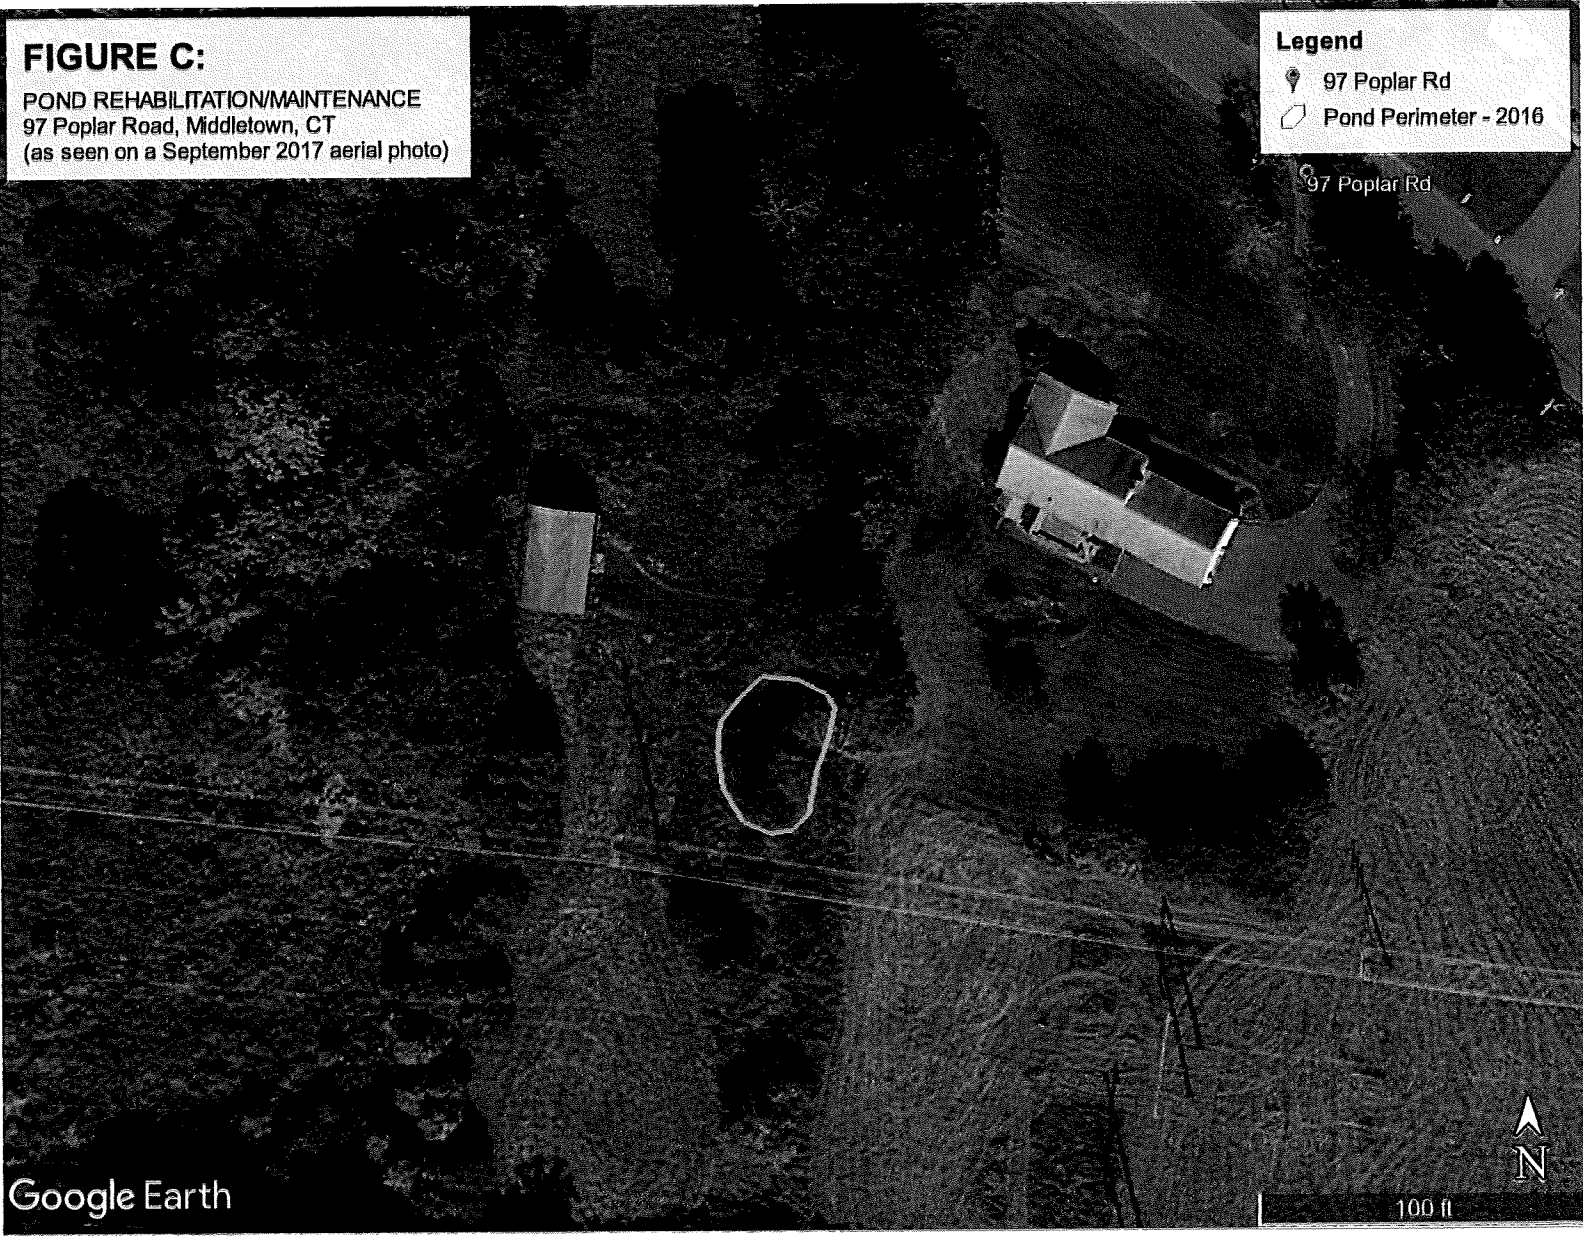
**FIGURE C:**

The finer sediment below the more recent deposits would indicate that this pond has been slowly filling for the past 3 to 4 decades. This natural accretion of sediment and organic matter typical of small waterbodies. The presence of mature willows and silky dogwood shrubs within the “pond” proper (see Photo 1, attached), especially closer to the inlet, would also indicate that accelerated accretion has taken place over the past decade. For instance, a September 2017 aerial photograph, taken before any substantial work upgradient associated with second phase of the residential development, shows the pond to be completely vegetated with emergent vegetation and shrubs, with no evidence of open water (see Figure C, attached).

POND REHABILITATION/MAINTENANCE  
97 Poplar Road, Middletown, CT  
(as seen on a September 2017 aerial photo)

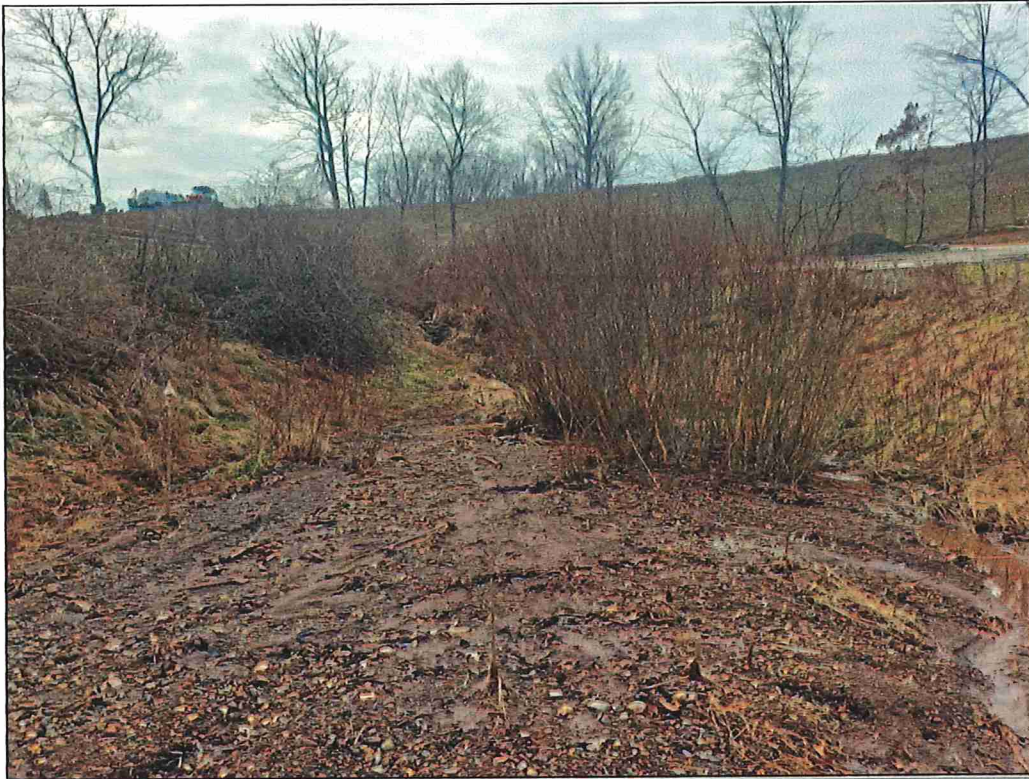
*Photo 1:* Central and southern portion of "pond"; facing southerly

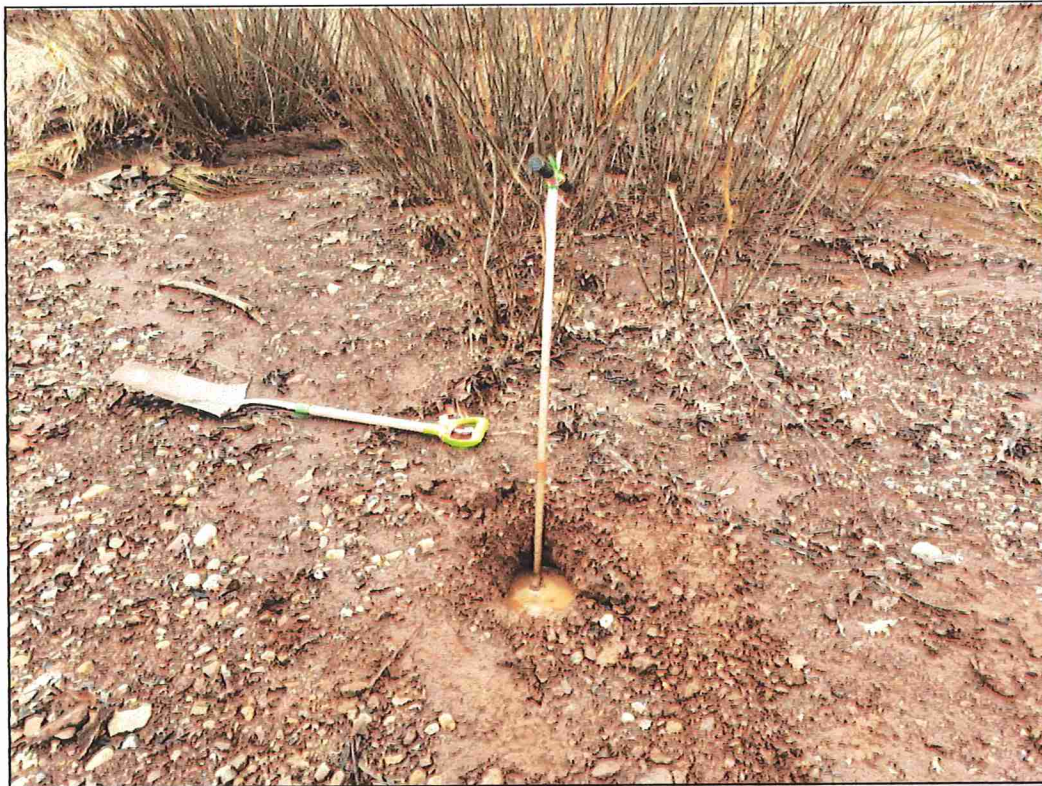
Exploration with a soil auger within the aforementioned shallow channel revealed two or three inches of coarse sediment (i.e., sand and gravel). However, finer sediment with incorporated organic matter was observed below the “channel bed.” These finer and waterlogged sediments extended at least 42 inches below the surface, the length of our soil auger (see Photo 4, attached). At the southern end of the pond, just below the eroded inlet channel, 8 to 10 inches of coarse sediment, including pea size gravel, was noted, again above finer sediment (see Photo 2, attached). The texture of this sediment is similar to what was observed in the eroded channel upgradient of the “pond.” This would indicate that it is of relatively recent origin, and was likely deposited here when the intermittent stream channel eroded during a significant storm event, or series of storm events.

*Photo 2:* Exploratory soil pit, southern portion of "pond"; facing southerly

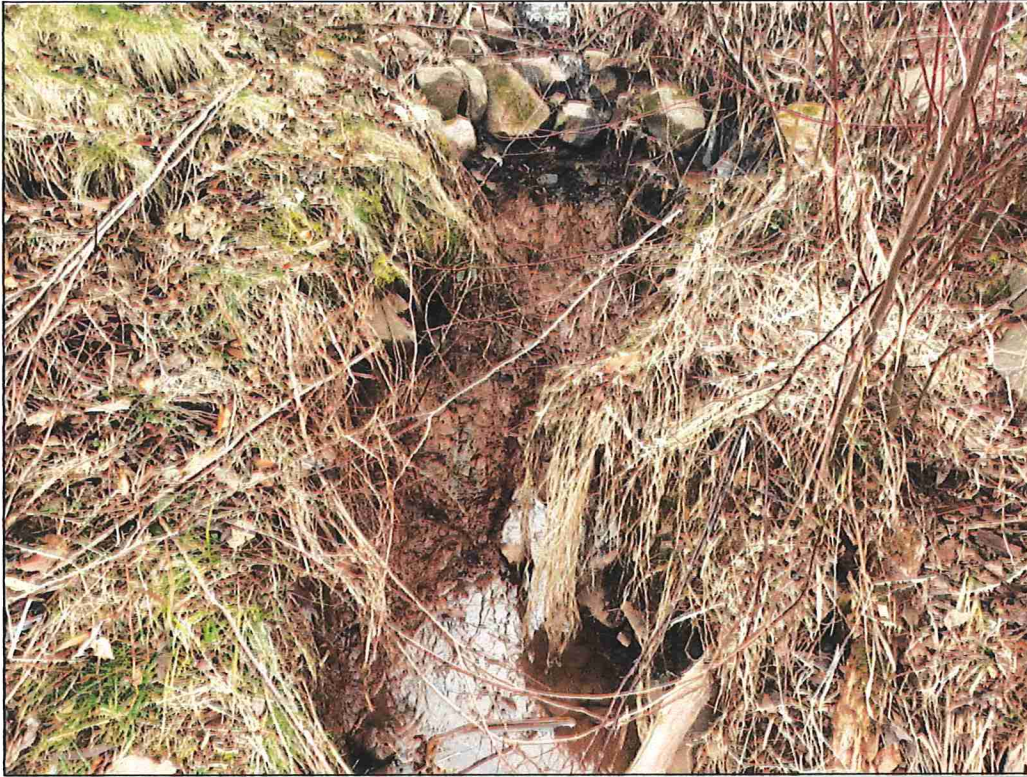
During the site visit we noted that the temporary bridge structure used by Eversource to cross the wetland/watercourse corridor upgradient of pond, may be in fact accelerating the velocities of flows to the downgradient segment of the stream. All of the severe channel erosion that has resulted in the recent deposition of sediment to the pond is downgradient of the temporary bridge.

*Photo 3:* One of the eroded portion of the intermittent stream feeding the “pond”; facing southerly

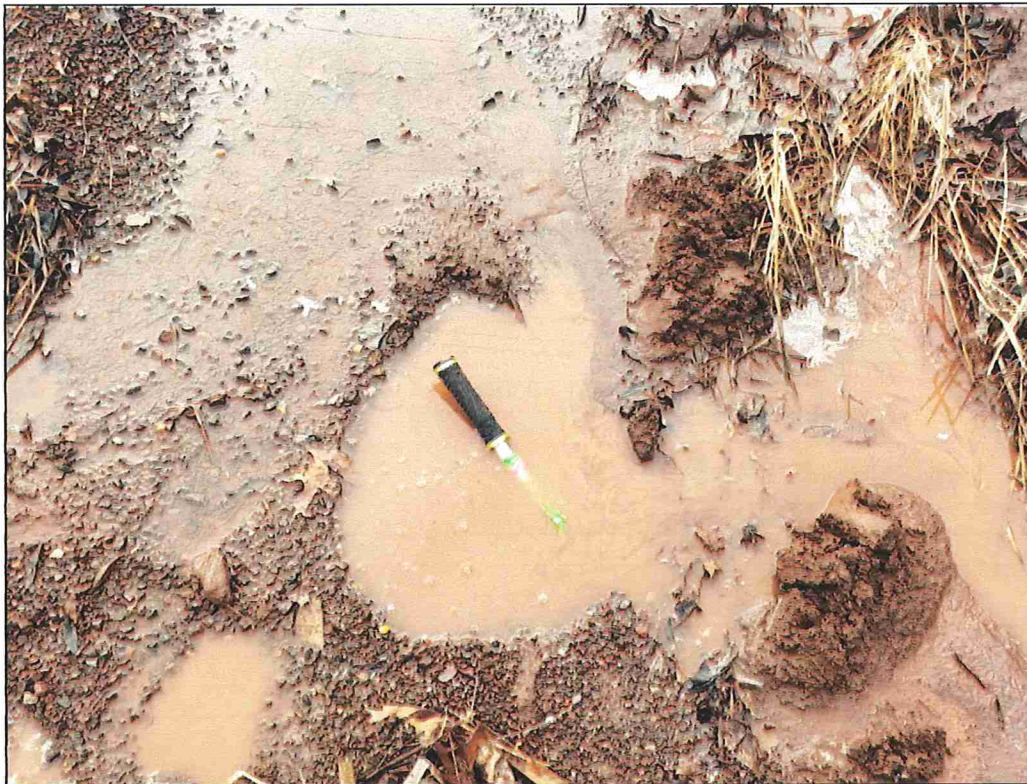
*Photo 4:* Exploratory soil pit along the existing flow path through the “pond;” auger buried to handle, indicating at least 42 inches of accreted sediment and organics

1. Removal of accumulated (i.e., accreted) sediment during the dry low flow season, typically July through September.
2. Leaving an aquatic shelf on the east side of the pond, closer to its outlet. This would extend 3 to 4 feet from the pond edge, be 6 to 12 inches below the inlet invert elevation of the pipes, and allow for marsh and meadow type vegetation to be established.

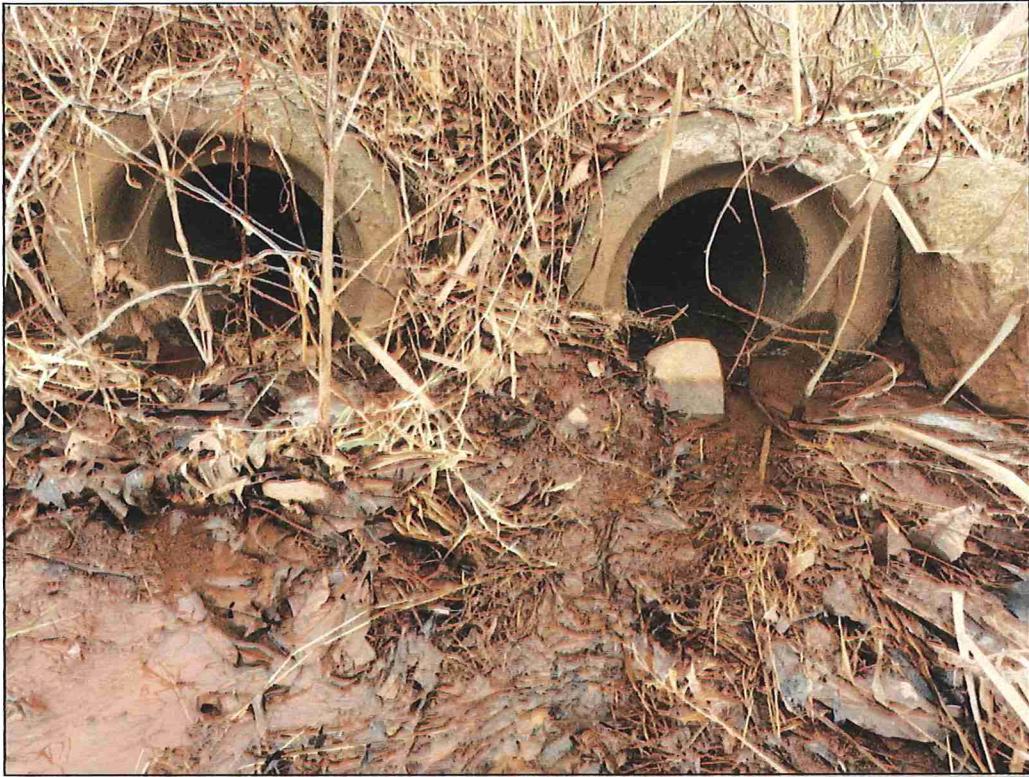
*Photo 5.* Twin outlet pipes through the "pond" embankment (berm); facing northerly
