5. **Clear cutting, tree removal, land destruction, and filling outside the easement from sites 7784 to sites 7787.**

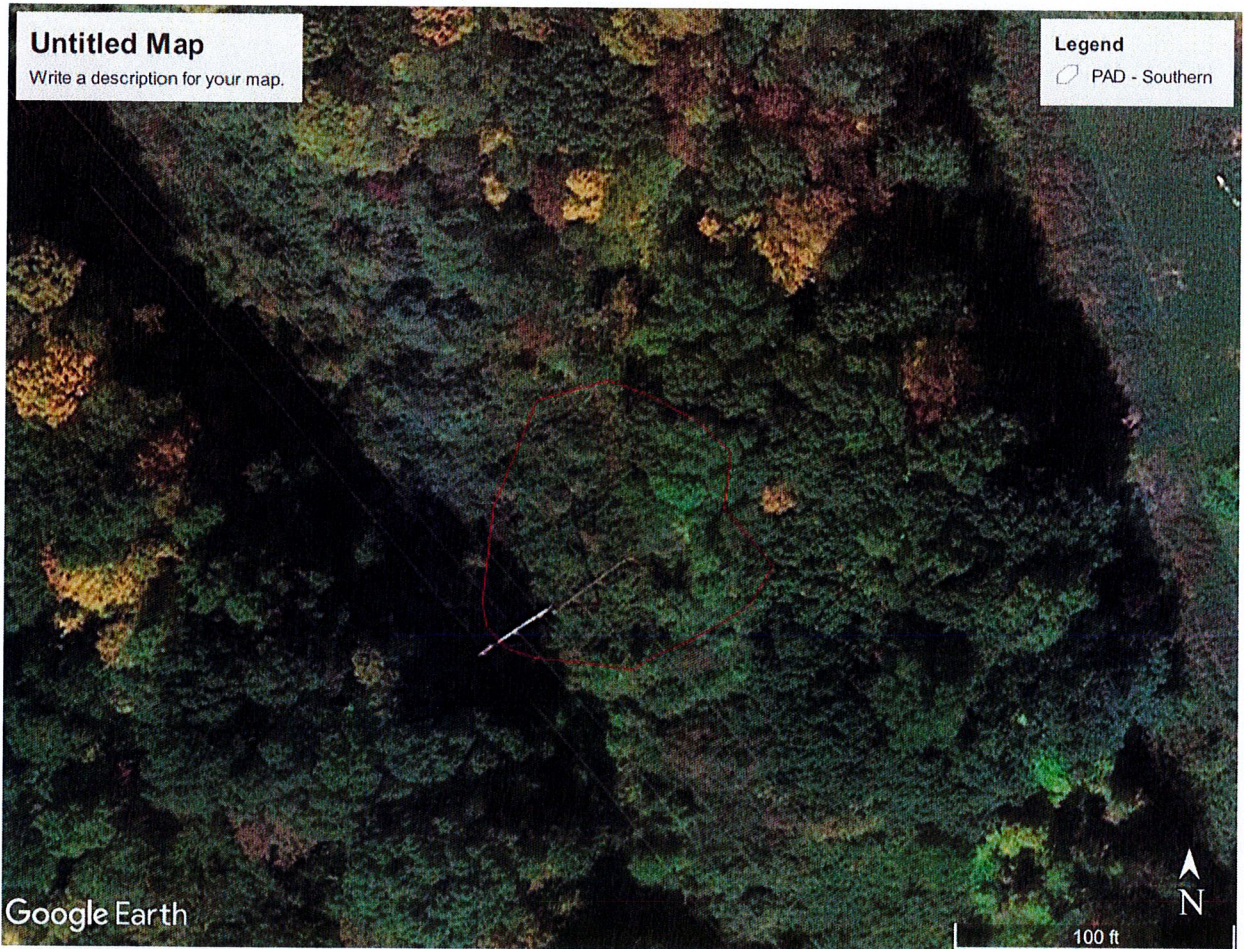
This is site 7786 prior to construction.

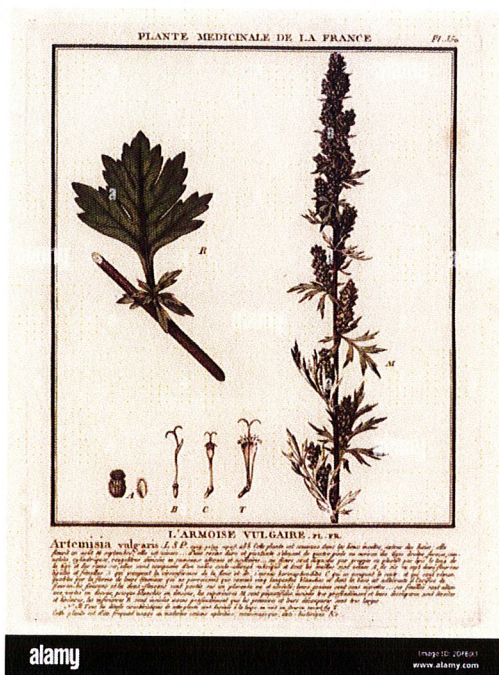
Soil compaction and disturbance by heavy equipment also damaged existing herbaceous plants and soils along the ROW, and **fostered colonization by noxious invasive plant species**, especially common mug wort (*Artemisia vulgaris*).

After logging to widen the ROW **increased light levels are accelerating invasive plant infestation of forest edges**, on Spaulding land. Restoration has not taken place following multiple types of vegetation and soil disturbance caused by ROW maintenance activities.

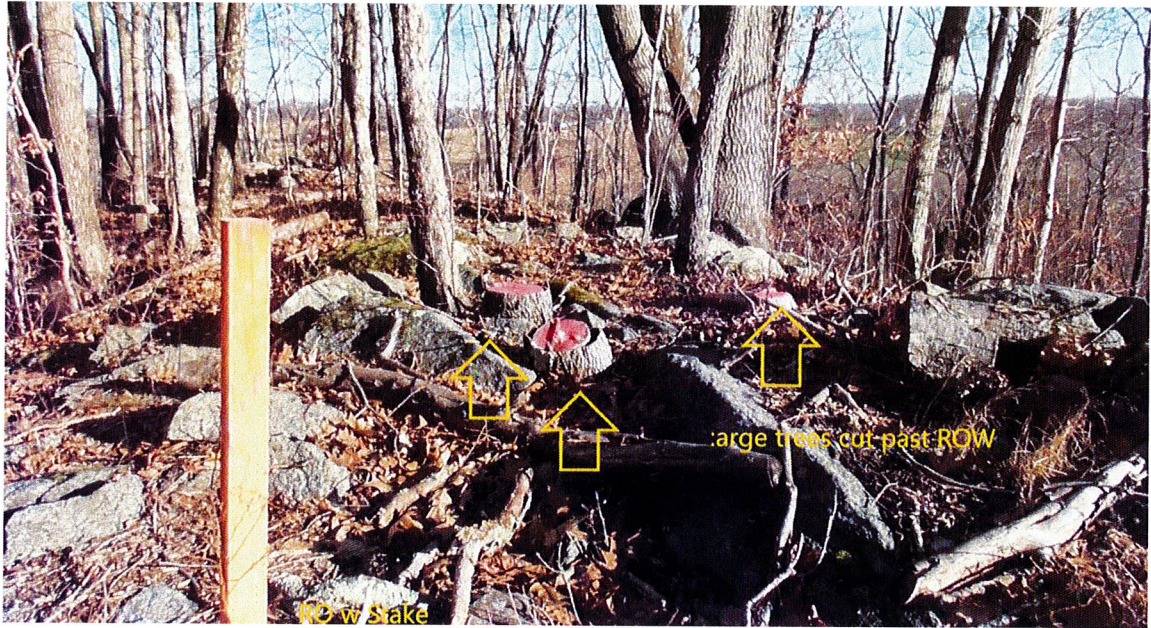
This is a photo from the east side of site 7786 where large trees were removed outside the easement.

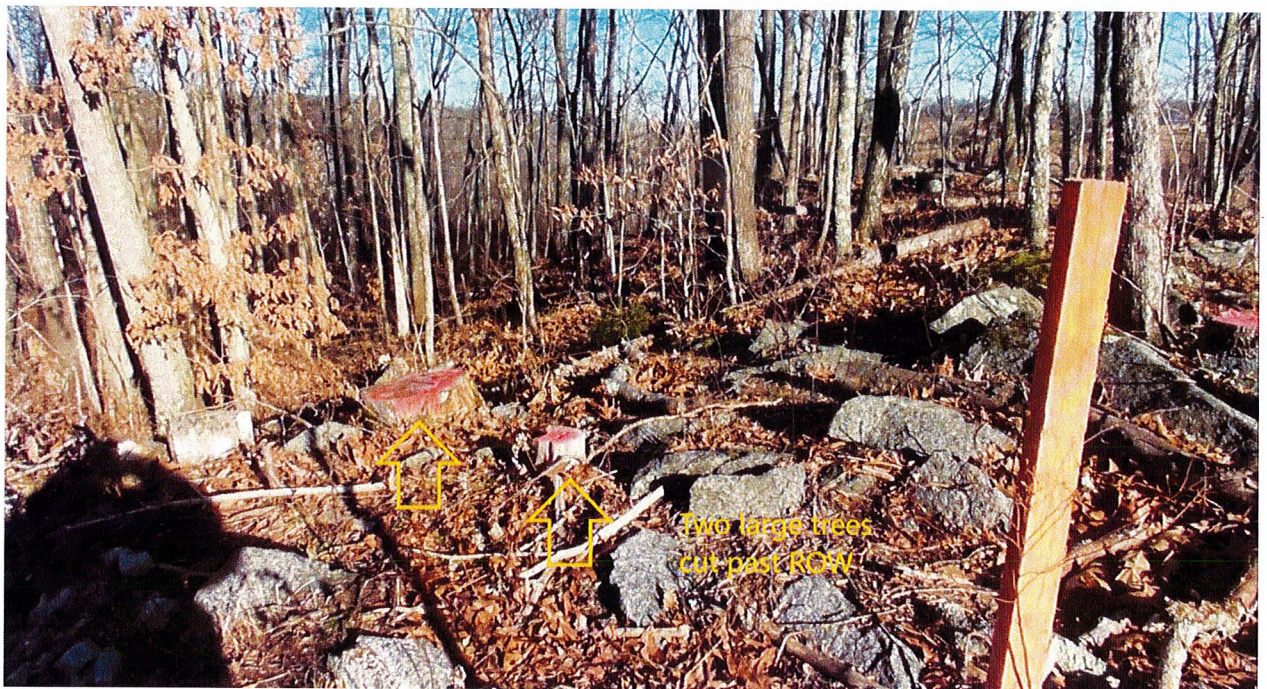
This is another example of the clear cutting of trees outside the easement.

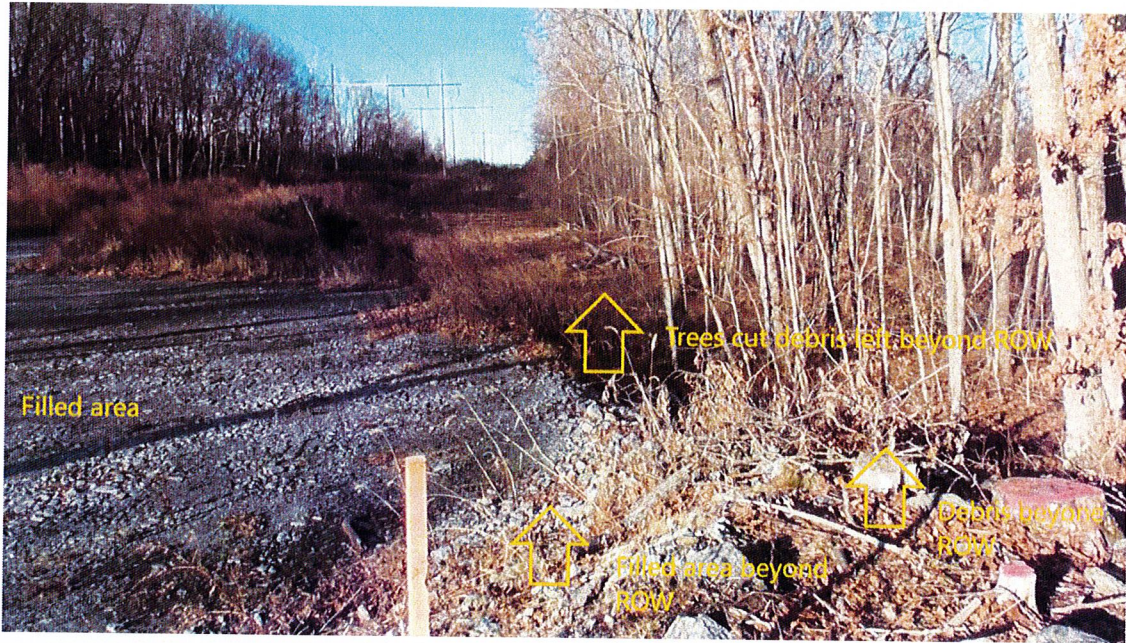
This photo depicts crushed rock fill deposited outside the easement and the debris left near site 7786.

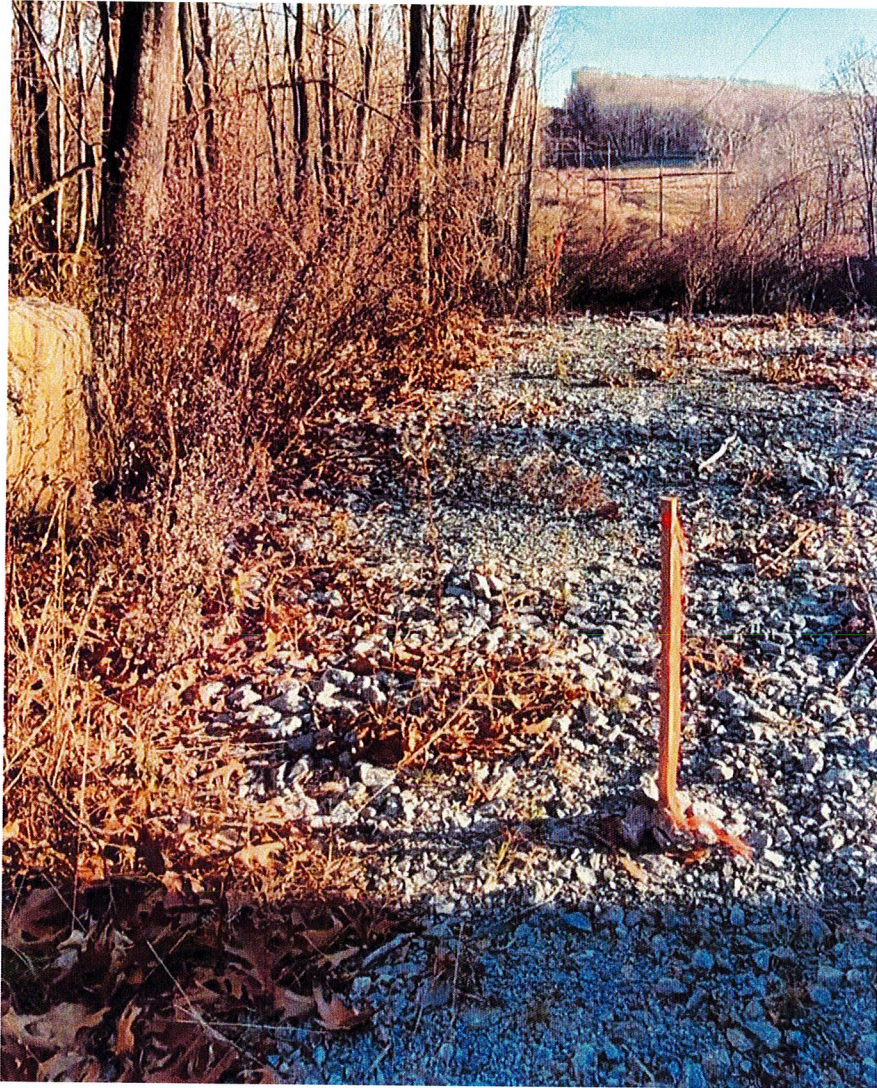
This photo shows the Eversource placed stake that defines the ROW limit at site 7785. Note the extensive filling and grading outside of the easement.

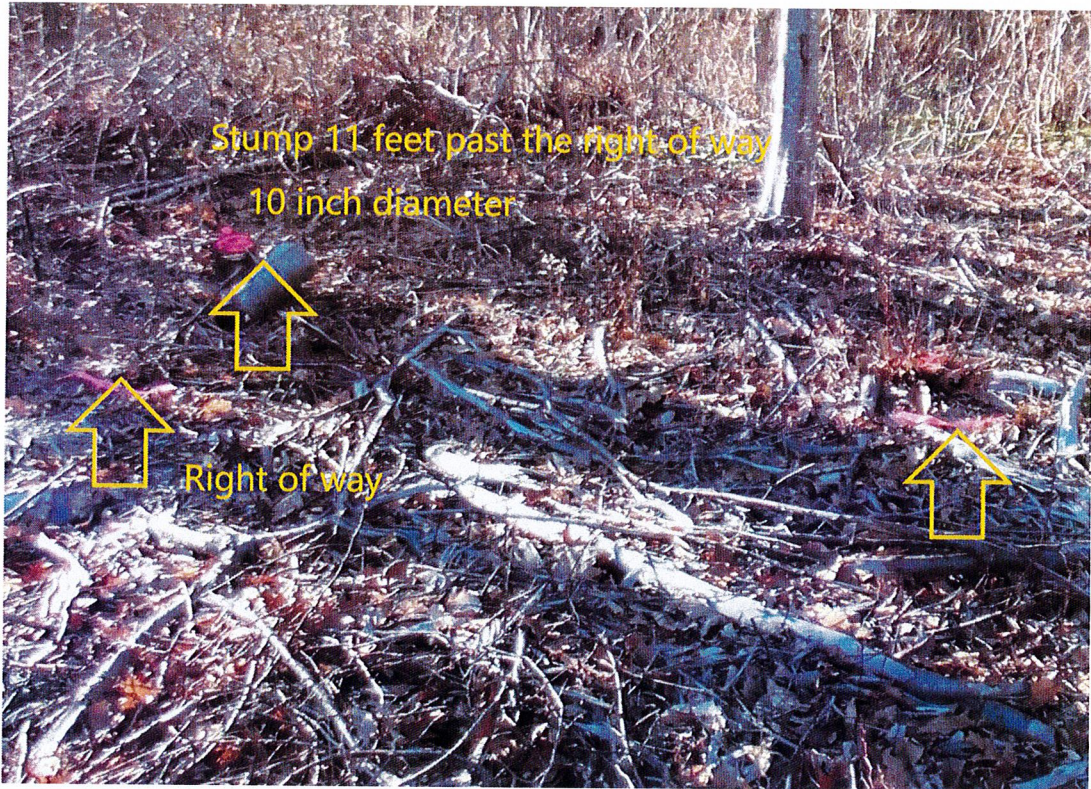
This image from 7786 to 7787 shows a 10-inch diameter tree taken down 11 feet outside the easement.

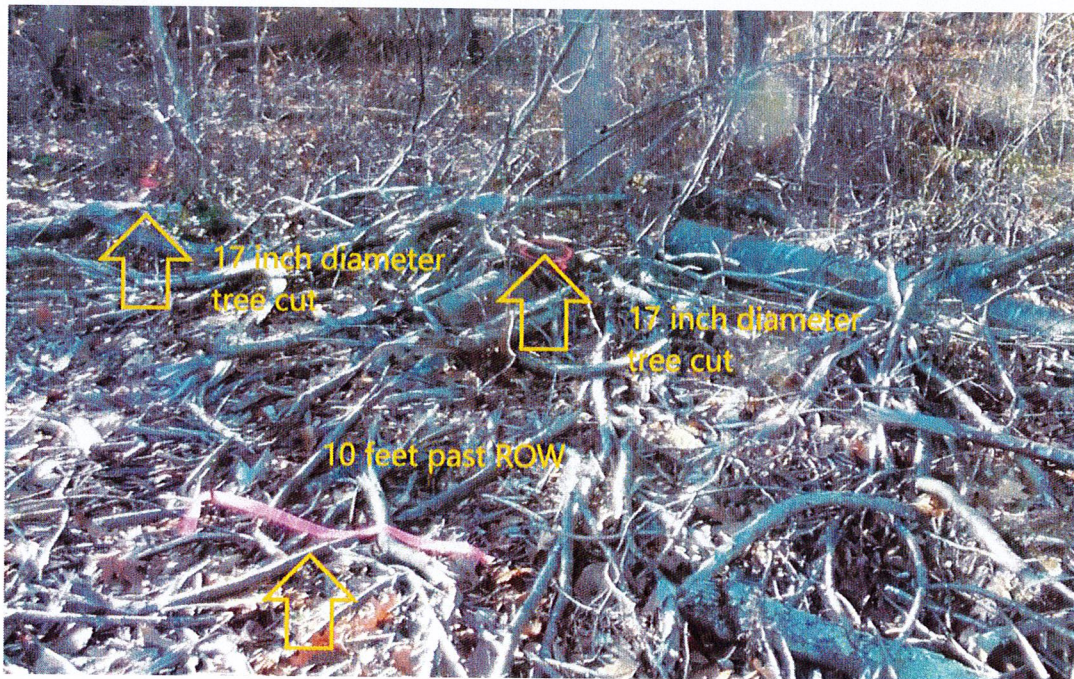
And this, showing a 17-inch diameter trees cut down 10 feet beyond the easement.

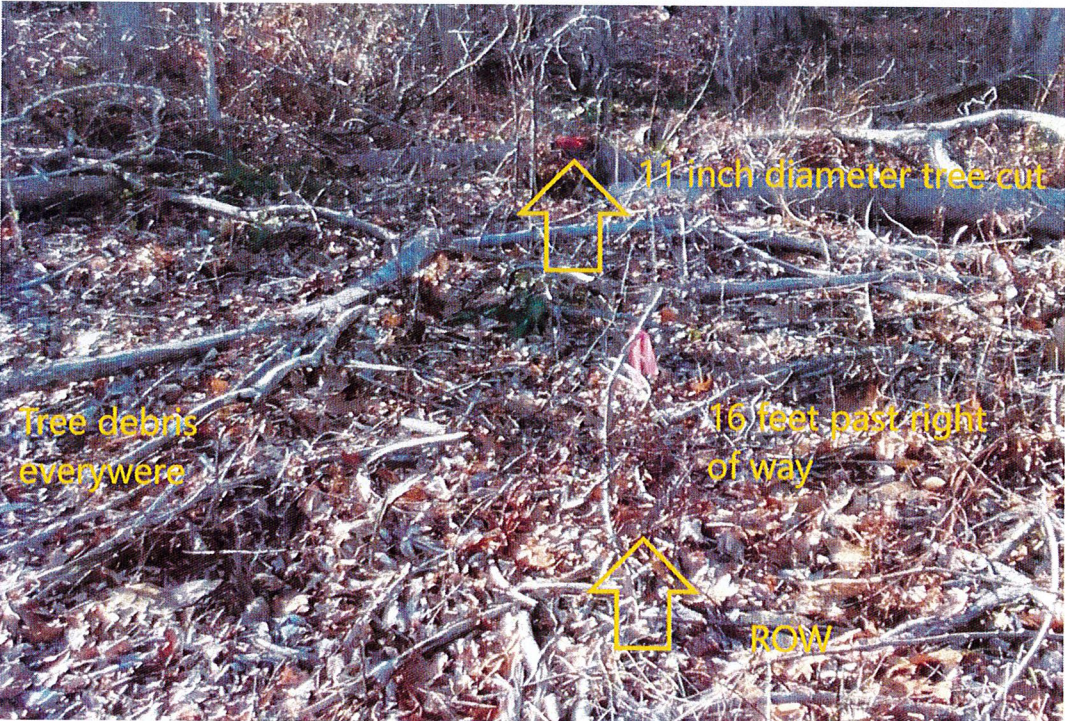
And this, 16 feet outside the easement, and still clear cutting of timber.

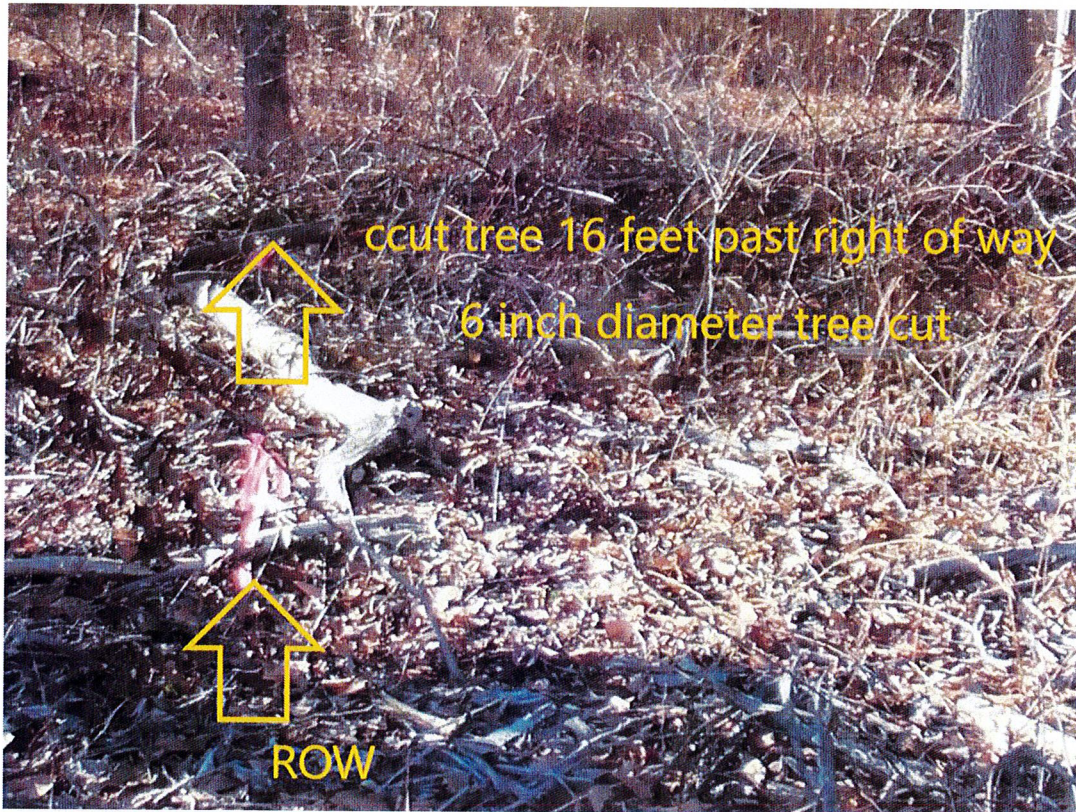
And here, 16 feet outside the easement, a 6-inch diameter tree is cut down.

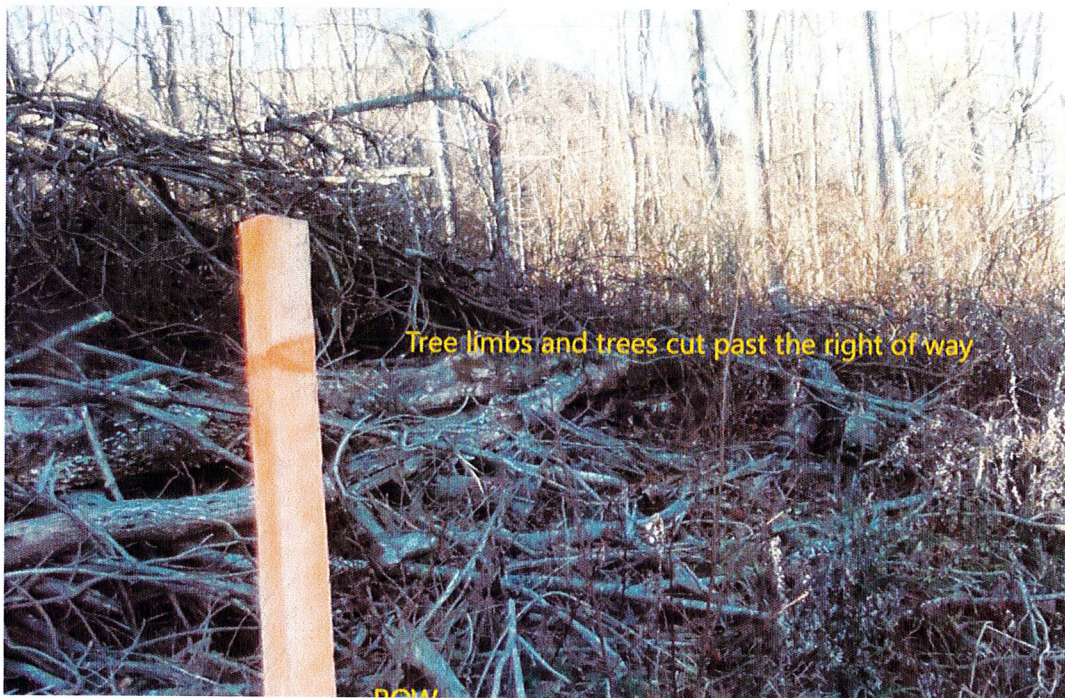
At site 7786 on the west side is this evidence of all the trees cut down outside the easement and the debris left.
