Docket No. 217 – Development and Management Plan Inspection

Northeast Utilities Service Company Certificate of Environmental Compatibility and Public Need for the construction of a 345-kV electric transmission line and reconstruction of an existing 115-kV electric transmission line between Connecticut Light and Power Company's Plumtree Substation in Bethel, through the towns of Redding, Weston, and Wilton, and to the Norwalk Substation in Norwalk, Connecticut.

Date: September 7, 2005

Location: 115 kV Underground Route

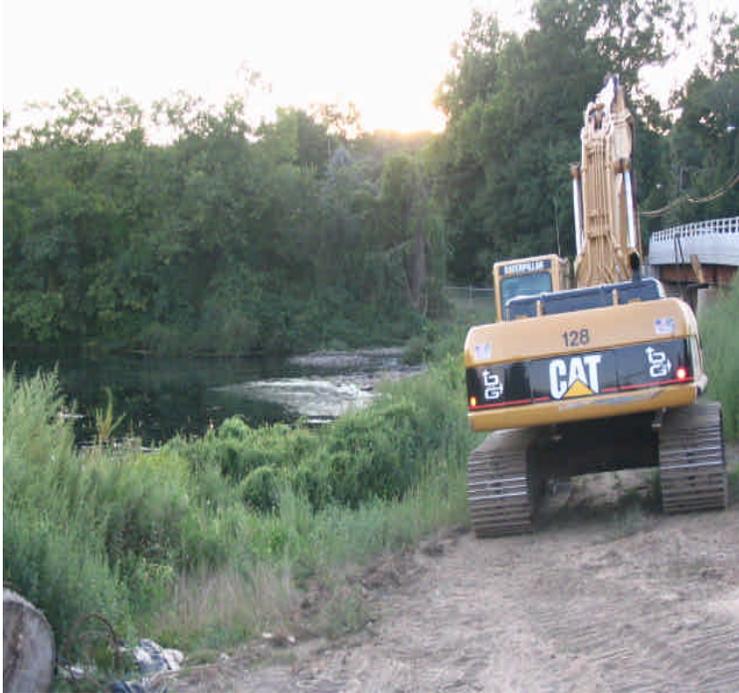
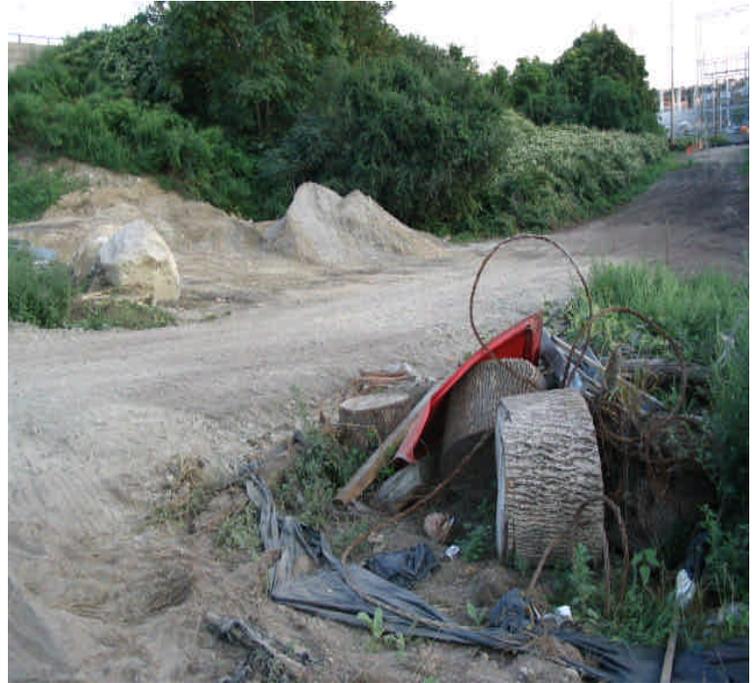
115 kV (Broad Street): Photo on the left shows the equipment parked too close to the Norwalk River. Machinery should be parked as far from resource areas as feasible. Photo on the right shows some stockpiles in the ROW which should be placed with silt fence at the base. 9/7/05

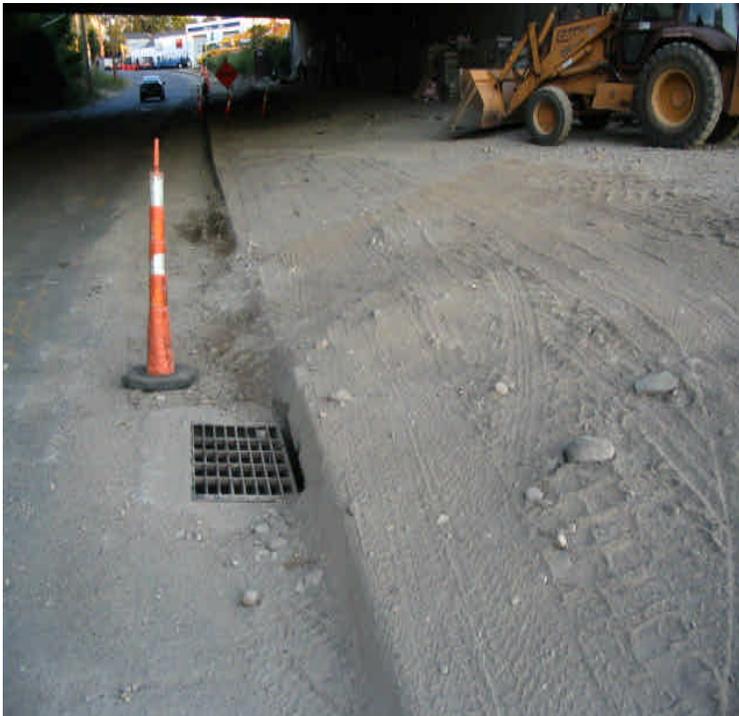
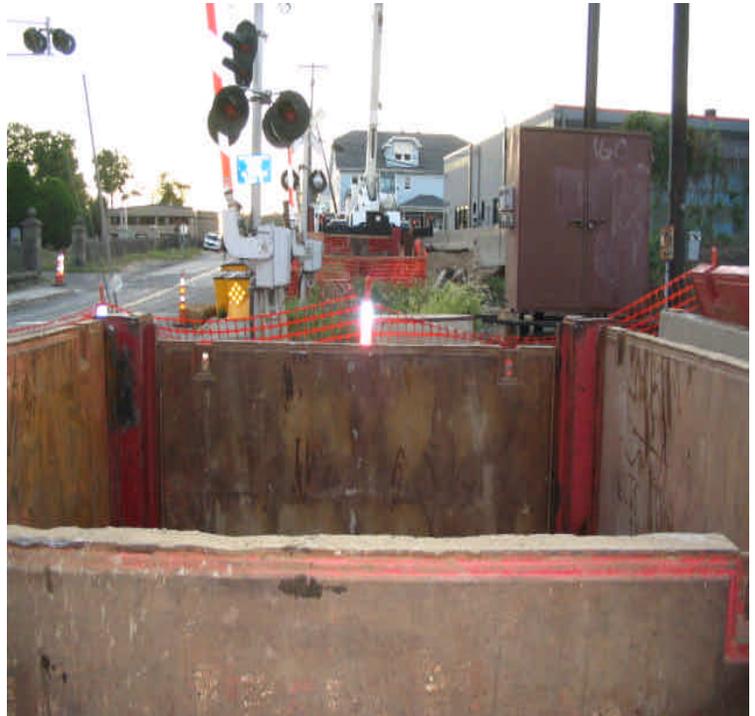
<p>Broad Street and Rt. 7, Norwalk</p>	<p>- A soil stockpile from the roadwork is being kept in the ROW. Remove any project related debris and brush from the ROW. 9/1-9/7/05</p> <p>-Bare soil was noted as a result of the vault work on Broad Street and the catch basin here was not protected. 9/7/05</p> <p>- The jacking and receiving pits off Broad St. are well contained and the catch basin here is protected with haybales. 9/7/05</p> <p>-Nightwork on Rt. 7 continues. No issues were noted leftover during the day inspection. 9/7/05</p>	<p>- Place silt fence around the pile if it is to remain for any length of time. 9/1-9/7/05</p> <p>- Perform regular “good housekeeping” to remove leftover materials and clean up the workspace. 9/1-9/7/05</p> <p>- Protect any catch basins or inlets which may receive sediment. 9/7/05</p> <p>- None at this time. 9/7/05</p> <p>- The vac truck approach used at night is a very effective means of handling the muds. Continue to utilize consistently.</p>

Photo on the left shows a bare soil area adjacent to a catch basin that is not protected with fabric or haybales. Photo on the right shows the receiving pit for the jack and bore at the railroad crossing. 9/7/05

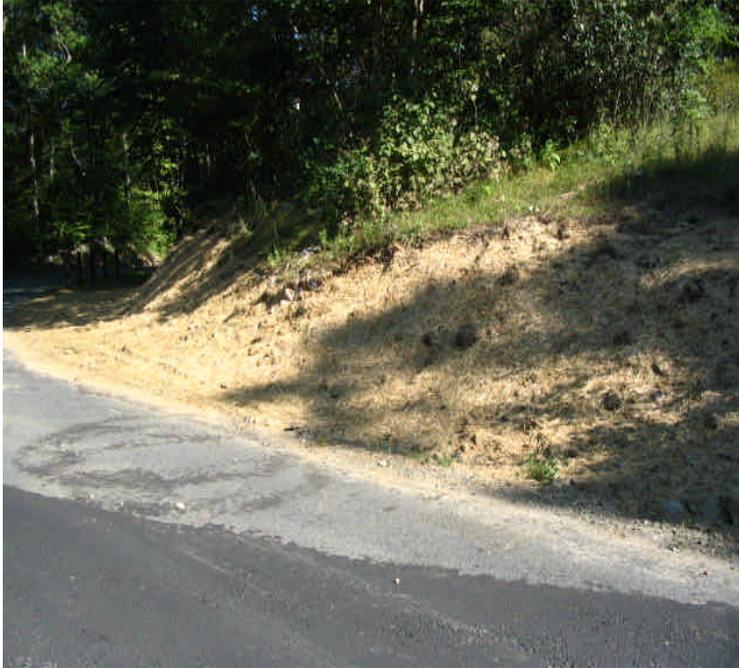
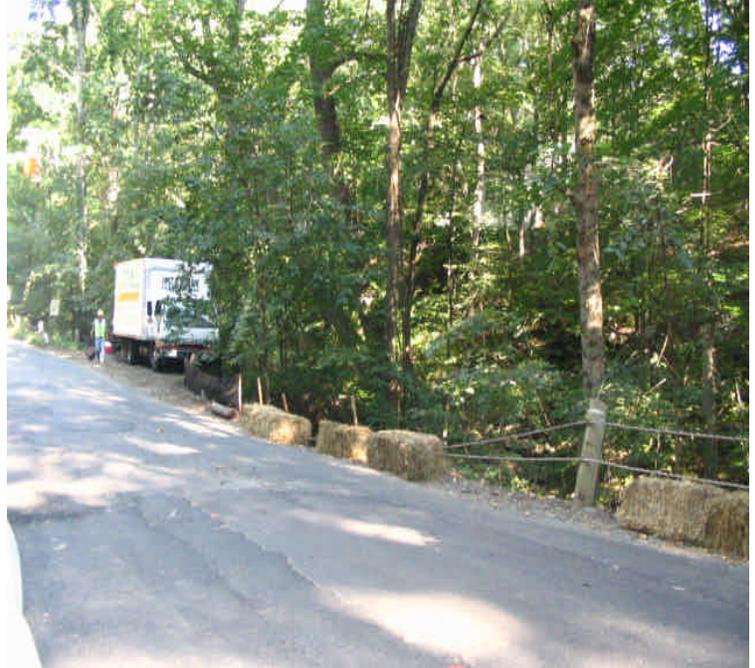
115 kV (Gallows Hill Road): Photo on the left shows the well restored area near the ROW intersection . Photo on the right shows where haybale check dams were added near #116. 9/7/05

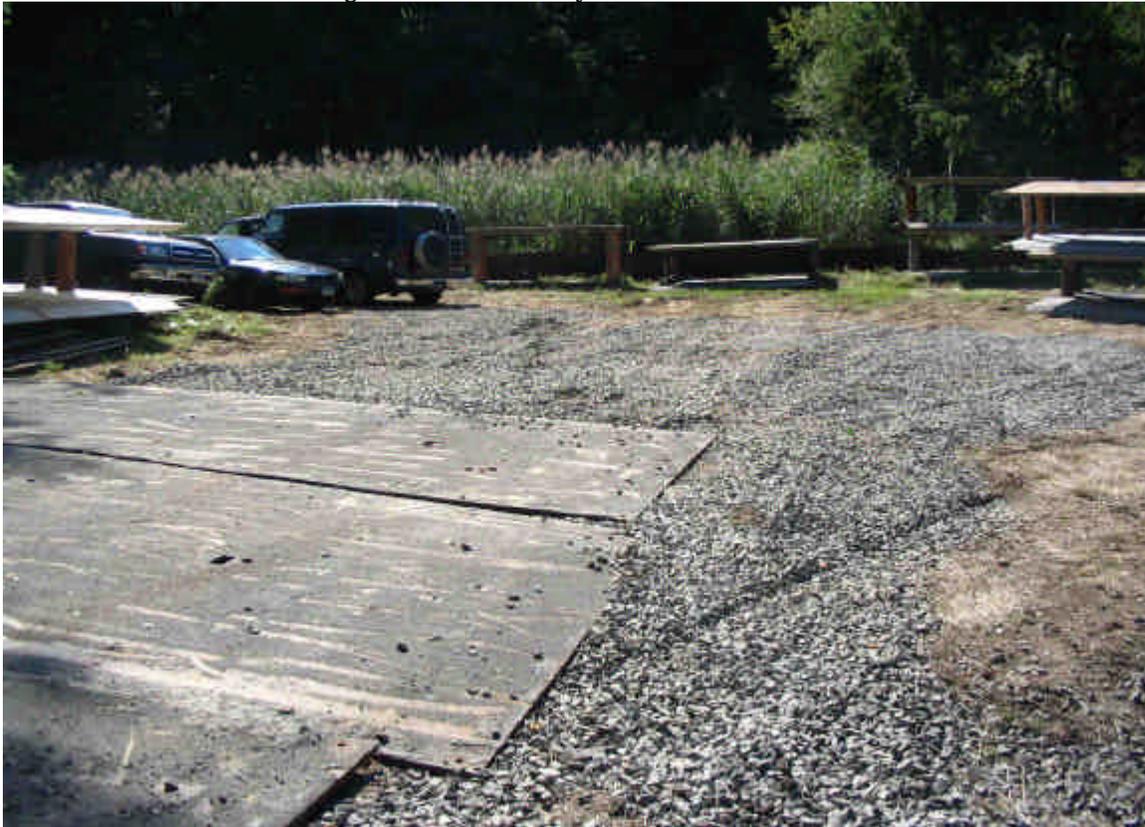
115 kV (Rt. 107): View of a new storage area identified near the Redding Country Club where stone was placed for access. 9/7/05

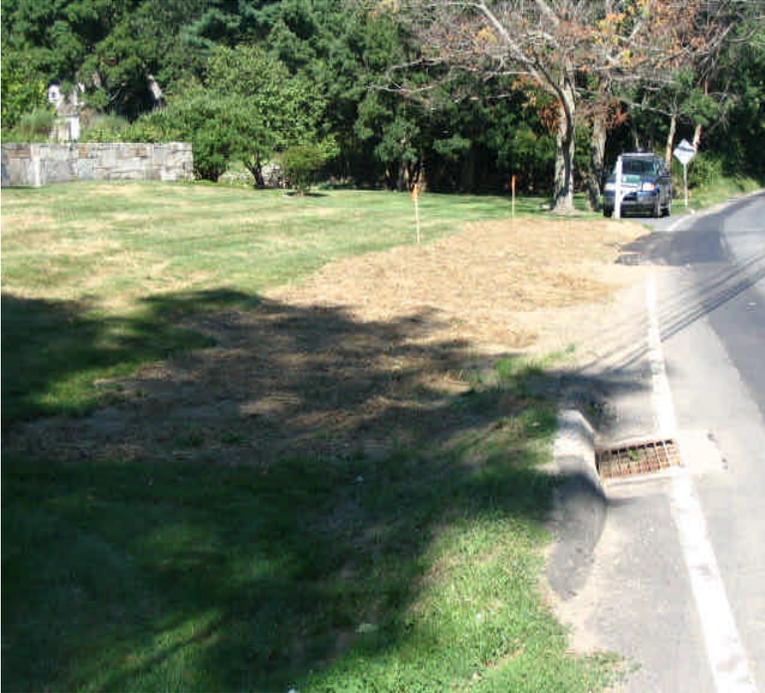
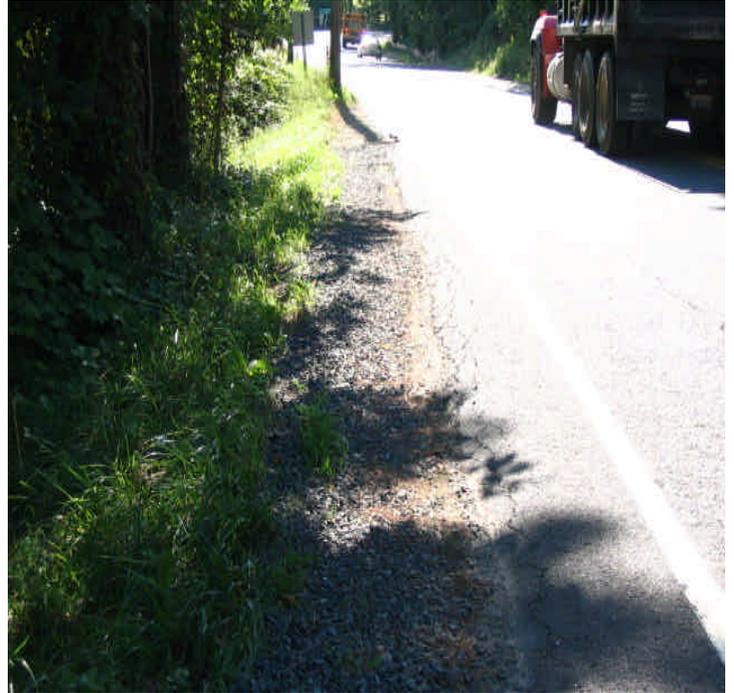
115kV (Rt. 107): Photo on the left shows a well restored vault area off the roadway. Photo on the right shows where stone was installed to stabilize a rut off the road edge. 9/7/05

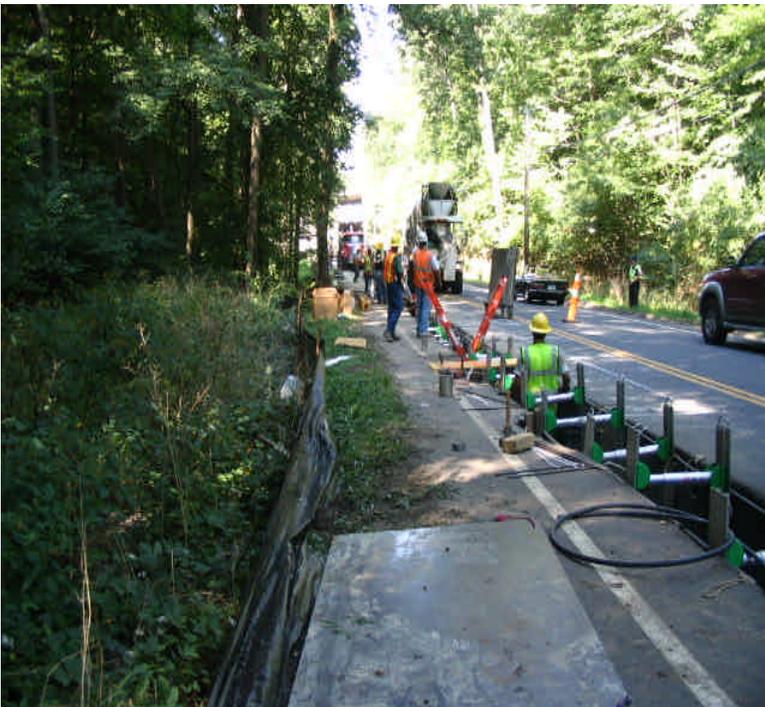
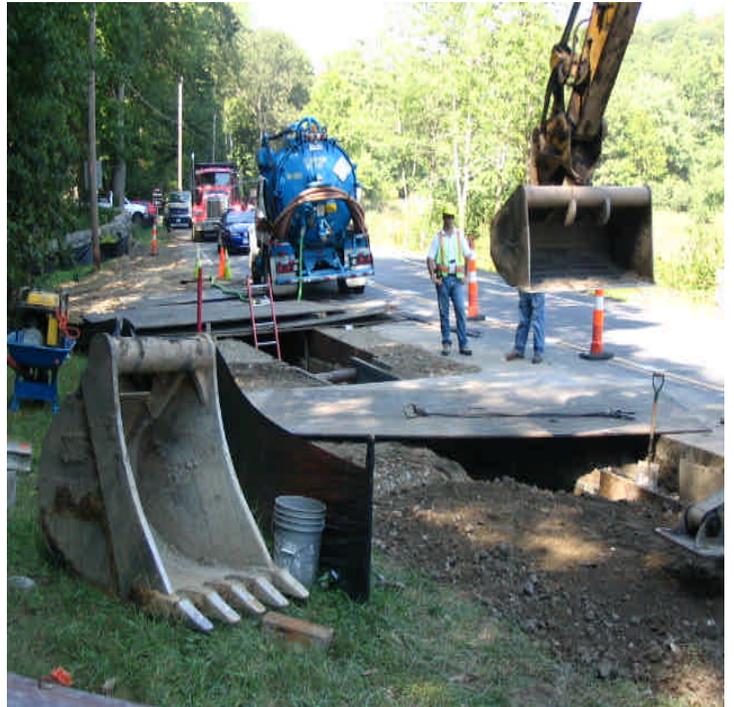
Dewatering	<p>- Almost all dewatering discharge along the route is being directed to frac trucks or tanks due to concerns about the polluted soils. 7/21-9/7/05</p> <p>-Active dewatering was noted going to a Fleet Environmental truck on Rt. 58 near the vault installation across from Putnam Park Pond. A large volume of water needed to be removed here 9/7/05</p>	<p>- It appears that the storage and disposal solution will continue due to concerns about the background pollutants in soils, even in those not considered contaminated. 7/21-9/7/05 It may be important to determine total daily volumes of water removal and evaluate whether this is a stress to the watershed or not a significant impact. 7/21-9/7/05</p>
Blasting	- No blasting is occurring in any areas at this time.	- None at this time.

115kV (Rt. 107 and 58) Photo on the left shows active trenching in the roadway for conduit installation. Photo on the right shows a vault installation with dewatering across from the pond near Putnam Park. 9/7/05

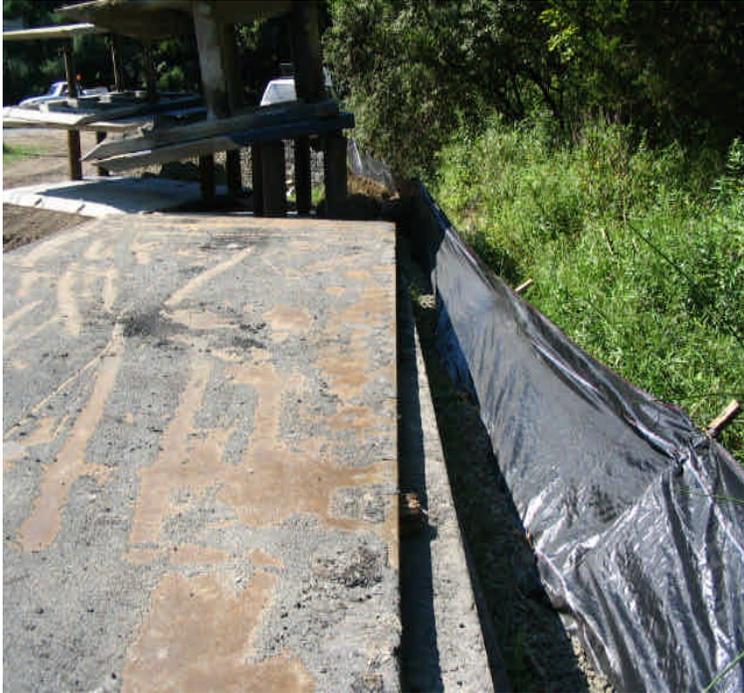
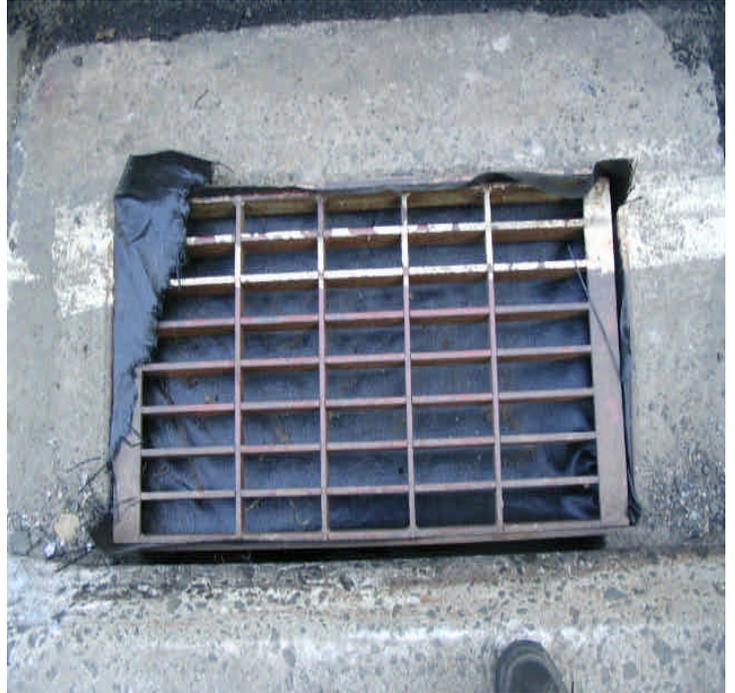
115kV (Rt 58). Photo on the left shows the storage area near Sunset Hill Road where trench covers were placed and were pushing over the silt fence. Photo on the right shows an example of catch basin protection with fabric. 9/7/05

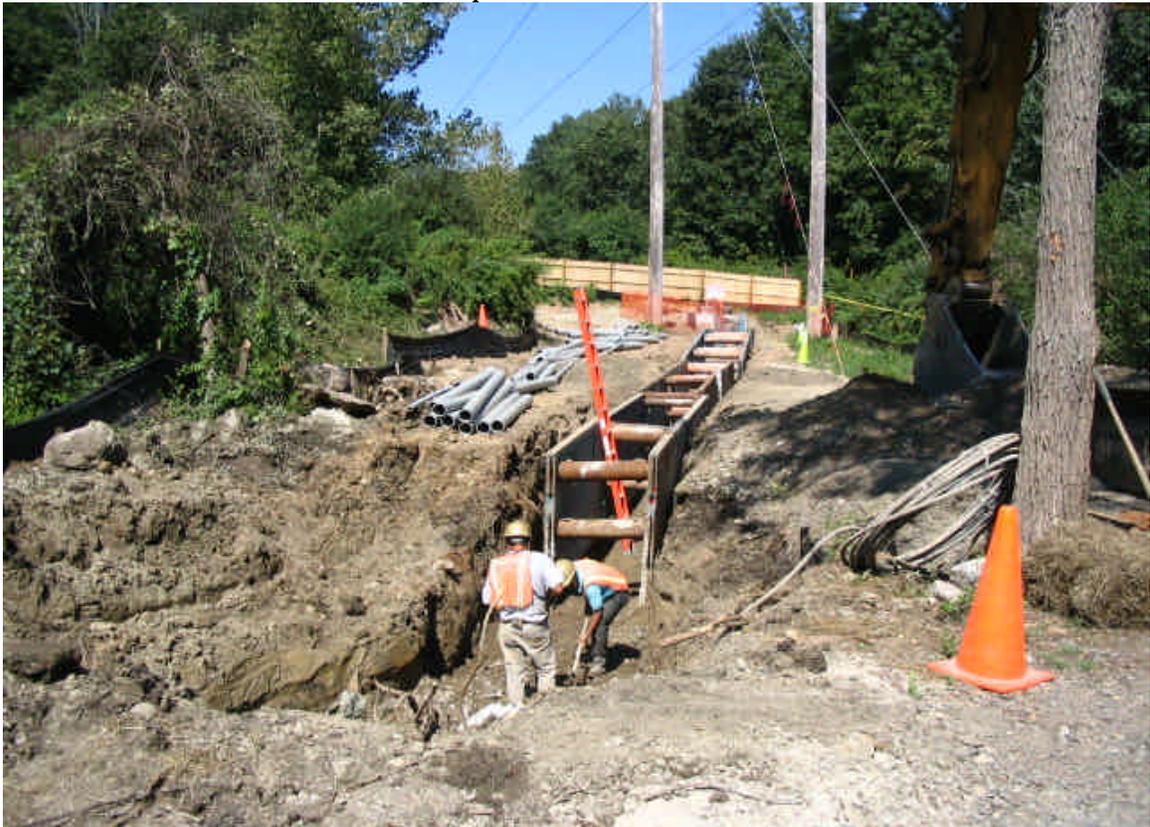
Areas of Inspection	Observation	Recommended Action
<p>Hoyts Hill Transition Structure (Off Rt. 58)</p>	<p>-Trenching has returned to this area in order to bring the conduit up to the transition structure. Erosion controls are mostly in good shape here. One spot along the access path needs to be toed-in 9/7/05</p> <p>- The contractor will ask the adjacent homeowner whether they would like their debris pile removed. 9/7/05</p>	<p>- Keep all areas of erosion control maintained. 9/7/05</p> <p>- The siting council suggested that NU could offer to remove the wood/debris for the owner. 8/25-9/7/05</p>
<p>Route 58</p>	<p>- Most catch basins near the work areas have been placed with either haybales or silt fence. One was noted upgradient of the vault installation but below a small bare area and it was asked that it be protected. 9/7/05</p> <p>- At the storage area off Rt. 58 near the Putnam Park entrance, erosion controls were in place but see storage section for more details. 9/7/05</p> <p>-One work area had some silt fence pushed down but it was repaired during the inspection. 9/7/05</p> <p>-The storage area near Sunset Hill road had some trench covers placed against the silt fence, pushing it over. 9/7/05</p> <p>- Areas that have been mulched should be seeded and silt fence can then be removed when work will not return here. 9/7/05</p>	<p>-In general, contain slurry or mobile sediment to work areas and street sweep the road extent including the gutters, regularly. Place and maintain controls on all catch basins and inlets which may receive muds. 9/7/05</p> <p>- None at this time. Continue to maintain all fence as needed. 9/7/05</p> <p>- The fence is well toed in and still functioning but the stakes should be righted. Contractors were attending to it at the time. 9/7/05</p> <p>- This includes</p>

115kV (Hoyts Hill Transition Structure): Active trenching has returned to the area to lead the conduit up to the caisson/structure. 9/7/05

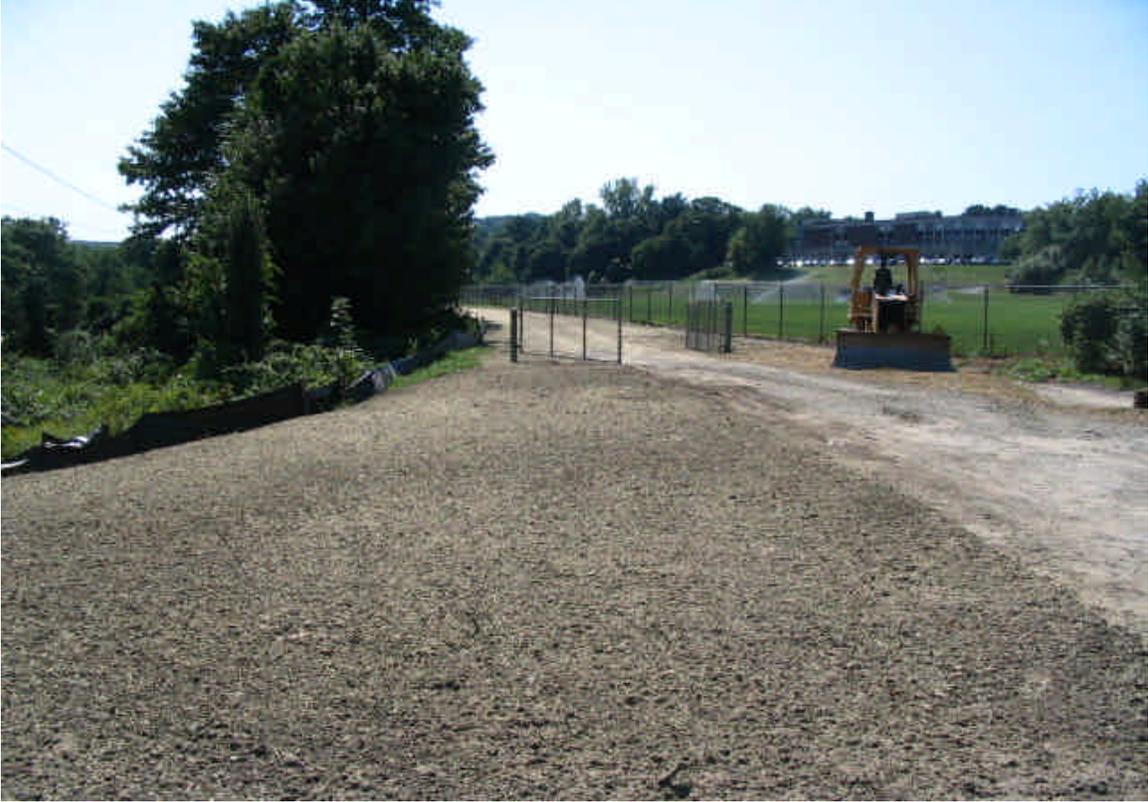
115kV (Bethel Educational Park): The southern portion of the ROW is very well restored with hydroseed in place and well installed silt fence for the entire length. 9/7/05

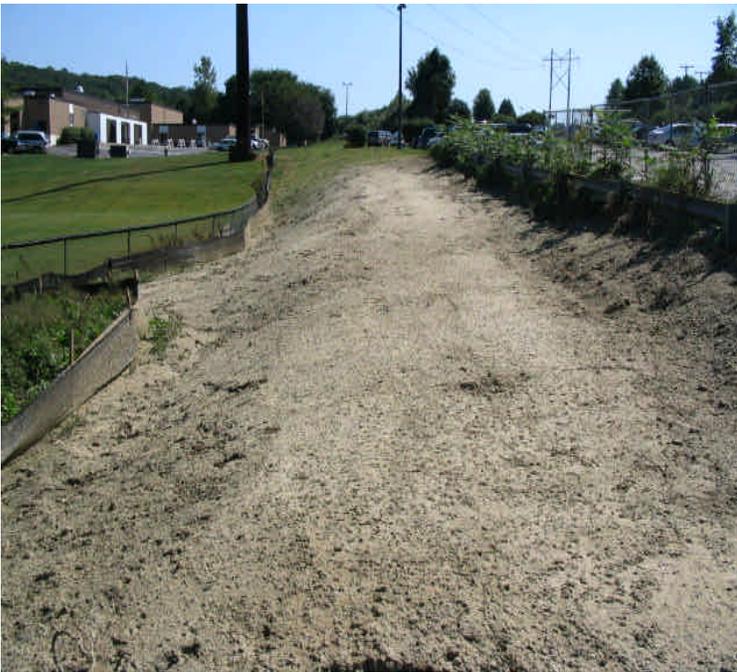
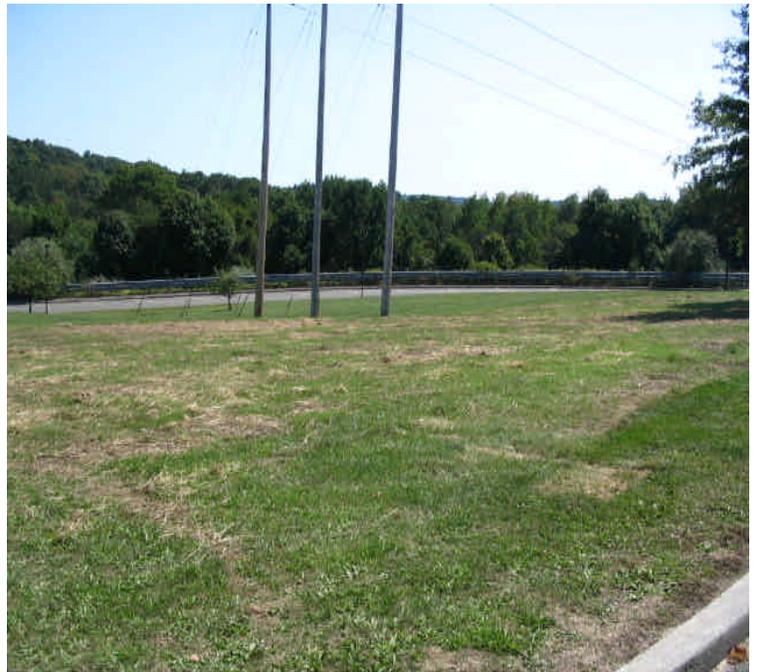
Photo on the left shows the well restored northern portion of the ROW with hydroseed and silt fence. Photo on the right shows the grass growth visible in the lawn areas of the school yard. 9/7/05
