Docket No. 217 – Development and Management Plan Inspection

Northeast Utilities Service Company Certificate of Environmental Compatibility and Public Need for the construction of a 345-kV electric transmission line and reconstruction of an existing 115-kV electric transmission line between Connecticut Light and Power Company's Plumtree Substation in Bethel, through the towns of Redding, Weston, and Wilton, and to the Norwalk Substation in Norwalk, Connecticut.

Date: March 9, 2006

Location: 345kV Underground Route

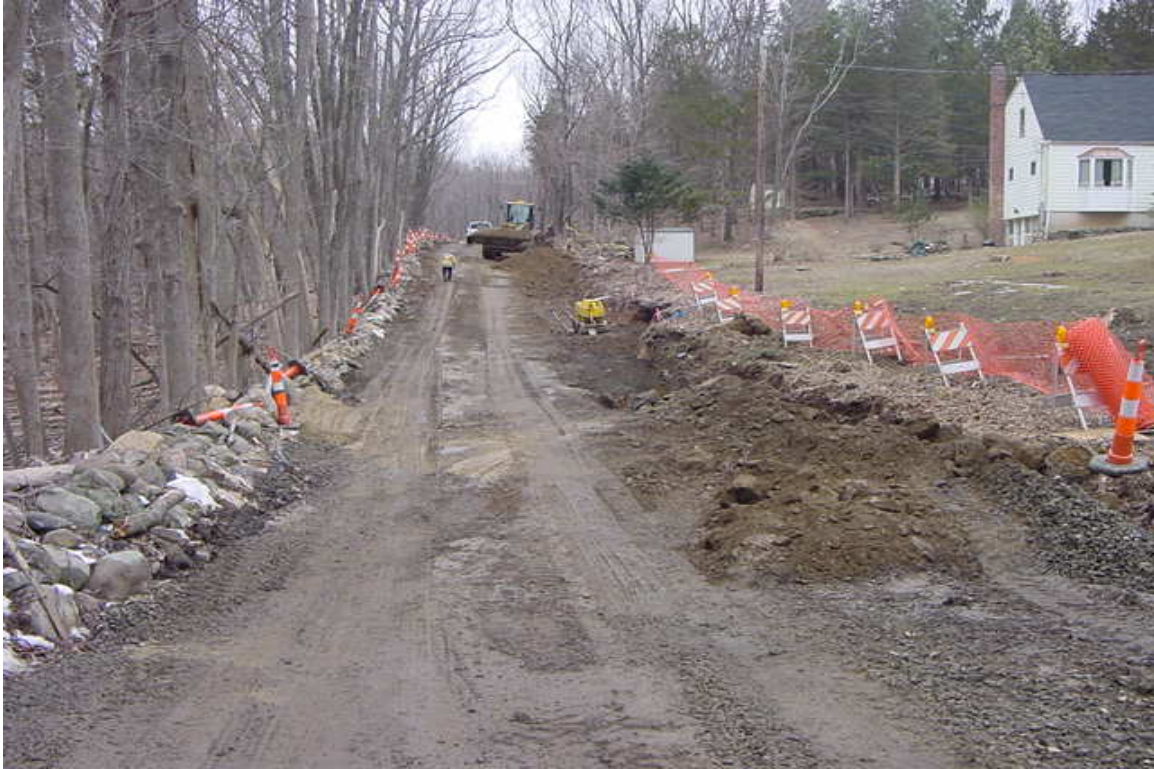
345kV (Archers Lane): Crews were backfilling the 345kV trenchwork along the access drive into the Archers Lane station. The site remains well contained at this time. Watch sediment along the stonewall as wetlands are located beyond it. 3/9/06

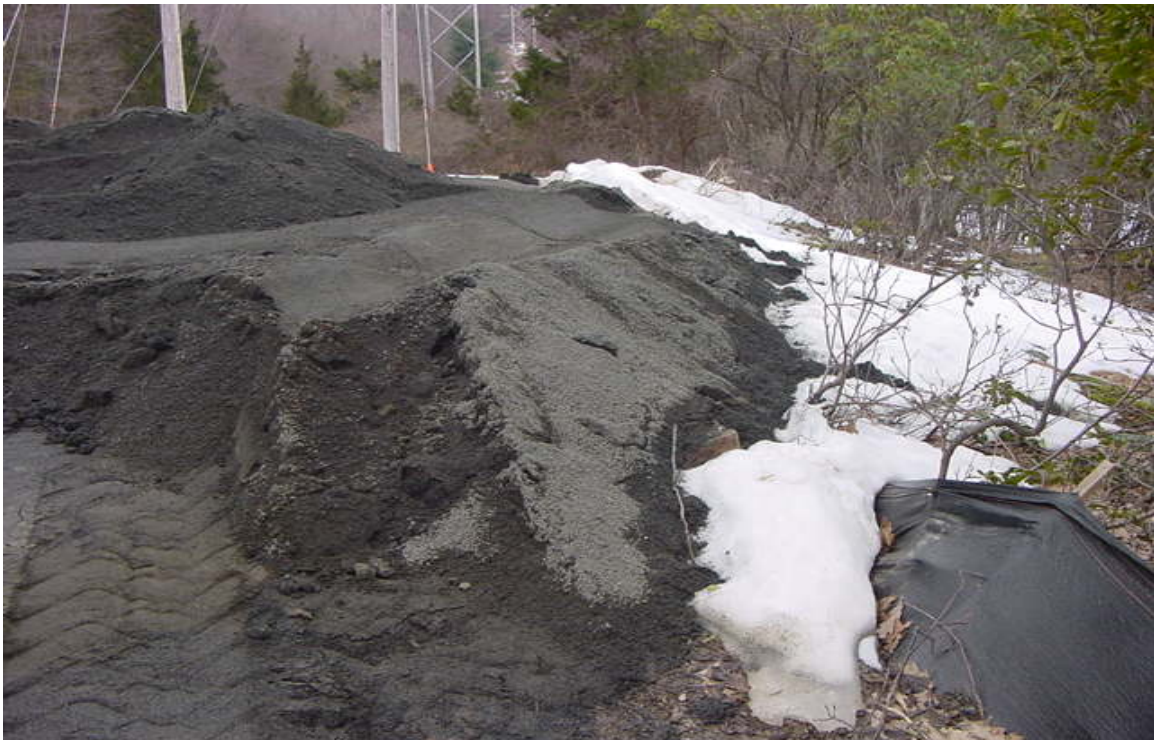
View of a stockpile of flowfill located adjacent to the drive and at the top of a slope leading to wetland. A silt fence was suggested due to its proximity to the slope. 3/9/06

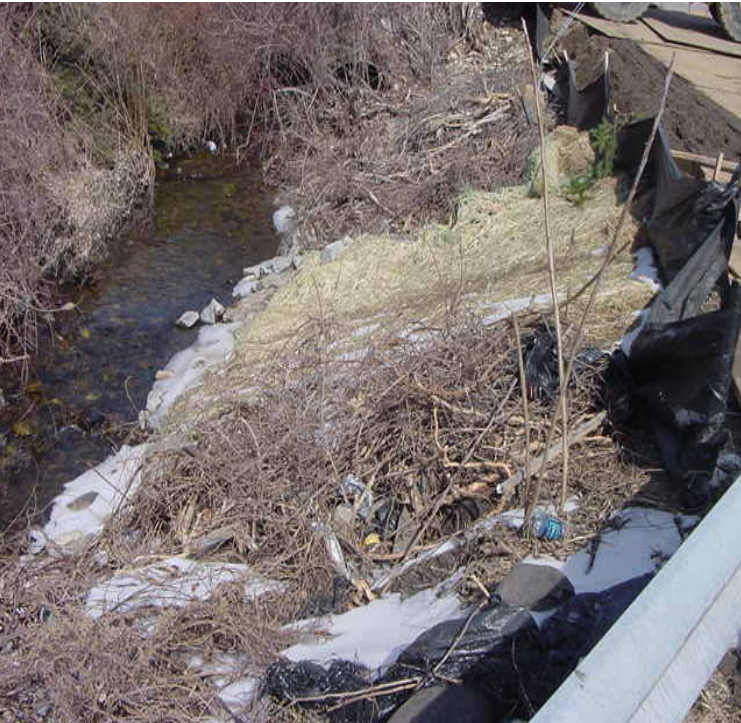
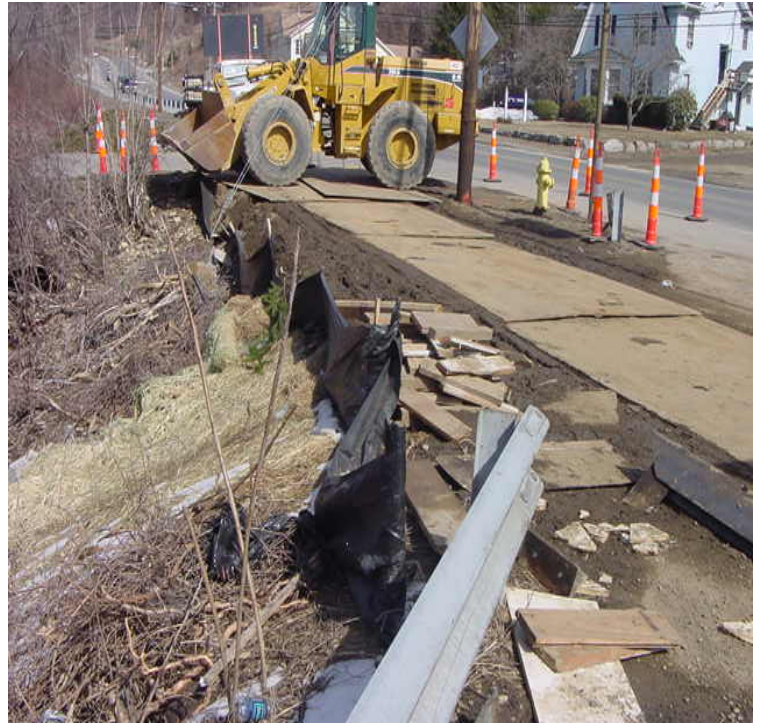
345kV (Rt 107) Photo on the left shows the Georgetown Deli with jute netting well in place along the bank. Photo on the right shows trenching along this area to connect in with the jack and bore. The silt fence needs repair in one area here. 3/9/06

Rt. 107 Daywork	<ul style="list-style-type: none"> - At the Georgetown Deli, trenching is continuing south along the roadway to the jack and bore site. An area of silt fence here required repair. 3/9/06 	<ul style="list-style-type: none"> -Repair the small section of silt fence. 3/9/06 	
Umpawaug Rd.	<ul style="list-style-type: none"> - A stockpile and small storage yard remain in place. - Active trenching and pipe installation continues along Umpawaug. Soil was stockpiled but as set to be 	<ul style="list-style-type: none"> - Remember to restore these areas when feasible 2/2-3/9/06 - Make sure soil is returned daily to the trench. Monitor adjacent erosion controls. 3/9/06 	- N/A at this time

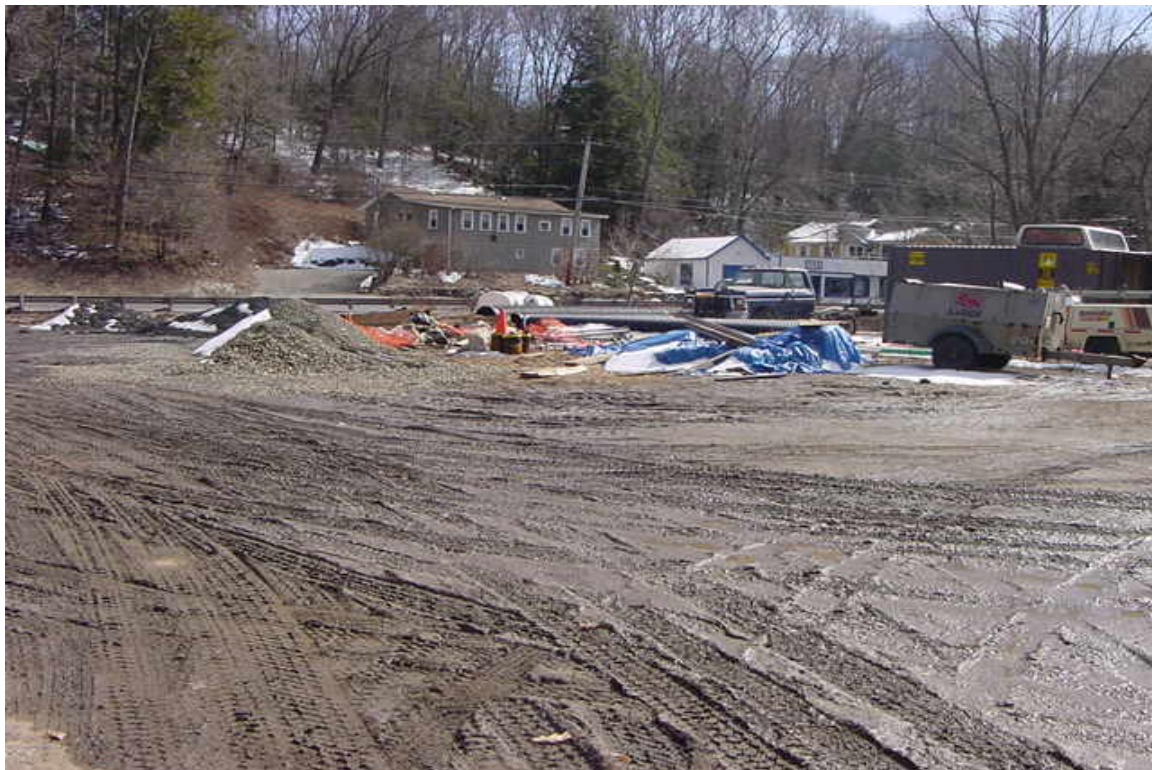
345kV (Rt. 7): Overview of the storage area off Rt. 7 where numerous materials and equipment still remain. Watch placement of equipment near the wetland swales as some of the machinery is parked closer than necessary. 3/9/06

Staging, Storage, and Parking Areas	- The equipment storage yard on the property south of the Rt. 7 & 107 intersection was muddy but mostly contained. 1/26-3/9/06 - Stone piles and machinery are being placed increasingly closer to the surrounding wetland swales. 1/26-3/9/06 - The racquet club storage	- In general, materials should be placed appropriately in storage areas or immediately adjacent to work each night. No potentially spillable materials should be left behind. - Equipment should not be placed near resource areas. 3/9/06 - Keep within the limits of	-N/A

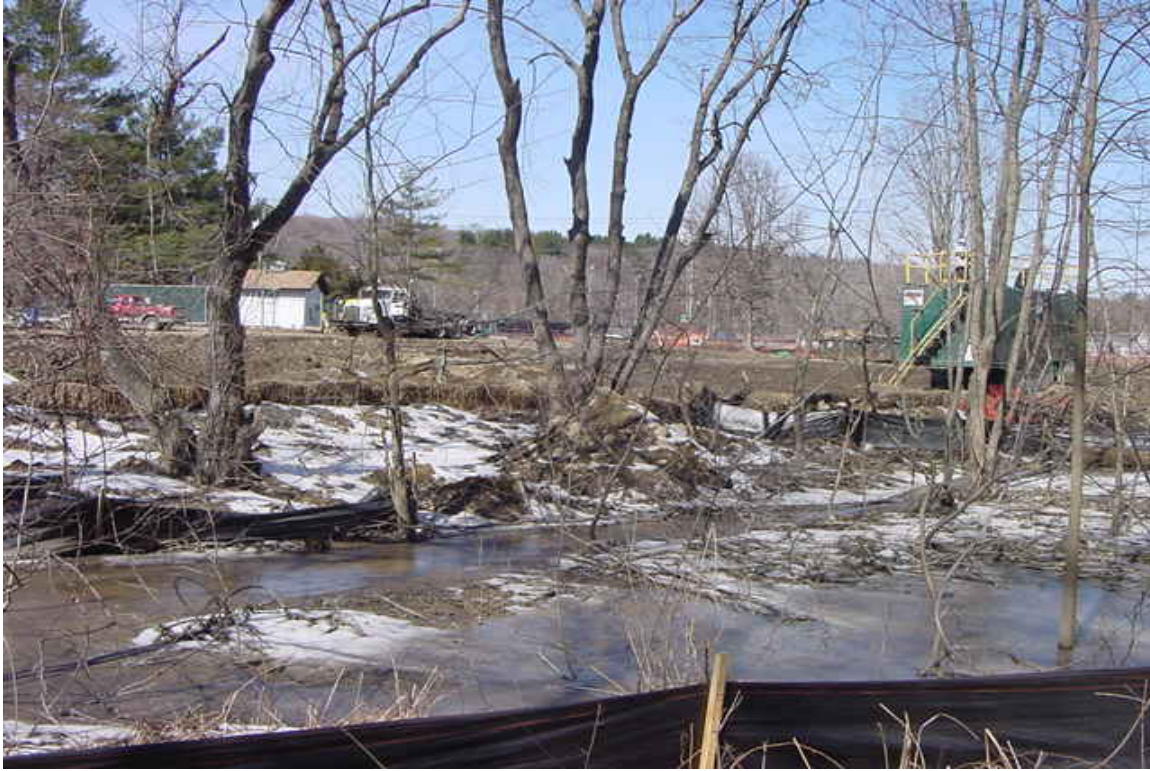
345kV(HDD): Overview of the site, looking in at the basin from the eastern wetlands. Sediment accumulation will need to be removed when access is feasible. 3/9/06

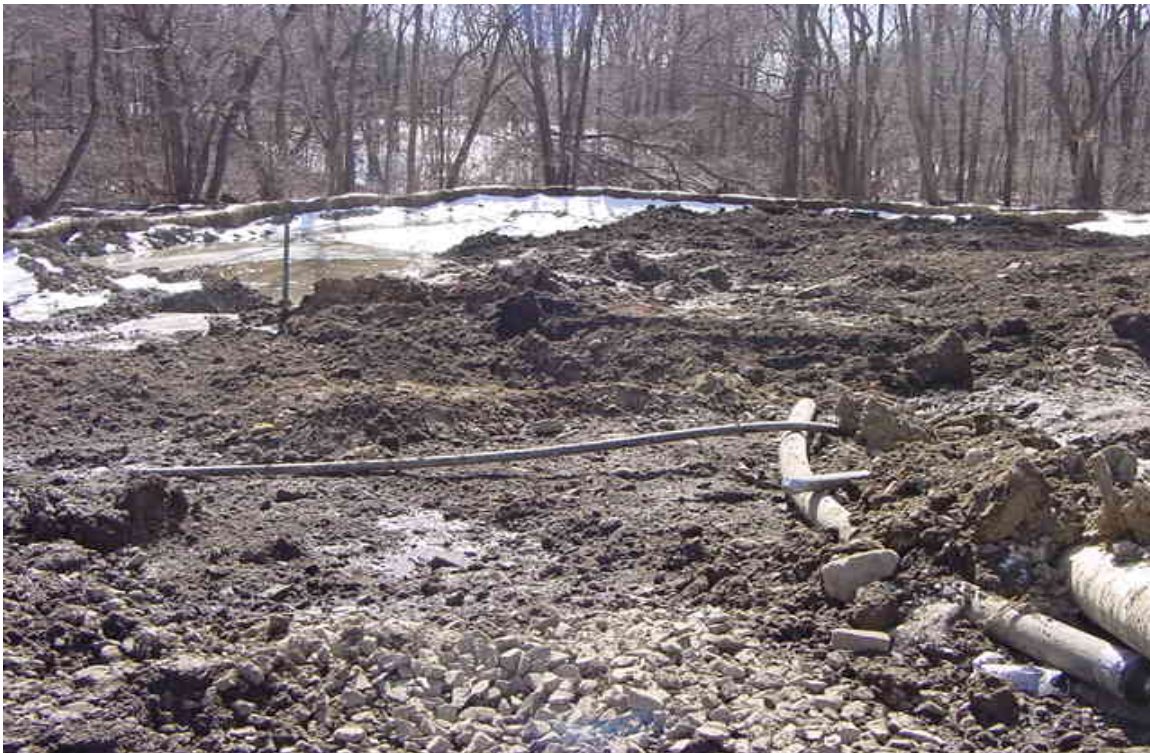
The drill equipment has demobilized and the basin is in the process of being filled in and graded as a temporary stabilization measure. After trenching connects to this area, the soil surface should be revegetated and restored. 3/9/06

- Equipment continues to demobilize from the Horizontal Direction Drill at School Rd. The basin is being filled in and graded as temporary stabilization. 3/9/06	- Further restoration will be necessary after the adjacent work is complete. See additional sections for more details. 3/9/06	- The basin is being graded which will help reduce sedimentation.
	-Trenching will need to continue here in the near future to link up the project. 3/9/06	- See other sections for more details. 3/9/06	-N/A
