**Docket No. 217 – Development and Management Plan Inspection**

Northeast Utilities Service Company Certificate of Environmental Compatibility and Public Need for the construction of a 345-kV electric transmission line and reconstruction of an existing 115-kV electric transmission line between Connecticut Light and Power Company's Plumtree Substation in Bethel, through the towns of Redding, Weston, and Wilton, and to the Norwalk Substation in Norwalk, Connecticut.

**Date:** April 12, 2006

**Location:** 345kV Underground Route

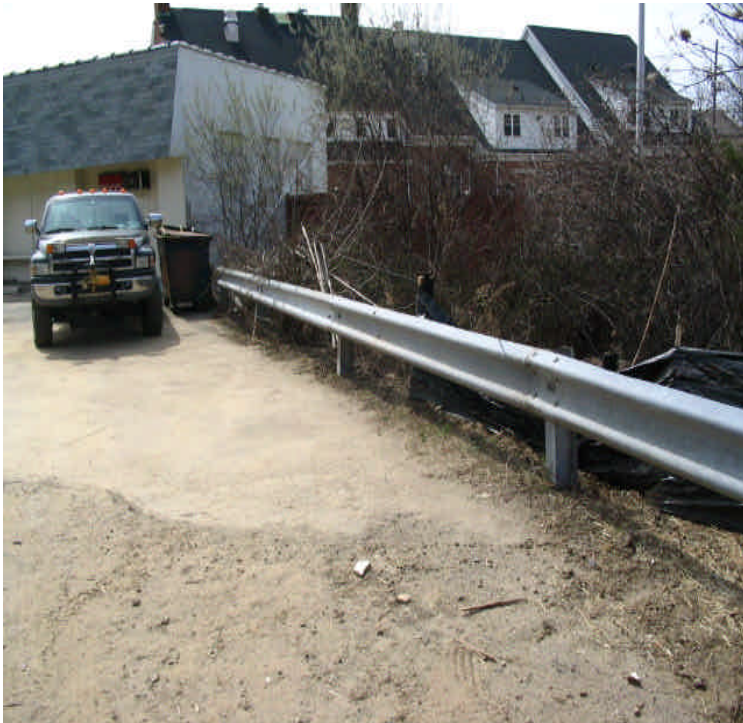
345kV (Georgetown Deli) Photo on the left shows where the small stockpile was removed from the lot. Photo on the right shows the bank controls well in place. 4/12/06

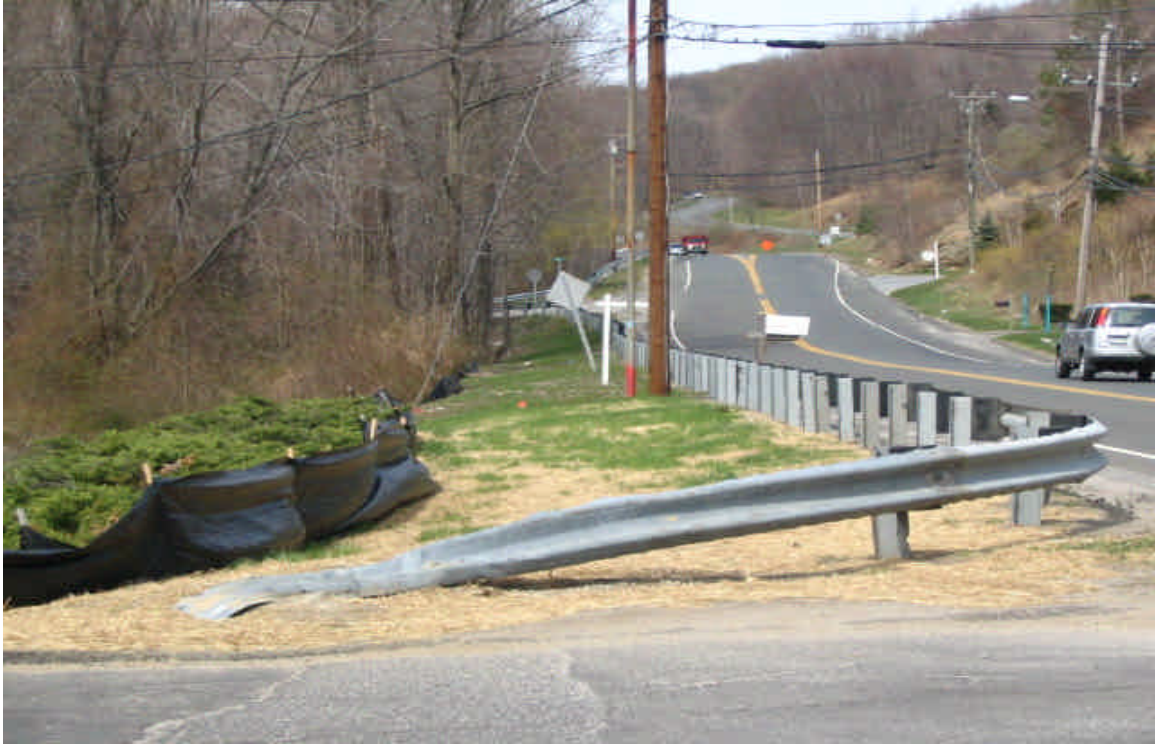
345kV (Rt 107) Photo shows an overview to the north of Georgetown Deli where grass is growing well and the area is stabilizing. 4/12/06

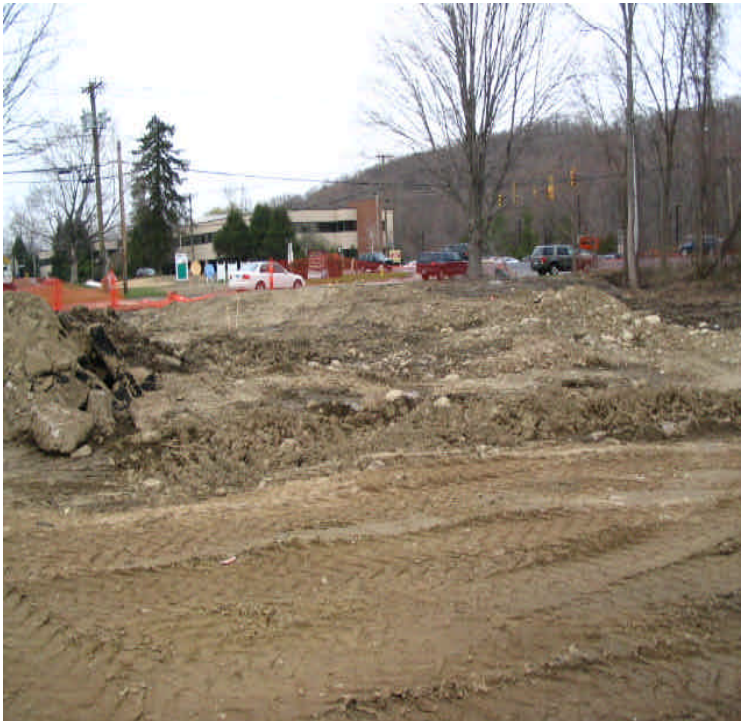
345kV (Rt 7-HDD) Photo on the left shows a view towards School Rd. where one of the excavation areas was backfilled. Photo on the right is a view of an open excavation remaining in the yard here. 4/12/06

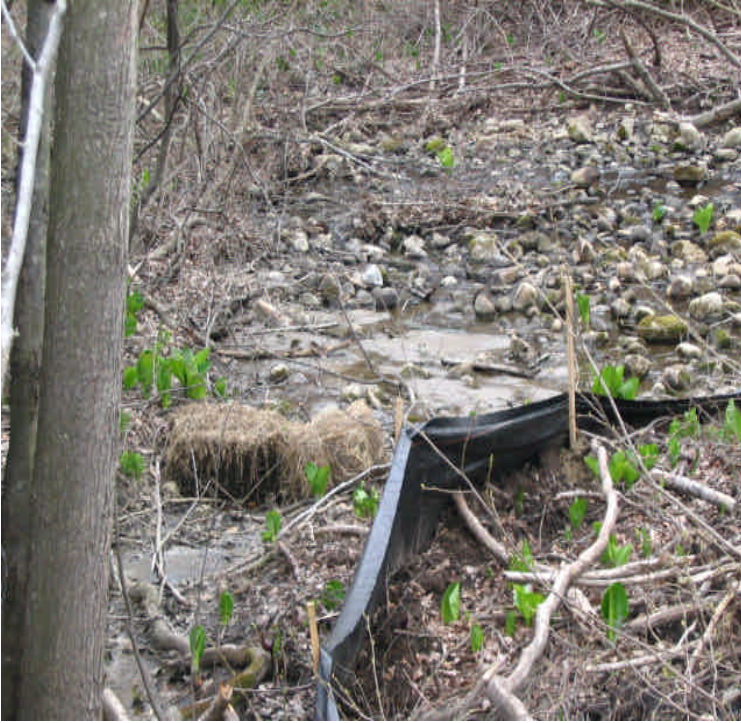
The photo on the left shows a view of the wetland area beyond the basin to the south where sediment accumulation still needs to be removed. Photo on the right shows a view of the wetlands to the east of the basin where sediment still needs to be removed. 4/12/06

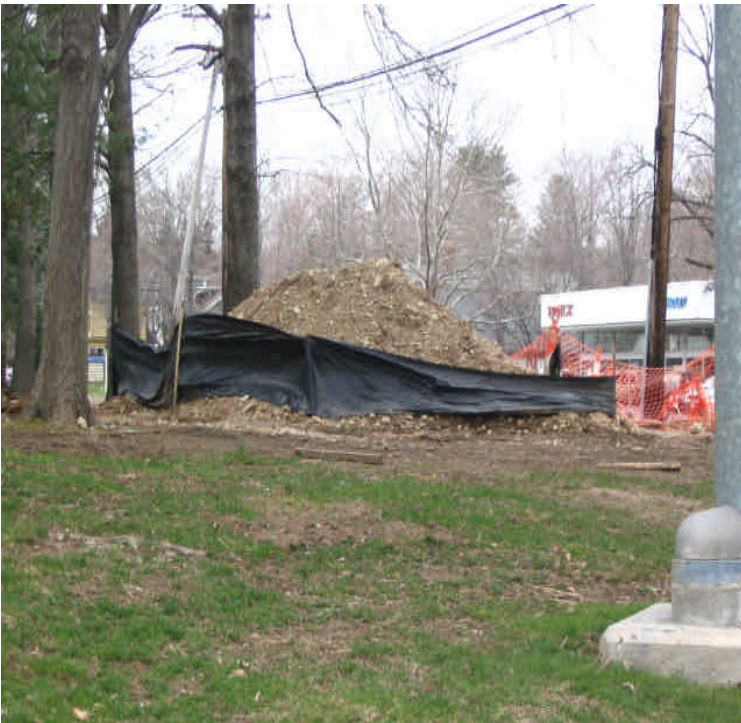
Areas of Inspection	Observation	Recommended Action	Corrected Action
Vault Openings and Trench Construction	- An open vault excavation remains near Wilton Corporate Park on Rt. 7. 3/9-4/12/06	- Some further attention is needed here. See erosion control section. 4/12/06	-Silt fence was placed at the stockpile but was not toed in.

Photo on the left shows silt fence up at the stockpile near the Wilton Corporate Park but it was not toed in. Photo on the right shows the perimeter of Norwalk Junction where 345kV trenching occurred several weeks ago. The resulting stockpiles and excavations were effectively backfilled. 4/12/06
