Docket No. 217 – Development and Management Plan Inspection

Northeast Utilities Service Company Certificate of Environmental Compatibility and Public Need for the construction of a 345-kV electric transmission line and reconstruction of an existing 115-kV electric transmission line between Connecticut Light and Power Company's Plumtree Substation in Bethel, through the towns of Redding, Weston, and Wilton, and to the Norwalk Substation in Norwalk, Connecticut.

Date: December 22, 2005

Location: 345kV Underground Route

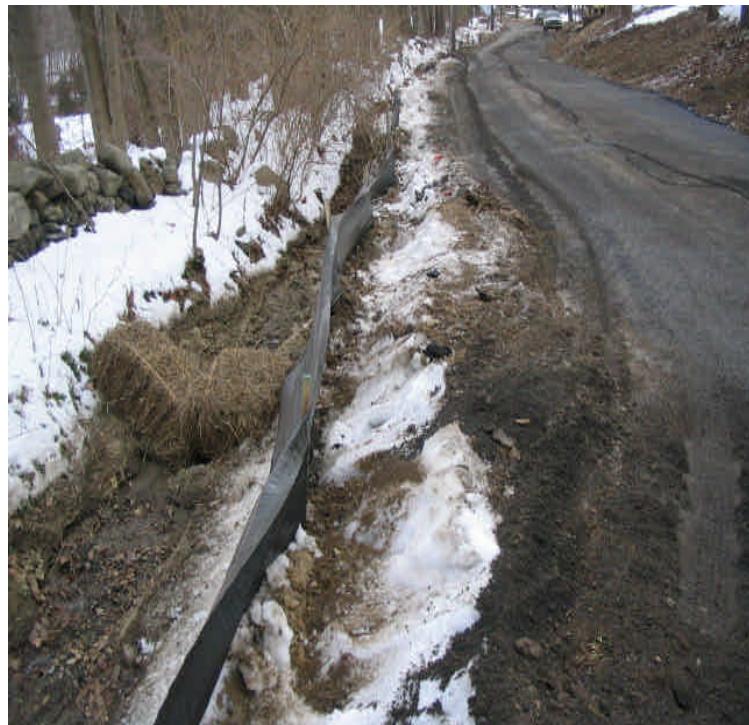
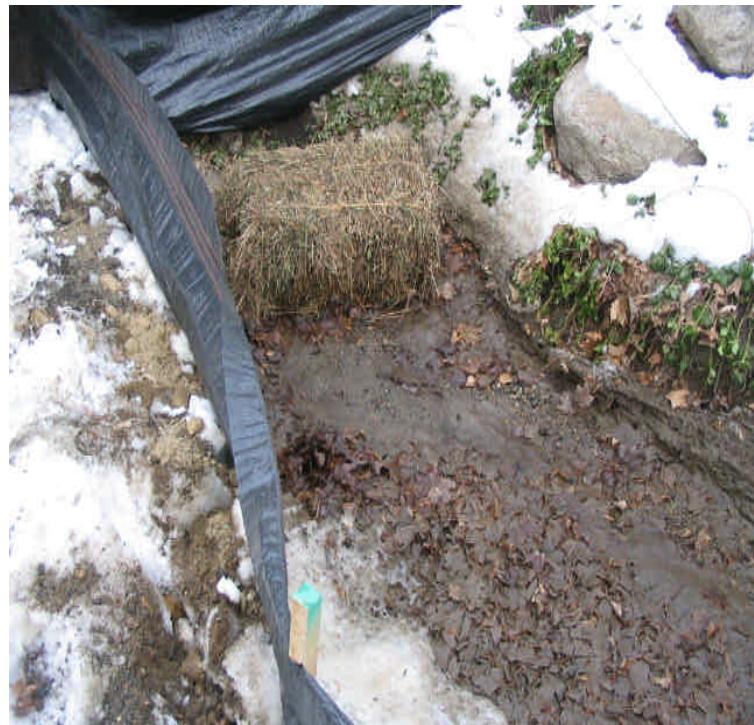
345kV (Umpawaug Rd Daywork): Silt fence and haybales have been installed along swales and wetland areas near the Diamond Hill Rd. intersection. Some sedimentation buildup was noted near the controls. It should be removed if possible. 12/22/05

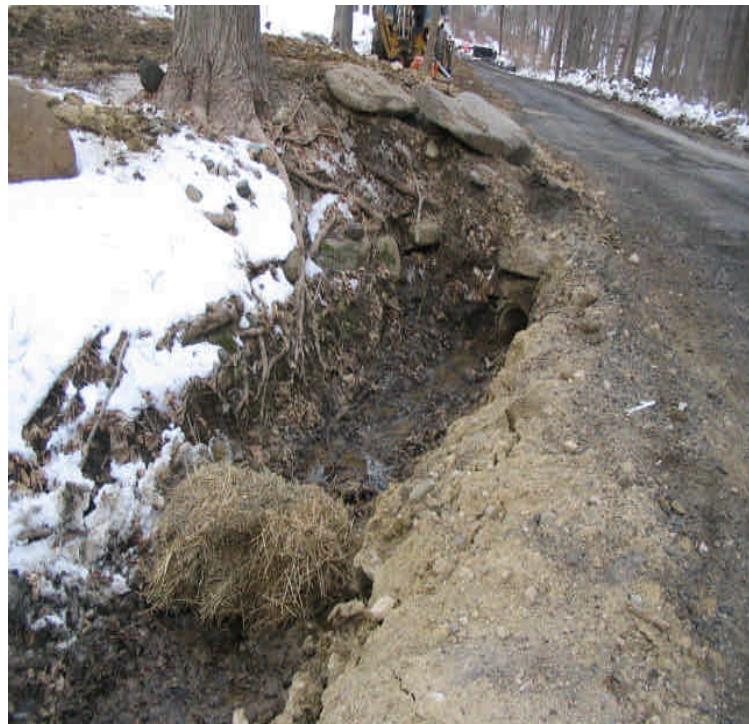
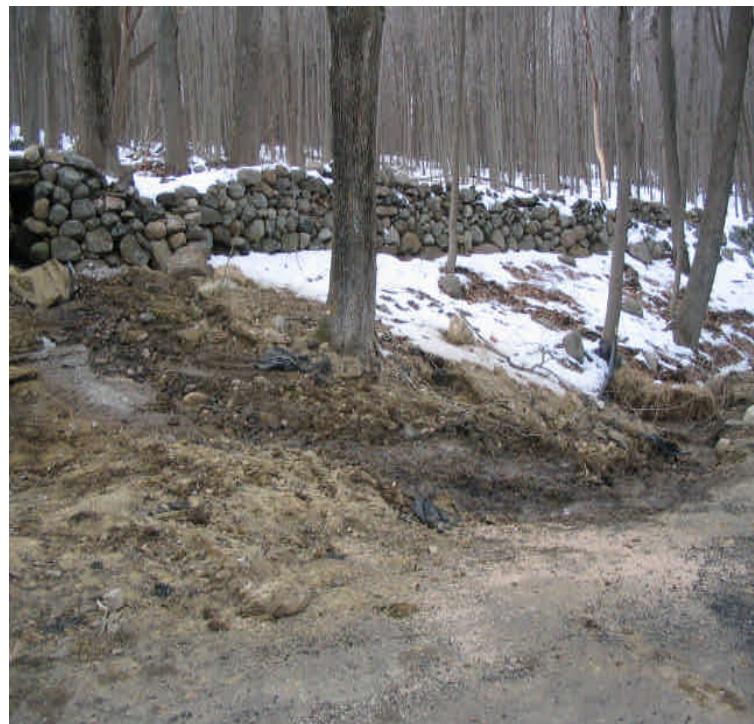
View of the wet swale near #144 Umpawaug Rd which had been placed with some haybales and controls as recommended. A significant amount of disturbed bank cuts remain following the completed work. The area should be mulched/restored when feasible. 12/22/05

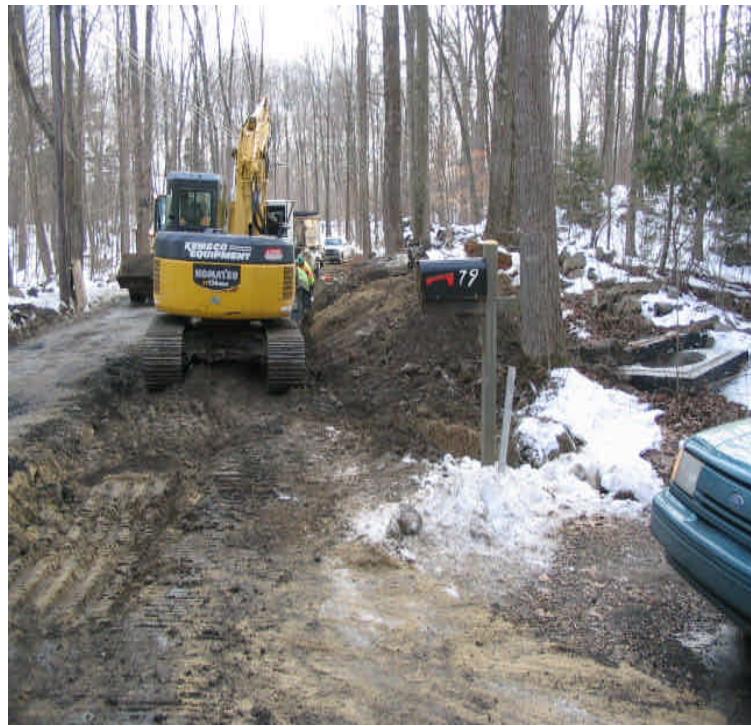
Photo on the left shows the continued active trench work in the street near #79 and resulting disturbed soil. Photo on the right shows the recently completed work at the vault near #134.

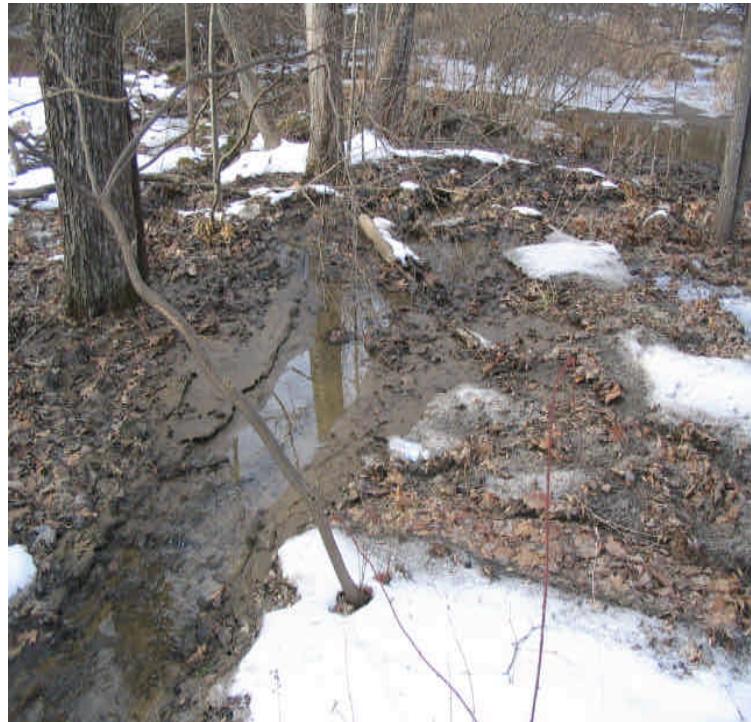
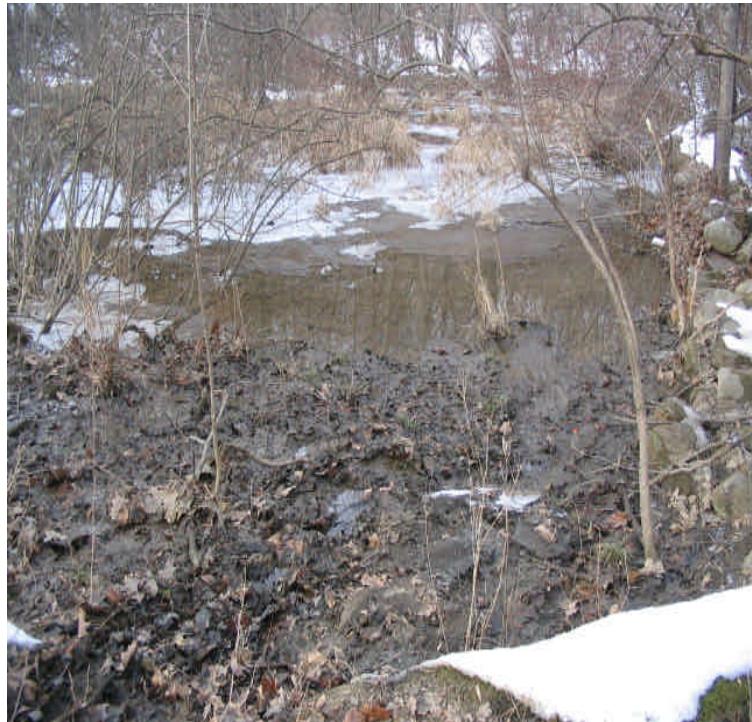
Both photos show a view of where sediment and turbid water migrated through a swale to the adjacent wetland near the work at #79 Umpawaug Rd. The inlet to this swale did have haybales installed but it wasn't enough prevent the sedimentation. 12/22/05

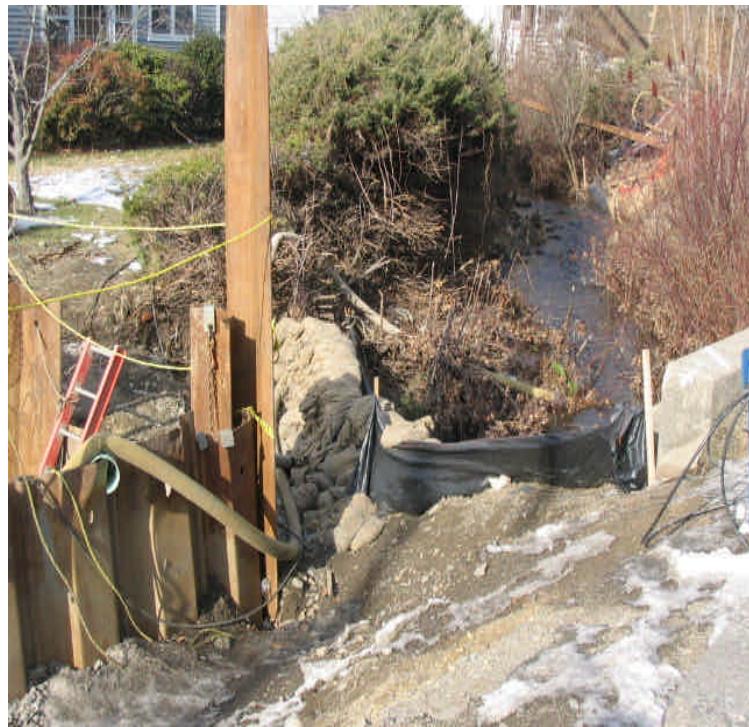
345kV (Georgetown Deli Jack and Bore): Photo on the left shows the receiving pit side where additional sandbags had been installed following the recent rain and flood event. Photo on the right shows where the silt fence at the dewatering outlet had been washed down. The stream was slightly turbid at this inspection. 12/22/05

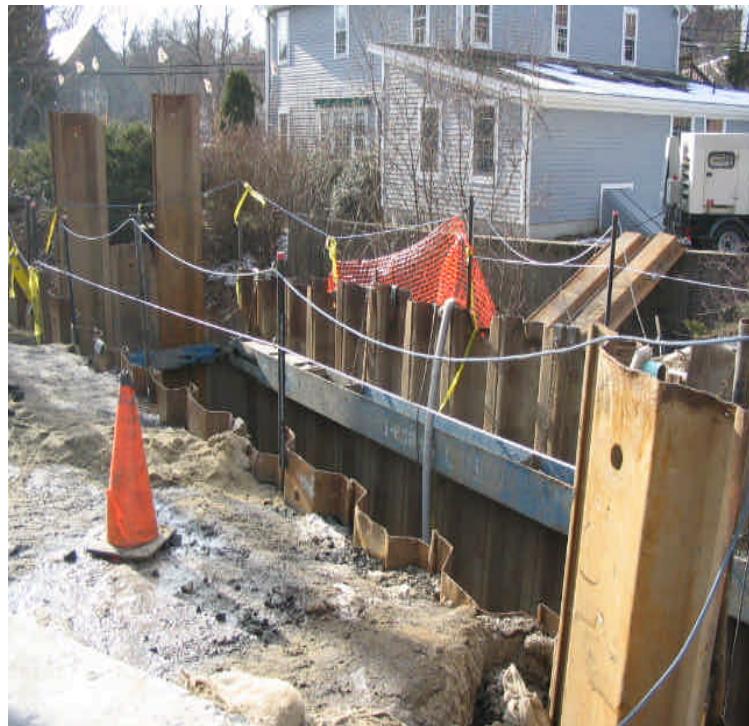
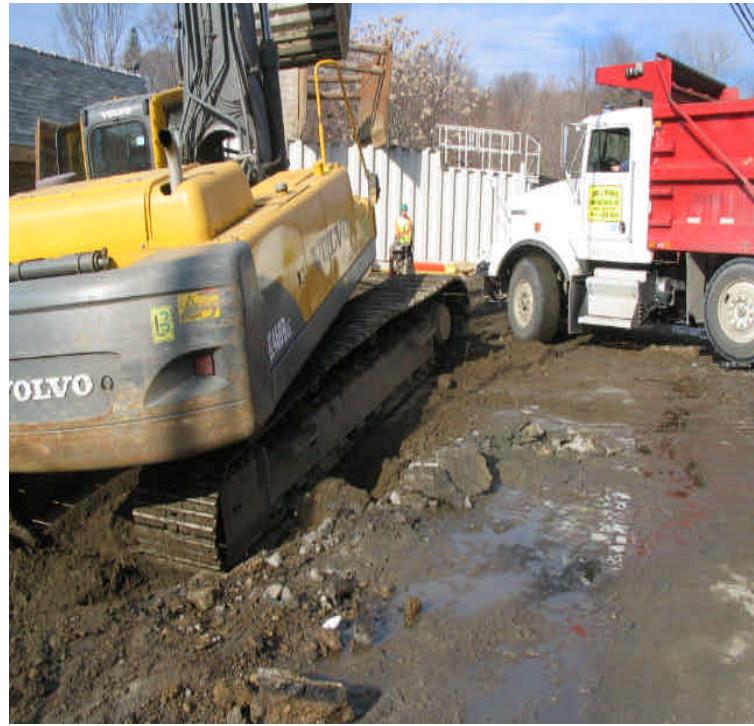
Photos show views of the bore pit which is currently being backfilled and moving towards completion. 12/22/05

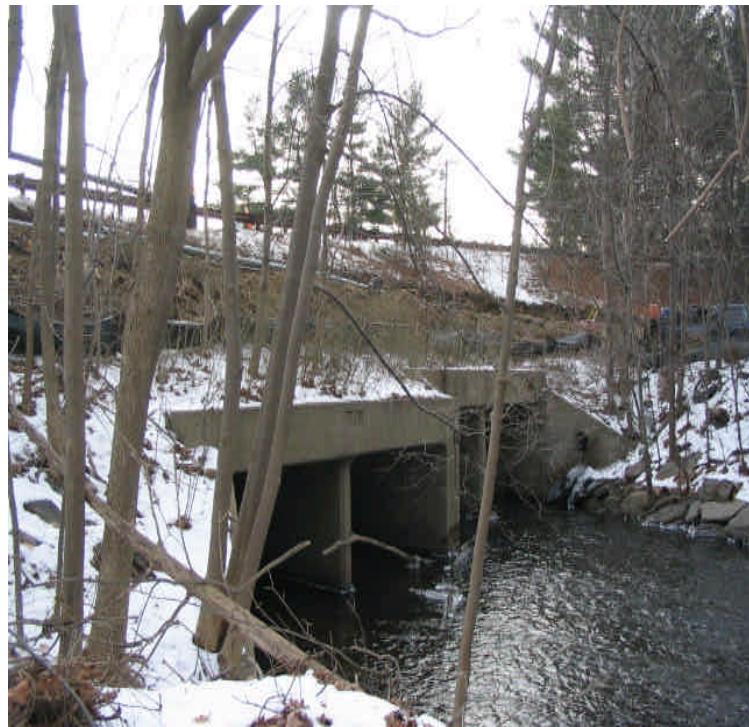
345kV (Rt 107): Photo on the left shows a view of where pipe is being installed above a bridge over the Norwalk River. Sit fence is in place at this time. Photo on the right shows a view of this work from the roadway. 12/22/05

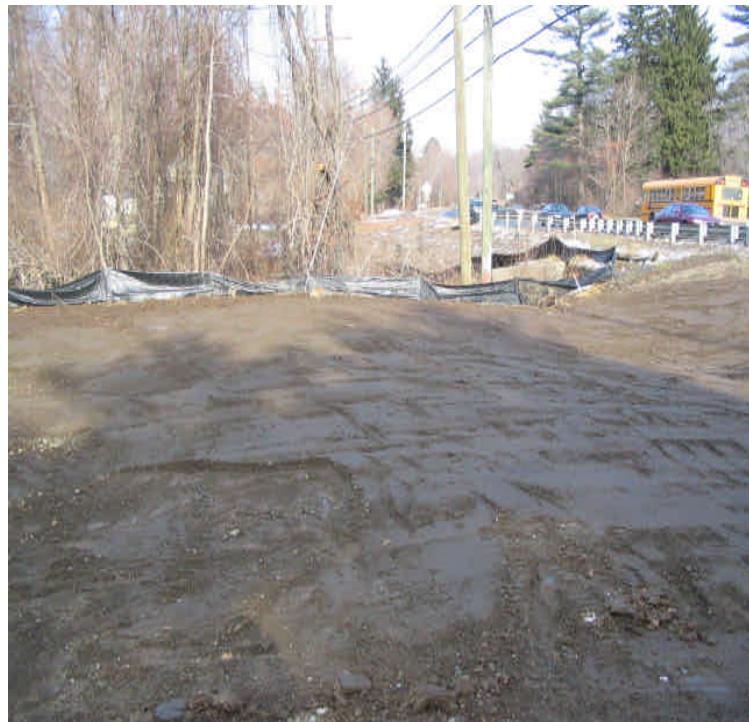
345kV (Wilton High School J&B): Photo on the left shows where the old settling basin has been filled in and the area regraded. Photo on the right shows a spot where the remaining erosion controls are lacking. This fence should be repaired as soon as possible. 12/22/05

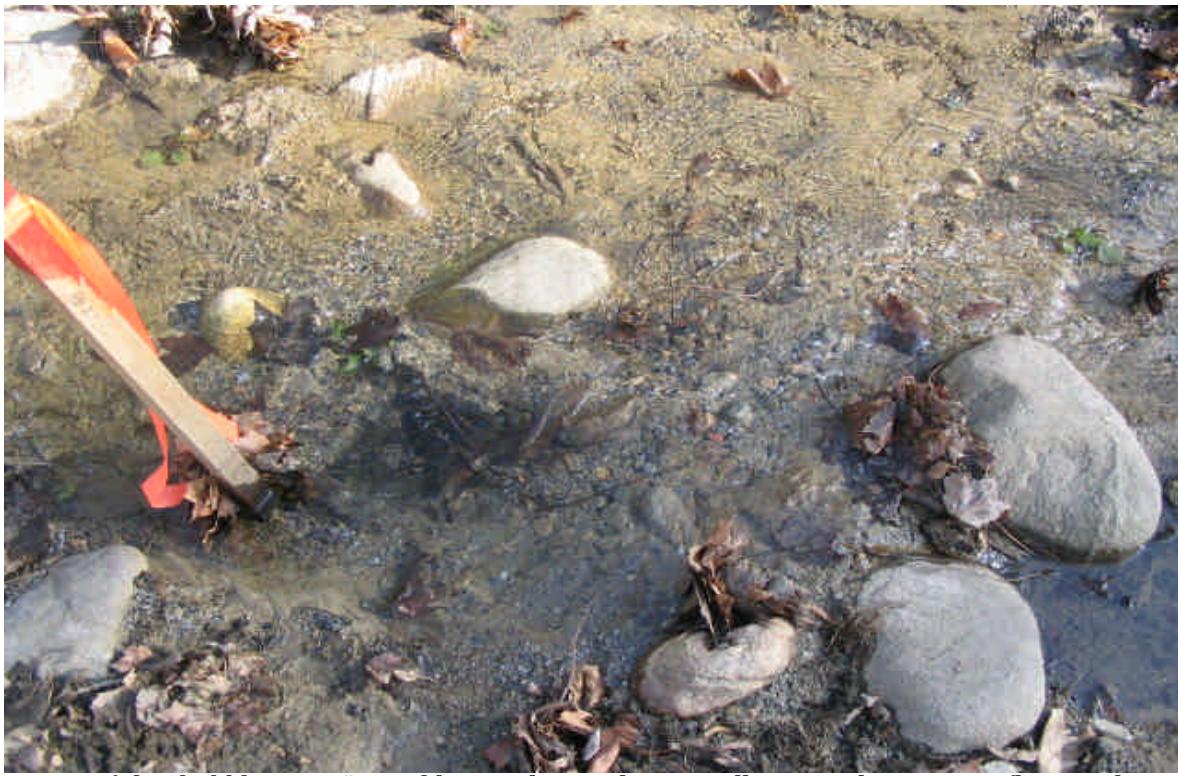
View of the “bubbling spot” noted last week near the Norwalk River. This area was flowing clear water at this time but the deposited sediment from last week has not cleaned up as discussed.

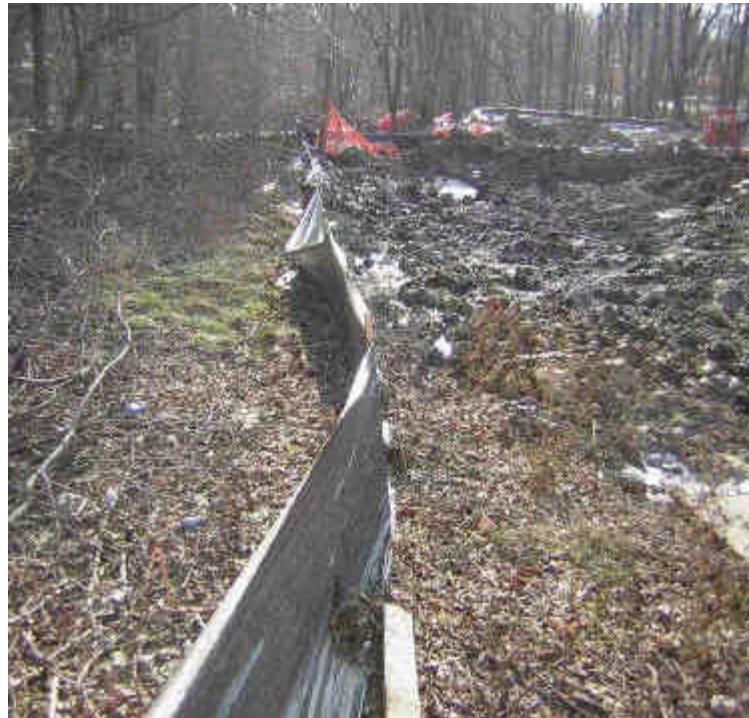
Photo on the left shows the perimeter silt fence and disturbed soil surface along the east of the site. Additional stability is needed here to prevent further disturbance during equipment access. The photo on the right shows a small spill (likely of fuel) near the tank on site. 12/22/05
