**Docket No. 217 – Development and Management Plan Inspection**

**Date:** September 7, 2006

**Location:** 345kV XLPE Component

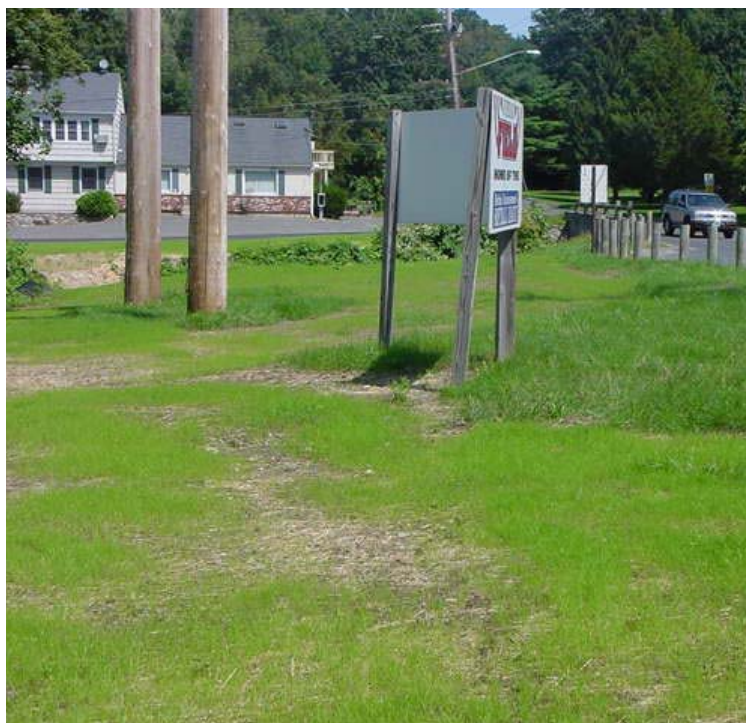
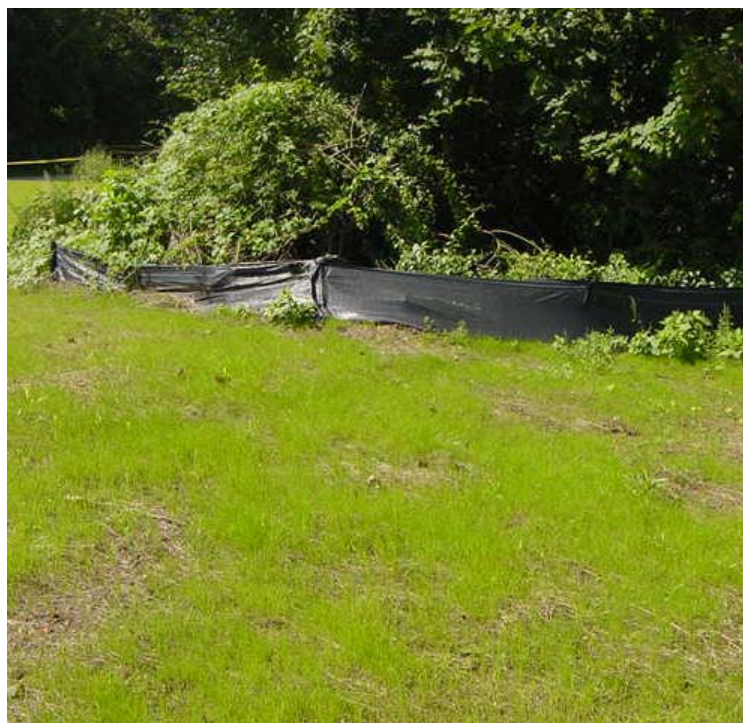
345kV XLPE: Both photos show the restored area in the ball park and near the streambank. Grass growth is returning and silt fence is in good shape. Continue to monitor. 9/7/06

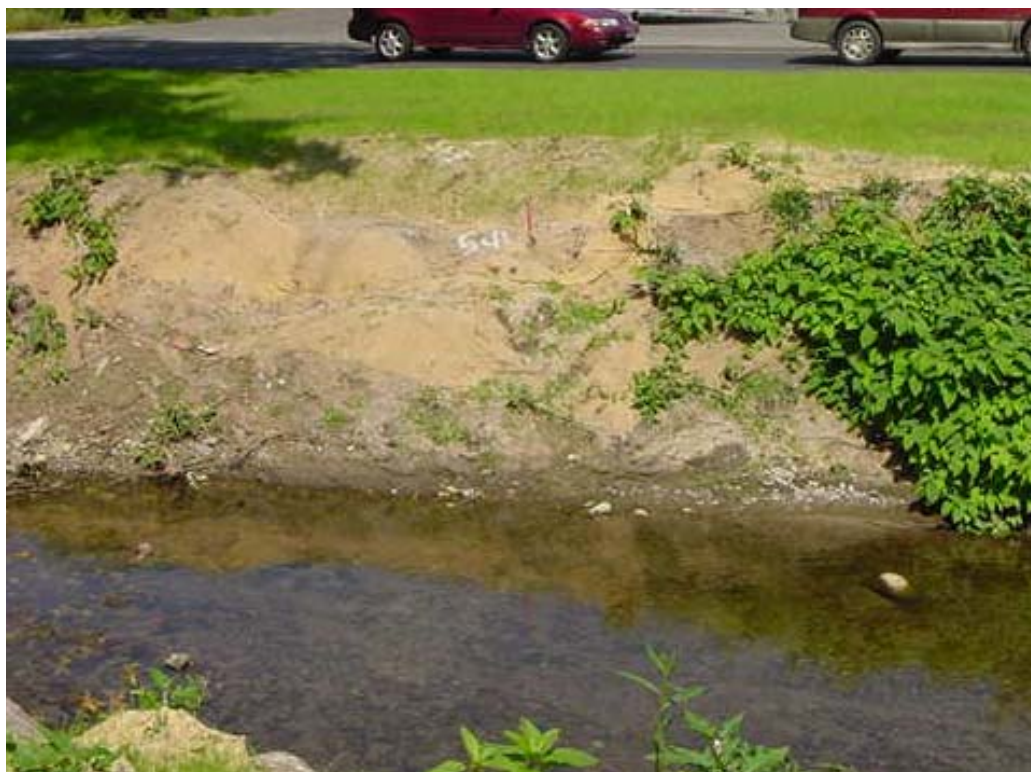
Photo shows vegetative growth returning in portions along the streambanks with the erosion control blankets in place. Some areas remain sparse and could use additional cover. 9/7/06

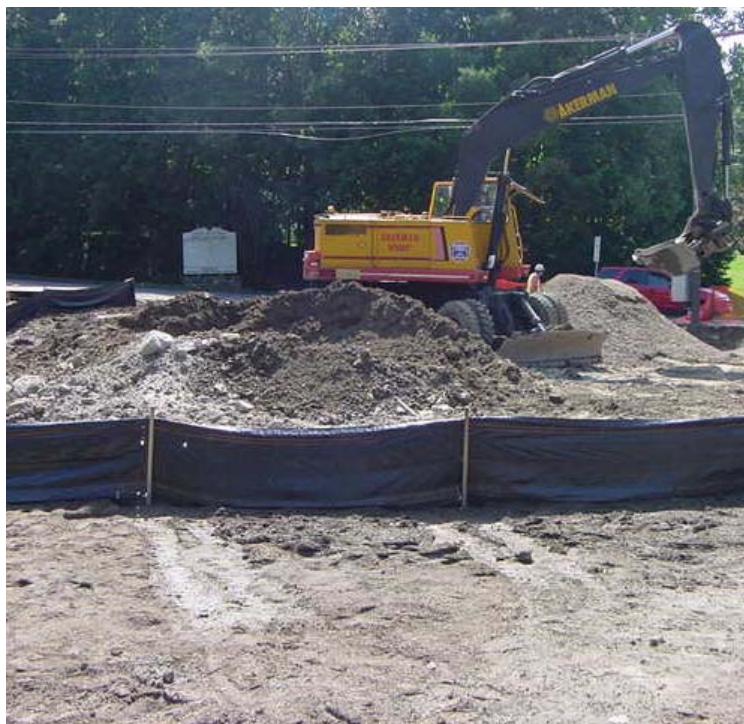
Photo on the left shows the grading and backfill work at the jacking pit at the jack & bore. Good silt fence is in place. Photo on the right shows the down-gradient line of silt fence in good shape.  
9/7/06

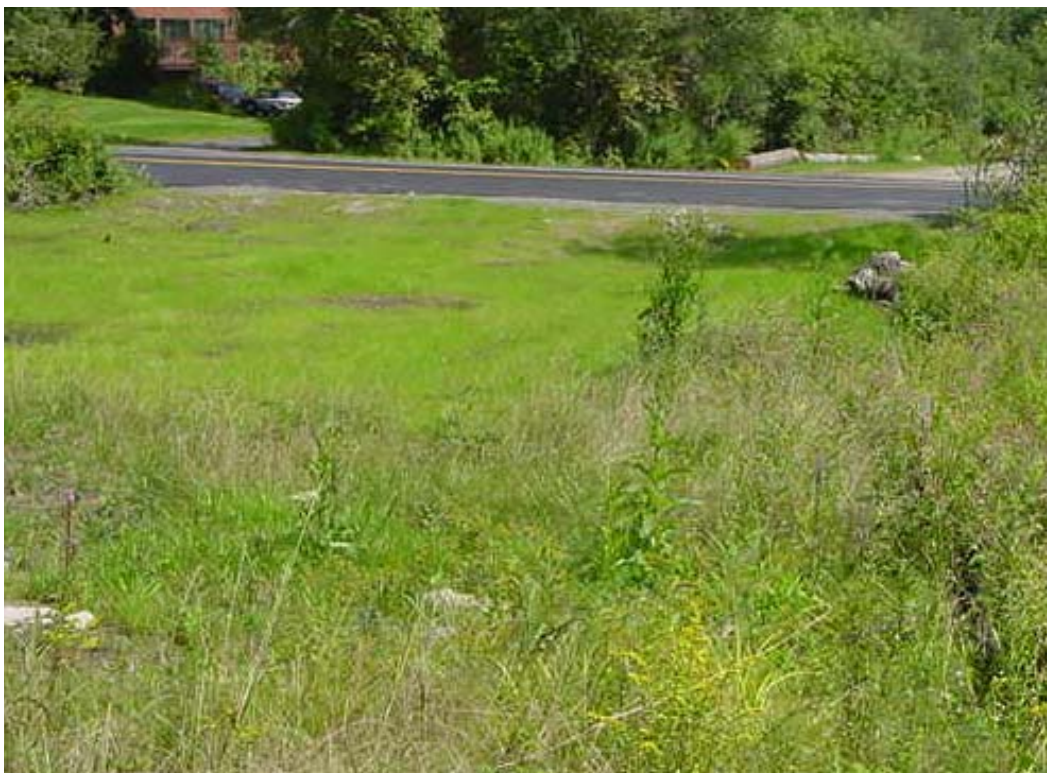
Photo shows the restored wetland area off Rt 58 which continues to revegetate. Pooling water was also present after the rain. 9/7/06
