**Docket No. 272 – Development and Management Plan Inspection**

**Beseck Switching Station**

**Date:** April 27, 2006

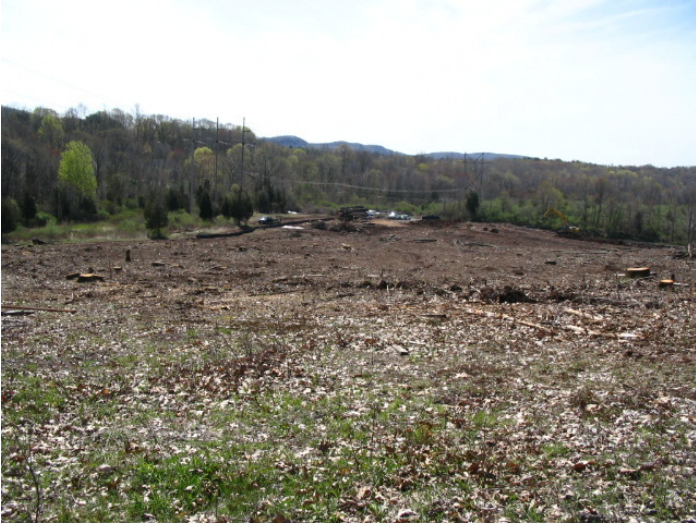
Entire site viewed from northwest corner toward southeast

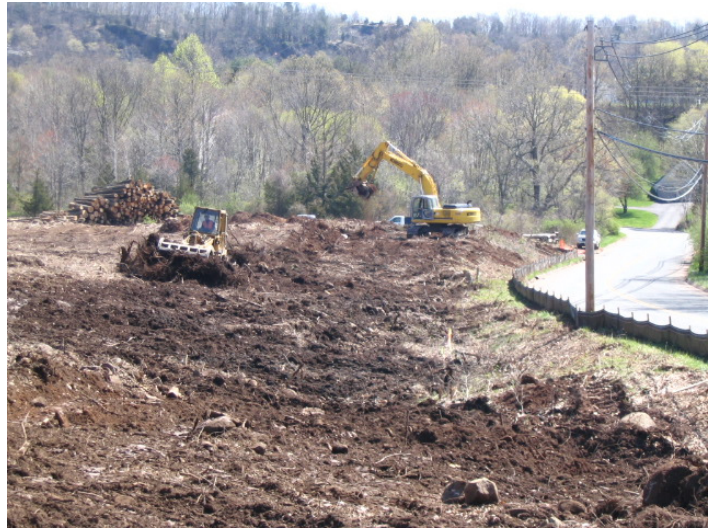
Silt fence being installed on east side of site

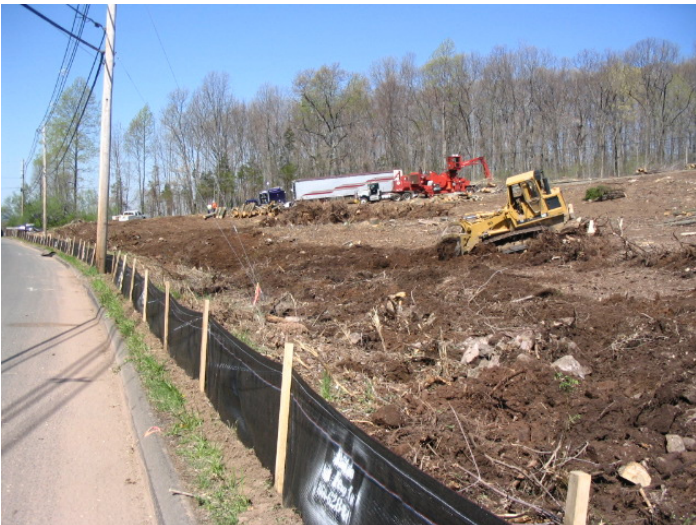
Clearing and grubbing, wood chipping visible in rear, viewed looking toward west-northwest along Carpenter Lane

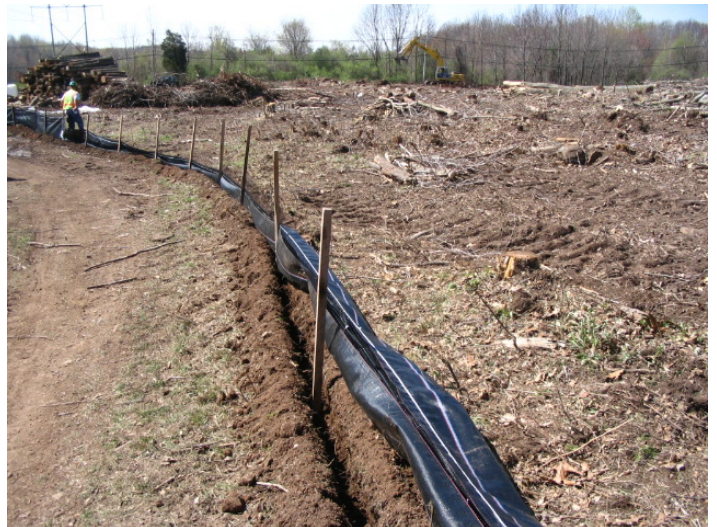
Clearing, grubbing south side of site, viewed toward east. Silt fence is being installed at this time.

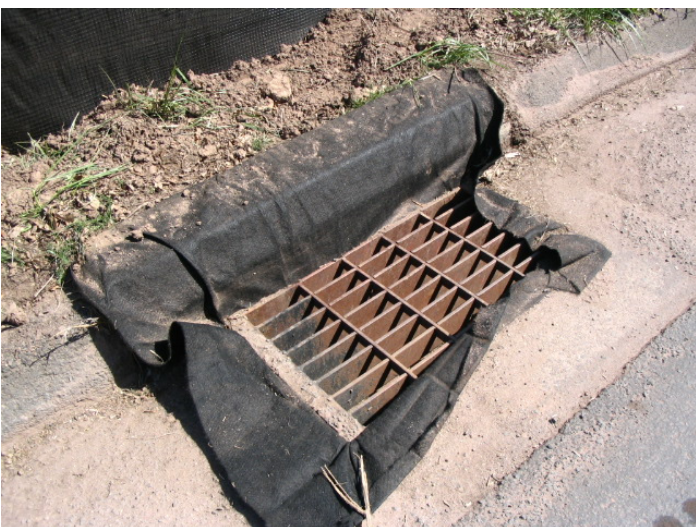
Catch basin on Carpenter Lane protected with silt sack

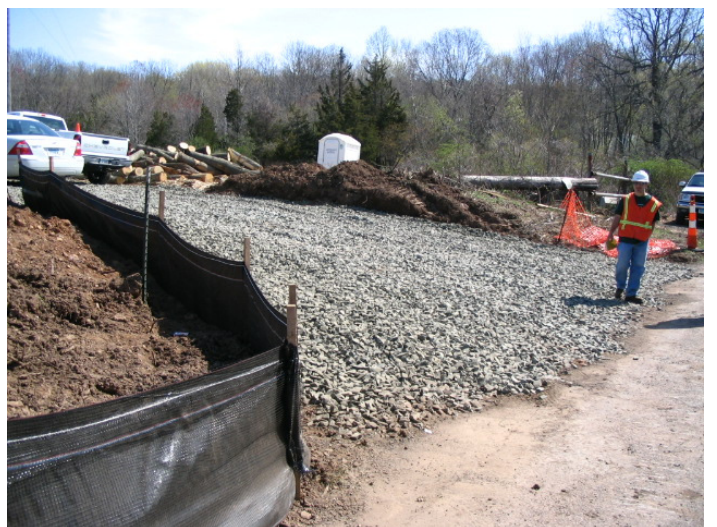
Crushed stone construction entrance on Carpenter Lane
