**Docket No. 217 – Development and Management Plan Inspection**

**Date:** October 5, 2005

**Location:** Overhead Line (Composite 345kV and 115kV Gallows Hill to Archers Lane)

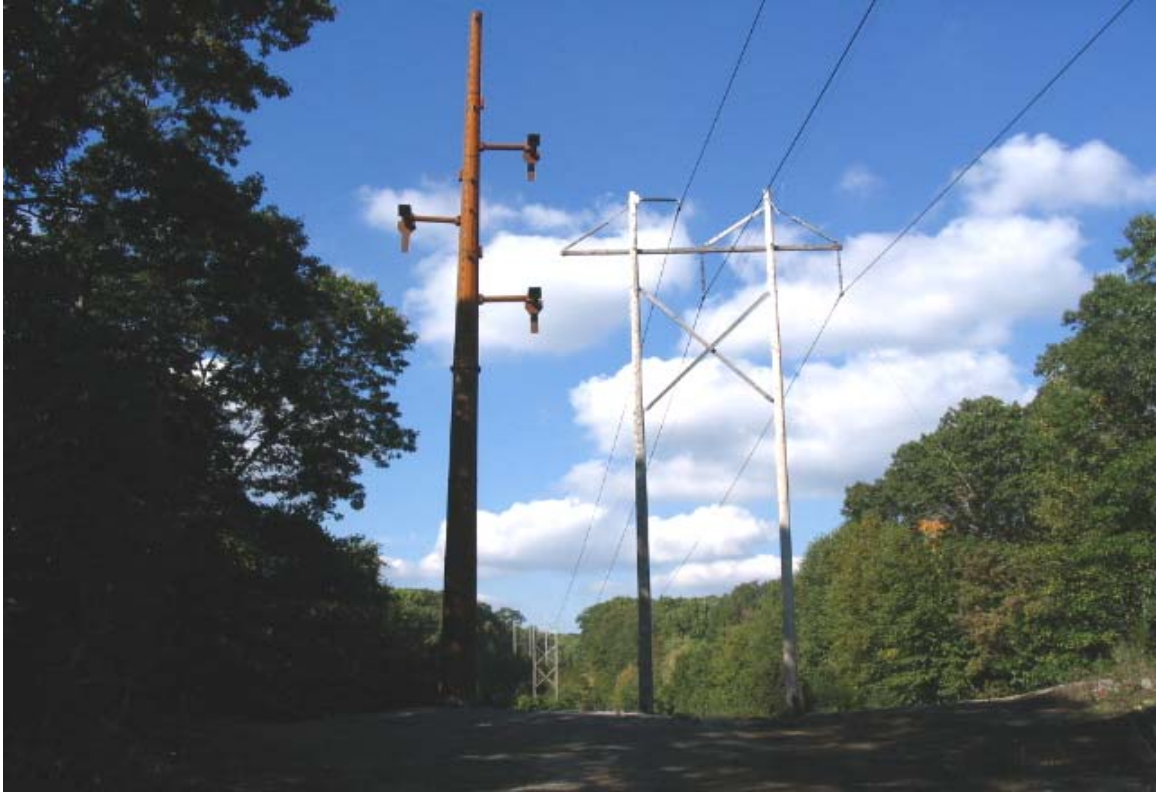
Overhead ROW: View of the riser structure recently installed just off Gallows Hill Rd. (10/5/05)

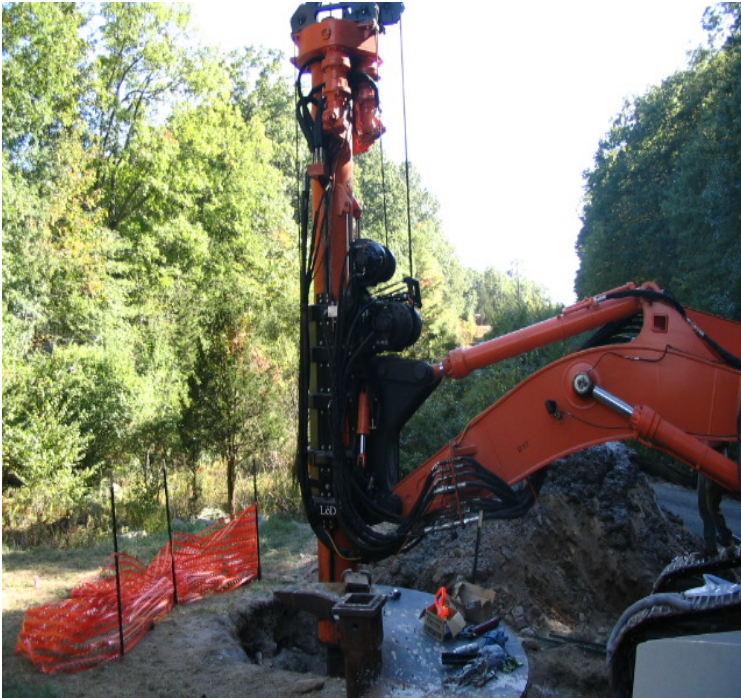
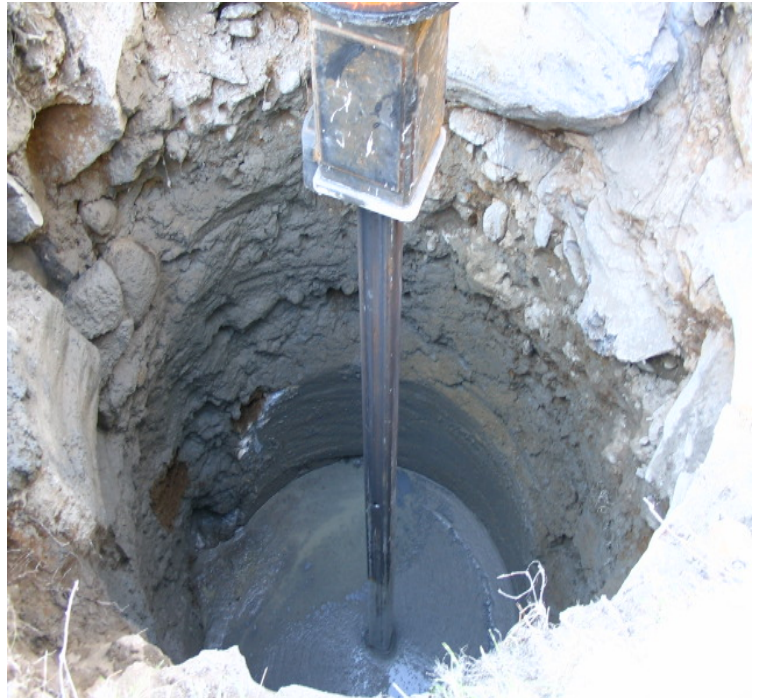
Photo on the left shows the active drilling at the next structure foundation. Photo on the right shows the

hole for the caisson/foundation with the thick muddy water to be removed. The stone dust created by the drilling accounts for the color. (10/5/05)

<p>Vegetative clearing limits (including trees to save or danger trees noted)</p>	<p>-The ROW has been mowed in this section in order to allow for truck access and foundation construction. Vegetation that did not need to be removed was left in place on either side of the access path 9/15-10/5/05</p>	<p>-None at this time. In general limit clearing to those areas necessary. 10/5/05</p>
<p>Dewatering</p>	<p>- Typical dewatering will not be possible in the foundation hole due to the water/mud</p>	<p>-A compound may need to be added to evaporate the water or a berm may need to be set</p>

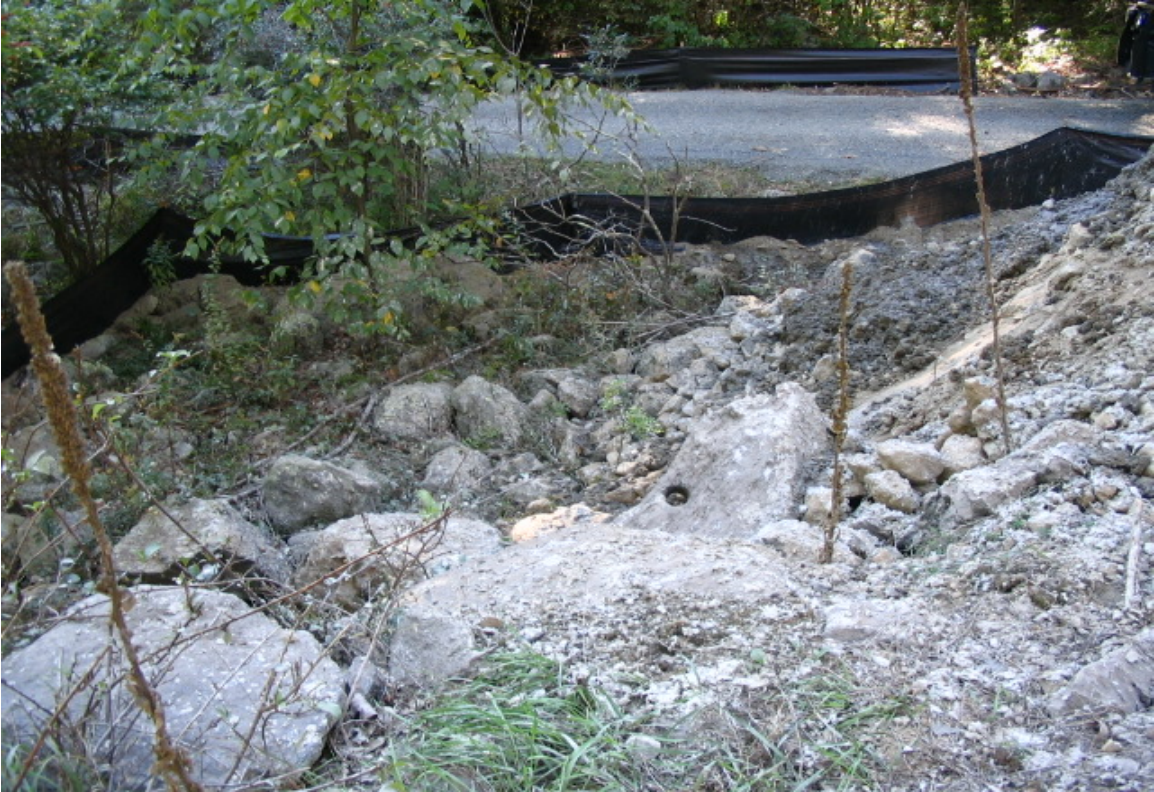
The pile of excavate from the structure foundation hole is immediately adjacent to the silt fence. Continue to maintain this fence well until this stockpile can be removed. Staked haybales would be a good addition here. (10/5/05)

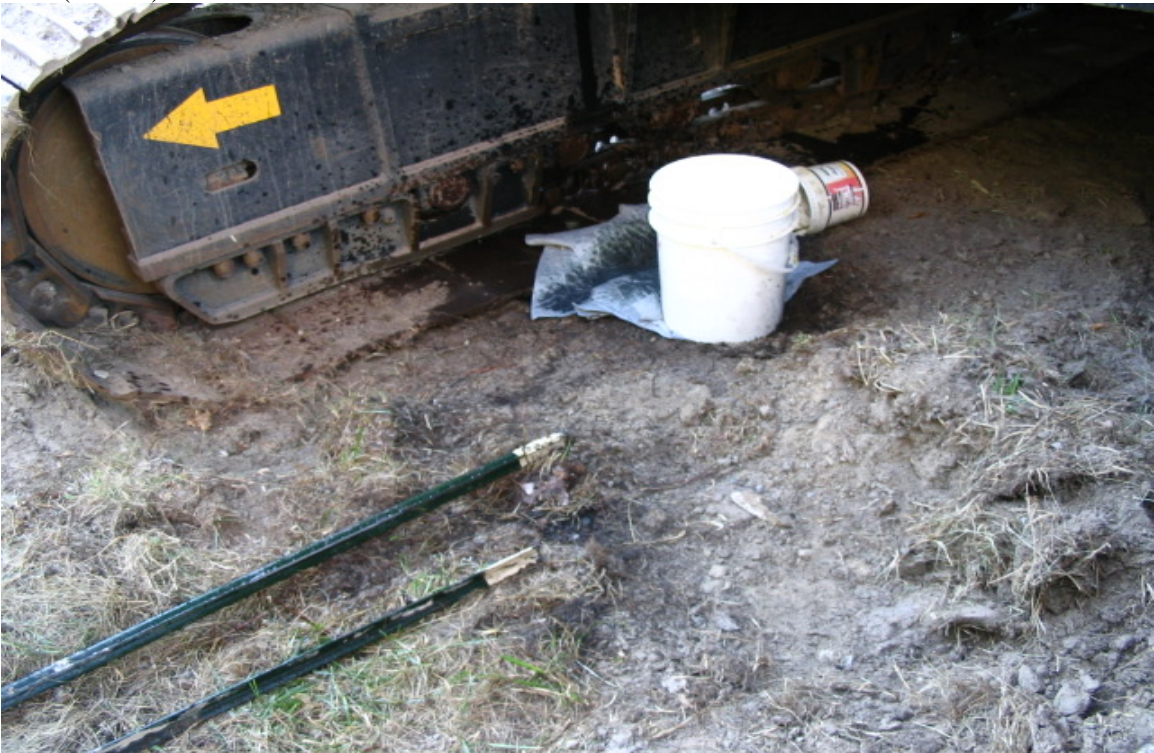
View of the hydraulic leak being contained with the bucket and pads for the time being. Mechanics were on site and the affected soil will be shoveled up and removed. (10/5/05)

Areas of Inspection	Observation	Recommended Action
	mixture. 10/5/05	up to contain it. 10/5/05
Blasting	-No blasting has been necessary at this time except in the adjacent Archers Lane transition station. 10/5/05	-None at this time. 10/5/05
Spills and Material Storage	<p>- A hydraulic fitting broke on a machine immediately before the inspection. Crews had already noticed it and placed absorbent pads and buckets by the time the inspector arrived. A mechanic had also been called for repairs. 10/5/05</p> <p>- The crew reacted quickly to the situation and were going to be shoveling up affected soil and disposing of it properly. 10/5/05</p> <p>- The spill was reported to internal NU departments and dealt with appropriately. 10/5/05</p>	<p>- Continue to keep all vehicles maintained well (i.e. no apparent fluid leaks) if they will be used or stored on site</p> <p>- Keep adequately size fuel kits for worst case scenarios.</p> <p>- Report spills immediately, even if they are being controlled.</p> <p>- Take care not to get carried away and to be vigilant when refueling. Avoid refueling in the areas near the wetlands. Use proper storage for all materials.</p>
