Docket No. 217 – Development and Management Plan Inspection

Northeast Utilities Service Company Certificate of Environmental Compatibility and Public Need for the construction of a 345-kV electric transmission line and reconstruction of an existing 115-kV electric transmission line between Connecticut Light and Power Company’s Plumtree Substation in Bethel, through the towns of Redding, Weston, and Wilton, and to the Norwalk Substation in Norwalk, Connecticut.

Date: October 19, 2005

Location: Overhead Line (Composite 345kV and 115kV Gallows Hill to Archers Lane)

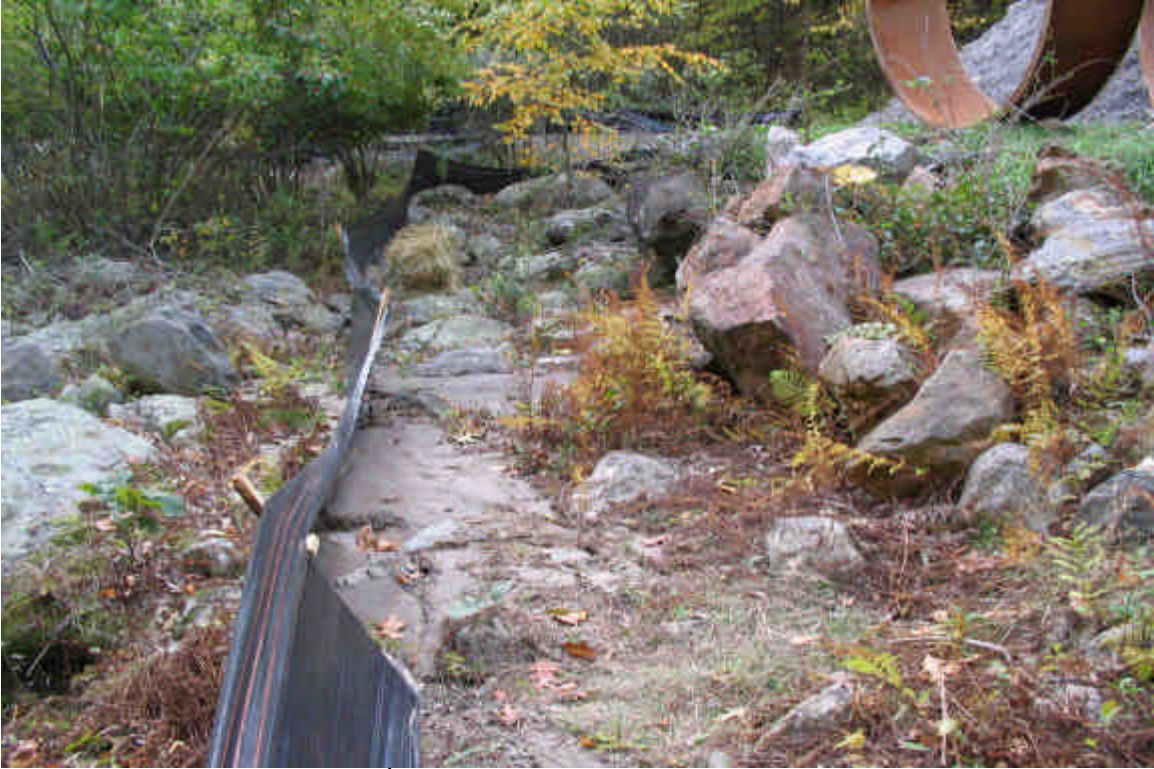
Overhead ROW: View of the 2nd structure in from Gallows Hill. Some sediment ran off from the stockpile and accumulated at the silt fence. Some also filtered through the rock to the wetland. Haybales will be added here to help prevent this and sediment will be hand removed. (10/19/05)

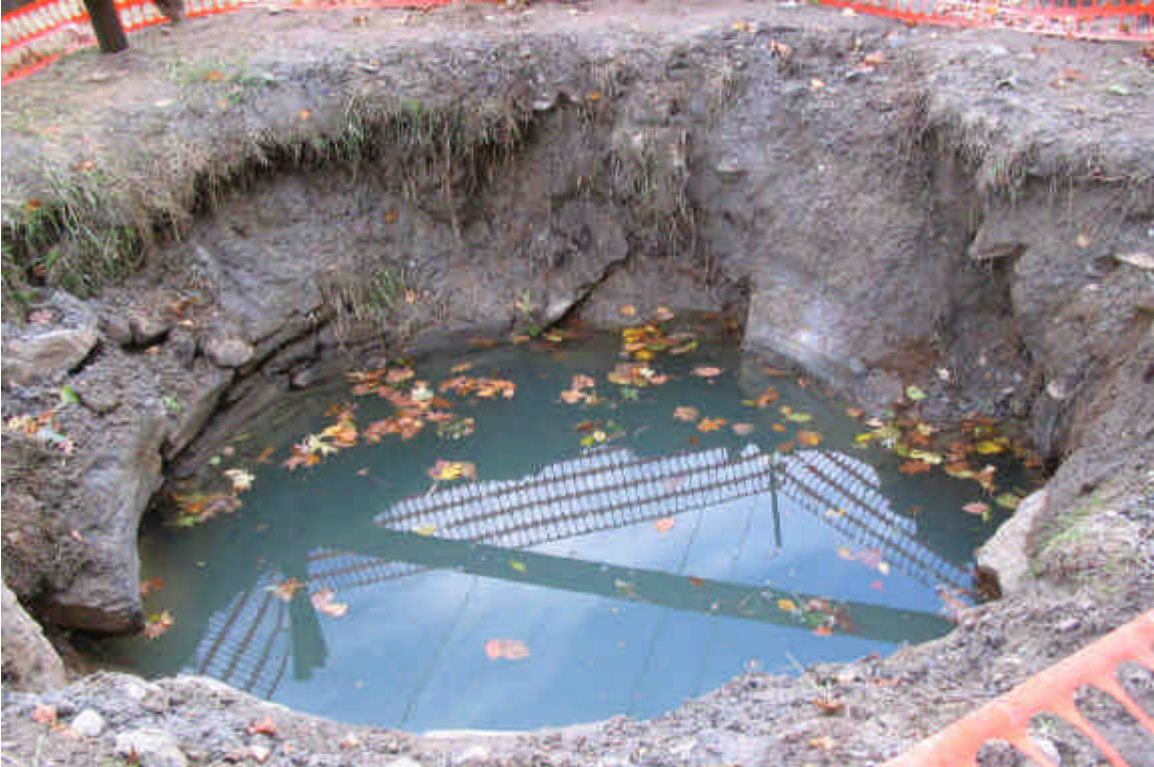
| Areas of Inspection | Observation | Recommended Action |
|---|--|---|
| <p>Dewatering</p> | <p>- Water has filled the hole at the second structure in from Gallows Hill. It was being allowed to settle out to remove sediment before it is dewatered. Water looked clear at the time. 10/19/05</p> <p>- Dewatering has also occurred at some of the structures adjacent to the upland. Water was released in well vegetated areas and did not reach any wetlands. 10/19/05</p> | <p>- A “corral” will need to be installed in the upland to filter the dewatering discharge. Use a filter bag if available 10/19/05</p> <p>- None at this time. Release water to the ground only if it will not reach any resource areas. 10/19/05</p> |

The excavation was filled with water following the rain but sediment had settled out. Dewatering will have to occur to a corral since the wetlands are located adjacent. (10/19/05)

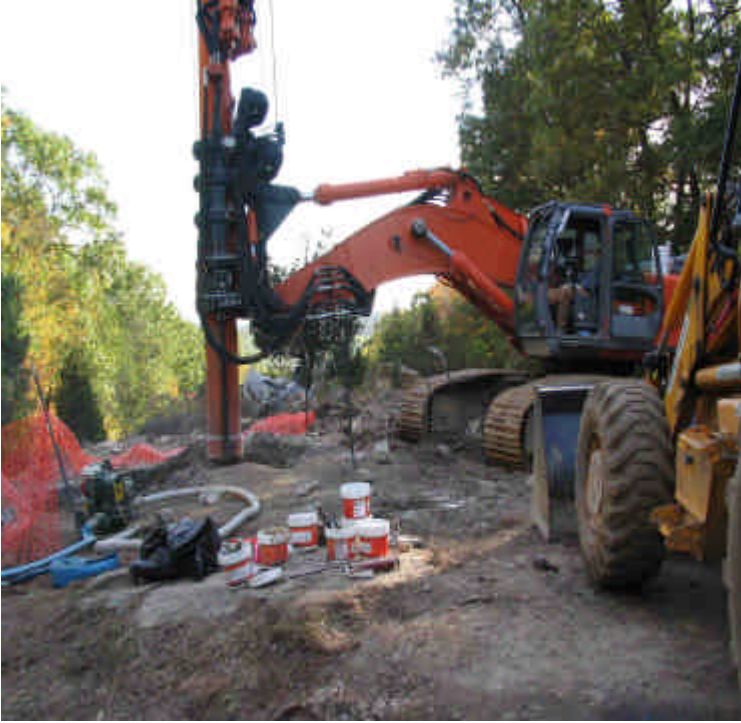
Photo on the left shows a view of the excavation for the next structure foundation moving south along the ROW. The area here was all upland and controls were well in place. Photo on the right shows work at a caisson closer to Archers Lane along the ROW. (10/19/05)

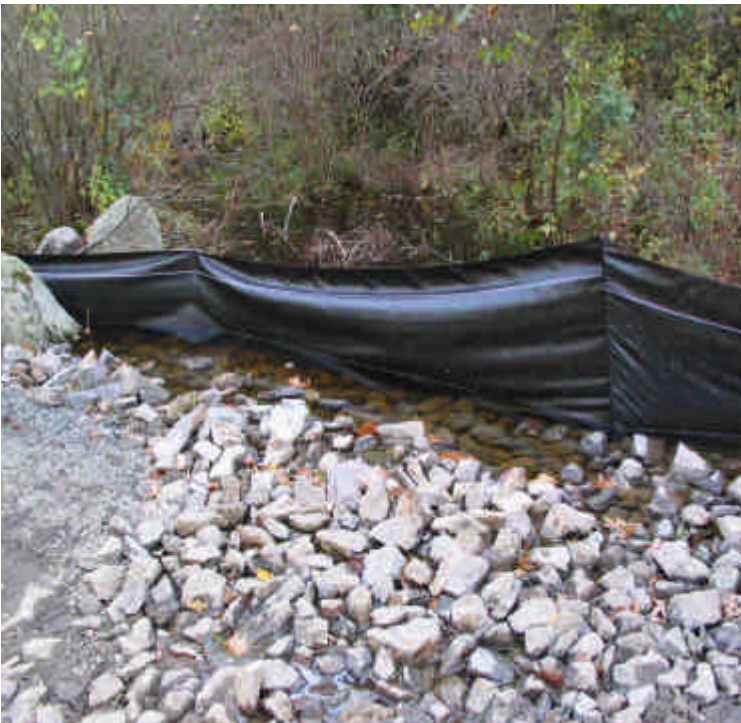
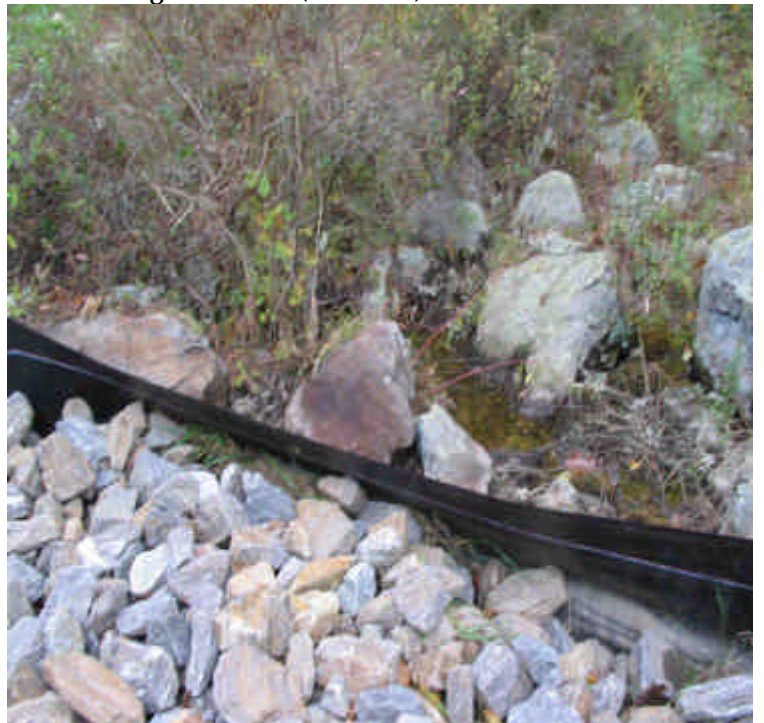
| Areas of Inspection | Observation | Recommended Action |
|--|---|--|
| Inland Wetland and Watercourse encroachment and mitigation | <p>-The D&M plan approved stone on geotextile fabric at the first wetland crossing in from Gallows Hill has worked very well to filter overflow. Water is traveling through the stone and very clear on both sides of the wetland. 10/19/05</p> <p>-Some sediment filtered through the silt fence from the stockpile to the adjacent wetland at the 2nd structure 10/19/05</p> | <p>- None at this time, the crossings have been constructed. As the access is considered temporary, the stone will be removed when final work ends so the wetlands can be restored. 10/19/05</p> <p>- The small amount of sediment will be scraped up as feasible and removed by hand. Attempts will be made to secure the controls here. 10/19/05</p> |

With the rain, water was filtering through the stone at the first low/wetland crossing on the ROW. Water was very clear and the wetlands seem to be well protected with this method. (10/19/05)
