Docket No. 217 – Development and Management Plan Inspection

Northeast Utilities Service Company Certificate of Environmental Compatibility and Public Need for the construction of a 345-kV electric transmission line and reconstruction of an existing 115-kV electric transmission line between Connecticut Light and Power Company's Plumtree Substation in Bethel, through the towns of Redding, Weston, and Wilton, and to the Norwalk Substation in Norwalk, Connecticut.

Date: February 22 and 23, 2006

Location: Overhead Line (Composite 345kV and 115kV Gallows Hill to Archers Lane) and (345kV H-Frame Hoyts Hill to Gallows Hill)

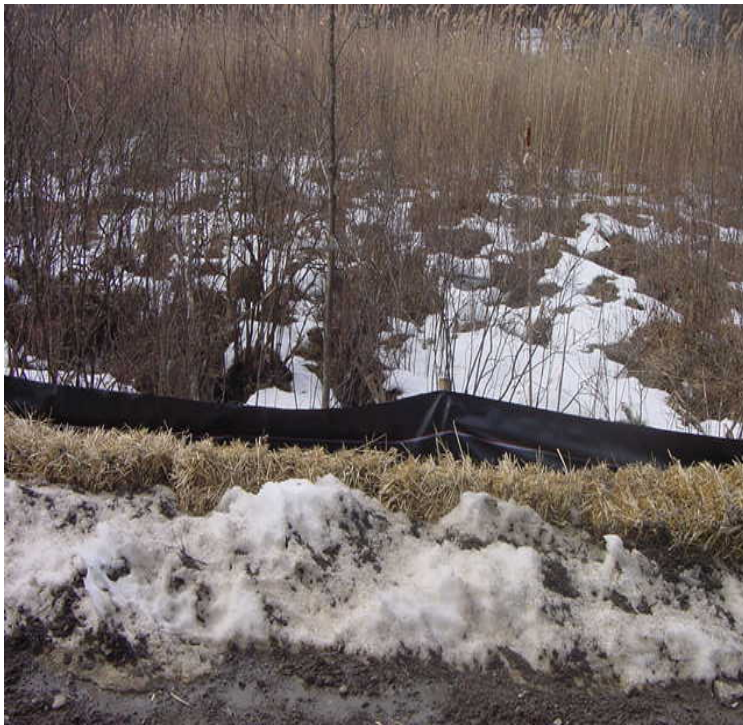
(Composite Section): Photo on the left shows a view of the 2nd crossing along the road from Archers Lane. Water had receded slightly from last week but sediment from snow plowing still needs to be removed. Photo on the right shows a spot where silt fence was damaged at the 3rd crossing. 2/22/06

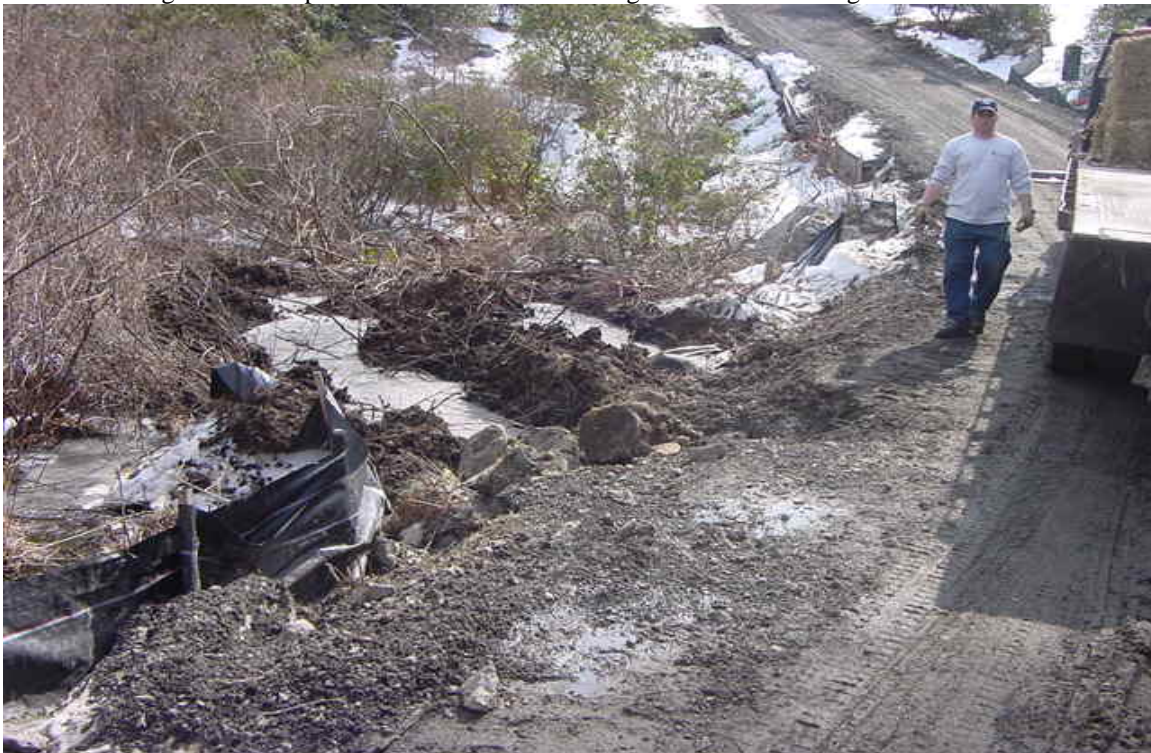
- Snow removal once again caused issues at the 2 nd and 3 rd wetland crossing along this access road. A skidder slipped off the road into the 3 rd wetland area creating some ruts in the wetland and taking out the silt fence. 2/22/06.	- Sediment was piled up and over the controls and needs to be removed from the wetlands. The damage should be repaired. See erosion control section for more details 2/22/06
345kV H-Frame	- Work along the access roads continues in the vicinity of Hoyts Hill. Significant clearing continues in this Chestnut Ridge Rd. section	- Continue to maintain as needed. 2/2-2/22/06 -Some brush could be removed from wetlands between poles #6 and 7 and some areas could use silt fence

Photo on the left shows the 3rd wetland crossing from Archers Lane. A skidder slid off the road and into the wetlands during snow plowing last week. The damage in the wetland should be repaired and the erosion controls fixed. 2/22/06

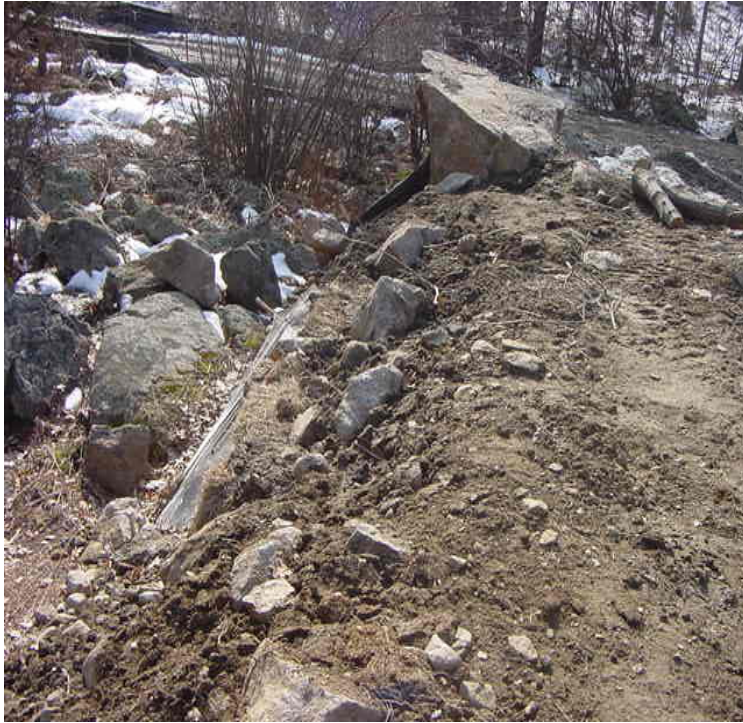
Photo on the left shows the erosion controls near the wetlands at the second structure off Gallows Hill. Sediment has been pushed over them and needs to be pulled back. Photo on the right shows the wetland crossing at the same location where silt fence is down. 2/22/06

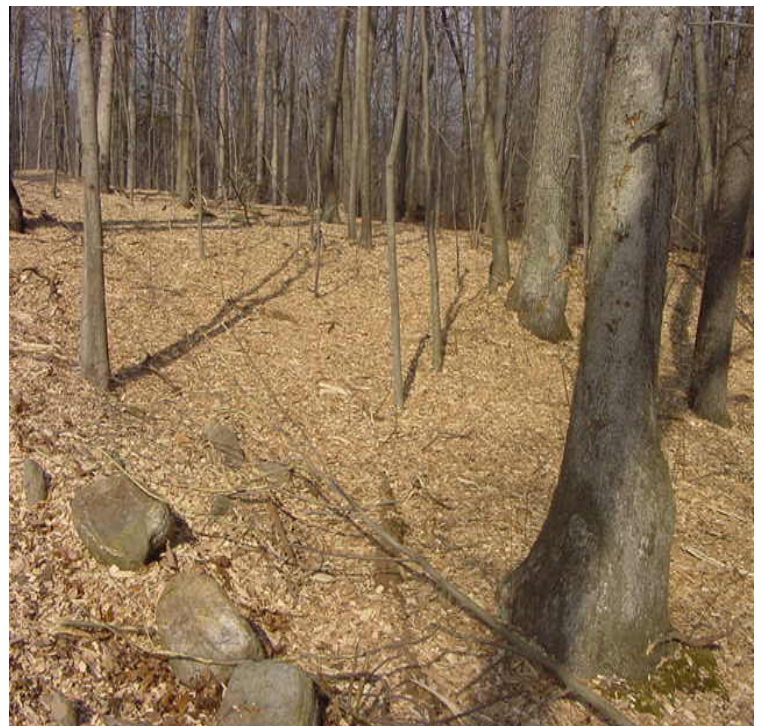
Photo on the left shows an overview of the ROW in this section where additional clearing has occurred. Photo on the right shows where wood chips were blown into the woods beyond the cleared ROW. This does not appear to be a good practice for land outside the ROW. 2/22/06

<p>345kV H-Frame</p> <p>Chestnut Ridge Section</p>	<p>- Significant clearing continues in the Chestnut Ridge section. Continue to provide good controls at the wetlands near poles #1 and 2.</p>	<p>-Make sure chips stay on the ROW or piles are removed. Consider asking contractors to remove the off ROW chips. 2/22/06</p> <p>-Continue to place controls at all four “corners” of the approach to the mats and crossings. Watch for increasingly muddy conditions</p>

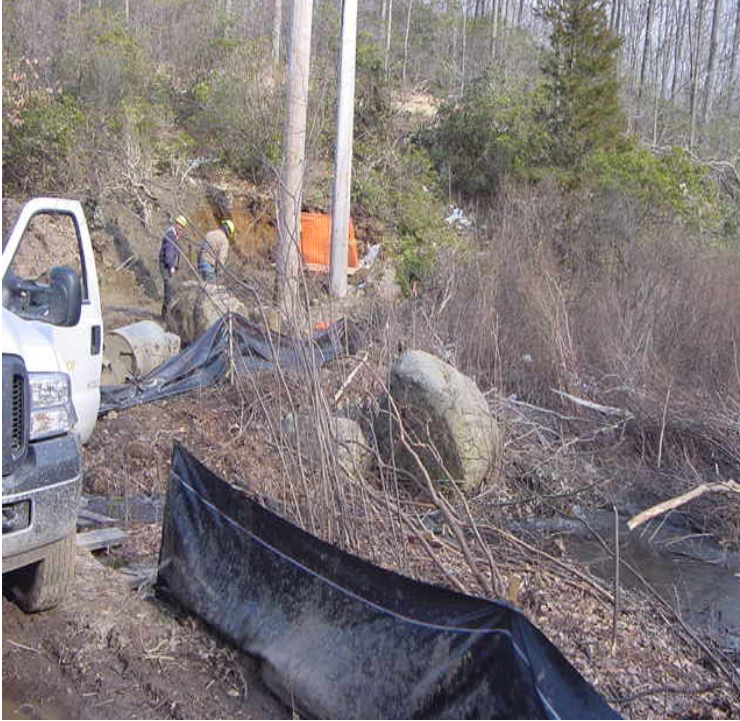
Photo on the left shows silt fence which has been installed at pole #19 now that foundation work is beginning here. Photo on the right shows the view along the access road in the Bethel Reservoir section with new wood chips in place to help stabilize. 2/22/06

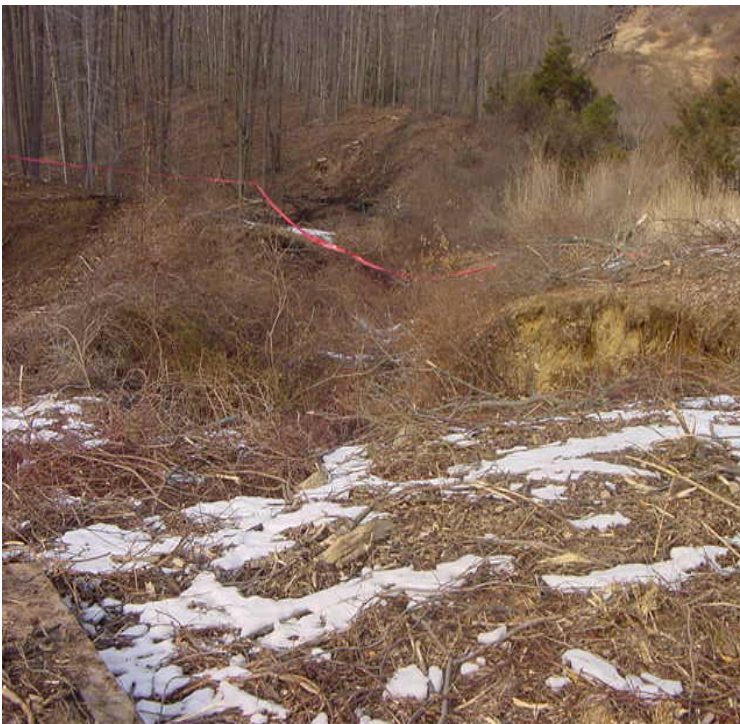
Photo on the left shows the area near the stream between poles #10 and 11 where mats have been removed. Photo on the right shows the mats stockpiled for removal. 2/22/06

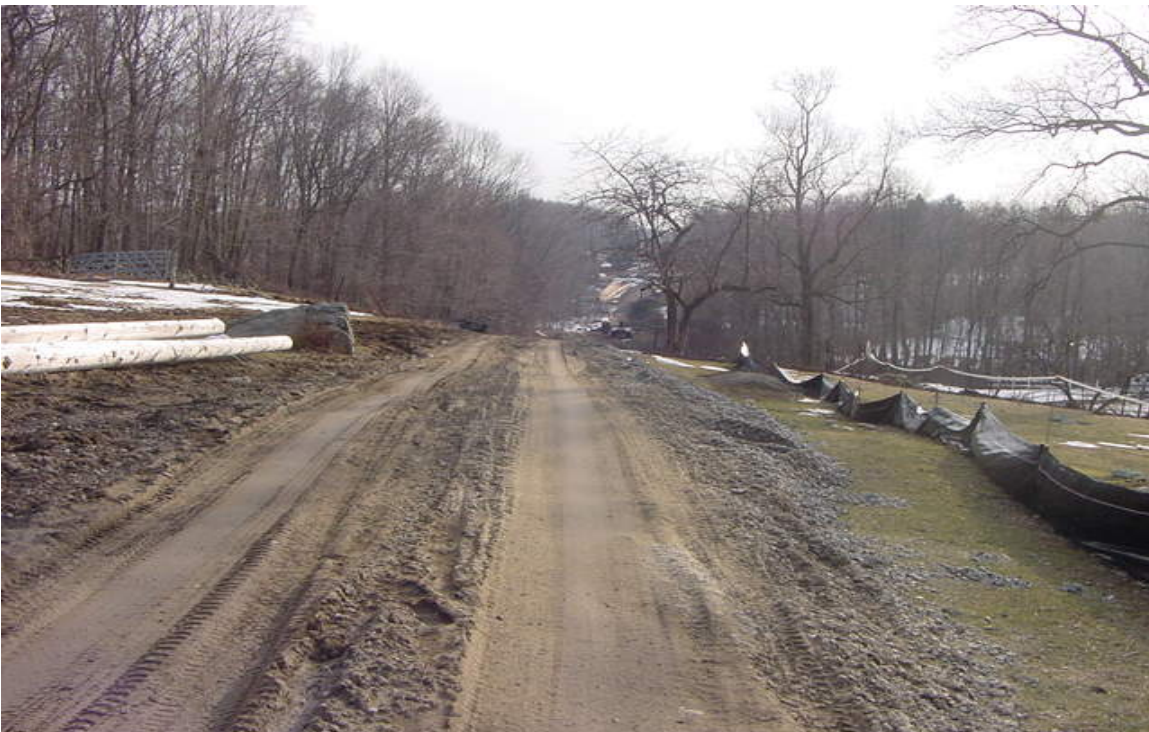
View of the access road and erosion controls near pole #7. Some repairs to the silt fence were recommended here. 2/22/06

Areas of Inspection	Observation	Recommended Action
Bethel Reservoir Section to Chestnut Ridge Rd.	<p>Some silt fence could be installed adjacent to the access road between poles #5 and 6. Conditions were muddy and wetlands are adjacent. 2/22/06</p> <p>-The silt fence at the pasture near pole #7 could use some repair. 2/22/06</p> <p>- A silt fence check dam at the wetland between poles #6 and 7 could use some repair as well. 2/22/06</p> <p>- A portion of the sediment near structure #6 has been removed. Continue to work on the remainder as the pile is in a wetland area. 2/22/06</p> <p>- The stockpile from structure #9 foundation installation was still present. The silt fence here has a gap in coverage. 1/26-2/22/06</p> <p>- Conditions at all matted crossings appeared to improve as additional wood chips had been placed. 2/22/06</p> <p>- Conditions had been muddy on the access road near proposed pole #19 beyond the original mat at the crossing. 2/16-2/22/06</p> <p>-Silt fence was also installed at this structure now that foundation work is beginning here. 2/22/06</p> <p>- Sediment had run-off the access road between poles #19 and 21 into some wetland pockets. 2/16-2/22/06</p>	<p>on the mats and install silt fence along the road as needed. 2/22/06</p> <p>- Repair as necessary. This is to prevent sedimentation to an adjacent landowners property rather than a resource area. 2/22/06</p> <p>-Repair as necessary. 2/22/06</p> <p>- Continue to remove the soil here ASAfeasible when conditions can support this without further impact. 2/22/06</p> <p>- The stockpile should be removed as soon as feasible to prevent run-off to the road. 2/16-2/22/06</p> <p>- Continue to maintain erosion controls at the corners of the mats at the approach. 2/2-2/22/06</p> <p>- An additional mat is being delivered to be installed with the first one to increase stability here. 2/22/06</p> <p>-Continue to maintain fence as necessary due to the proximity of the wetlands. 2/22/06</p> <p>- Silt fence cannot be toed in here easily so haybales will be installed instead along the access road 2/22/06</p>
