Docket No. 217 – Development and Management Plan Inspection

Northeast Utilities Service Company Certificate of Environmental Compatibility and Public Need for the construction of a 345-kV electric transmission line and reconstruction of an existing 115-kV electric transmission line between Connecticut Light and Power Company's Plumtree Substation in Bethel, through the towns of Redding, Weston, and Wilton, and to the Norwalk Substation in Norwalk, Connecticut.

Date: March 23, 2006

Location: Overhead Line (Composite 345kV and 115kV Gallows Hill to Archers Lane) and
(345kV H-Frame Hoyts Hill to Gallows Hill)

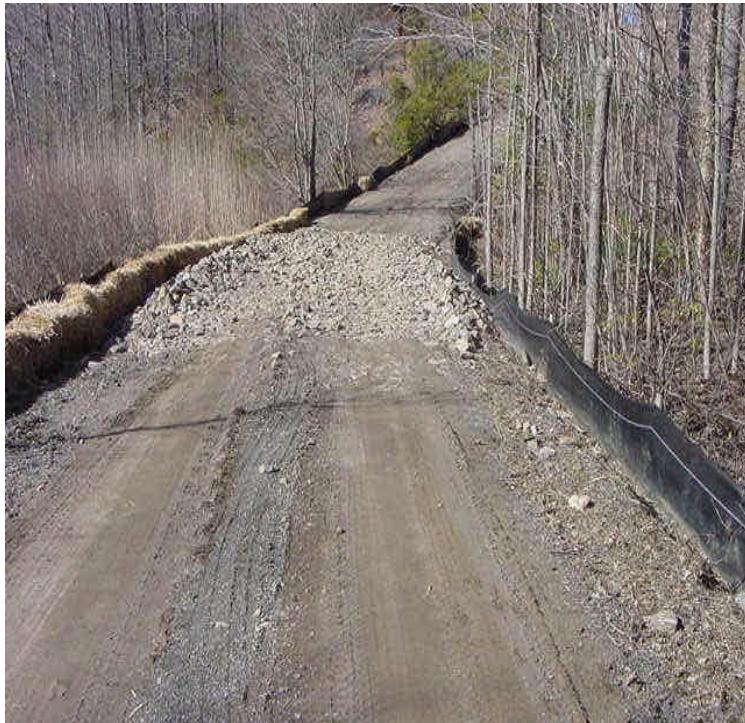
(Composite Section-Archers Lane): Photo on the left shows an overview of the 2nd crossing at Archers Lane where controls are in good shape. Photo on the right shows where the skidder slipped off the road at the 3rd crossing and ruts remain in the wetland. 3/23/06

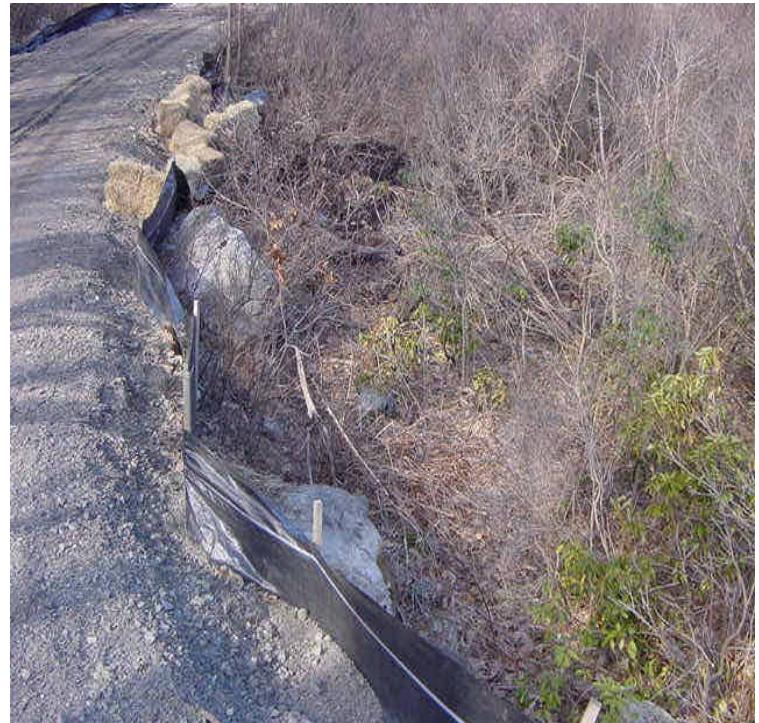
- Existing poles are in the process of being removed from both the John Todd Way and Costa Lane sections of the ROW. Pole installation is also occurring along these sections. 3/23/06.	-None at this time. 3/23/06	N/A
Norwalk Section	-Foundation drilling was occurring to the north and south of Perry Ave. 3/23/06	-None at this time. 3/23/06	-N/A
Erosion and Sediment Controls	- Water levels appear to remain low at the 2 nd wetland crossing along the Archers Lane access road. 2/16-3/23/06.	- None at this time. 3/23/06.	-N/A
Composite	- A skidder had slipped off the road into the 3 rd wetland area. Haybales had been placed but ruts in the wetland remain. 3/2-3/23/06.	- Damage to the wetland should be repaired. 2/16-3/23/06.	-Haybales were installed at the 3 rd wetland in place of the damaged controls but the ruts in the wetland remain.

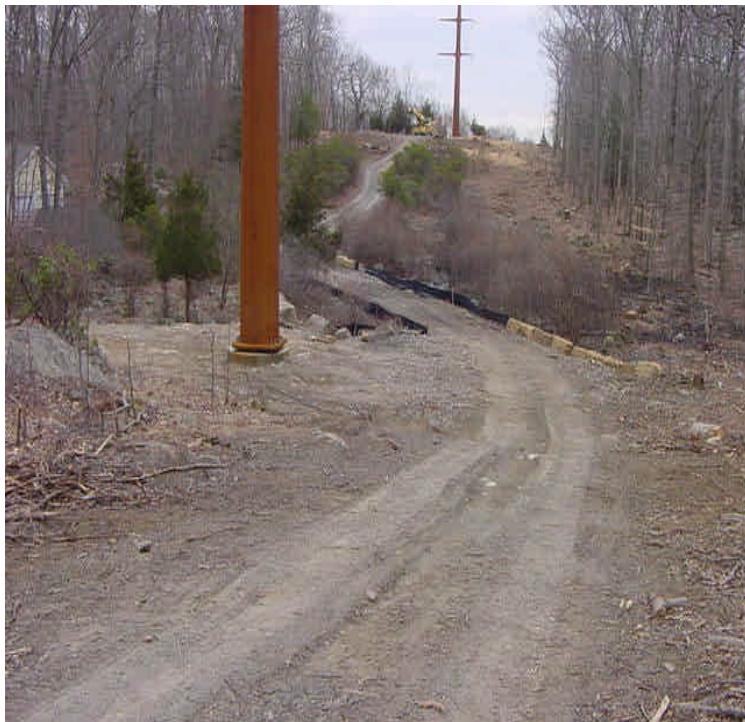
(Composite Section-Gallows Hill): Photo on the left shows an overview of the wetland crossing at the 2nd structure. Controls are in good shape and haybales were added. Photo on the right shows a closeup of the haybale extension. 3/23/06.

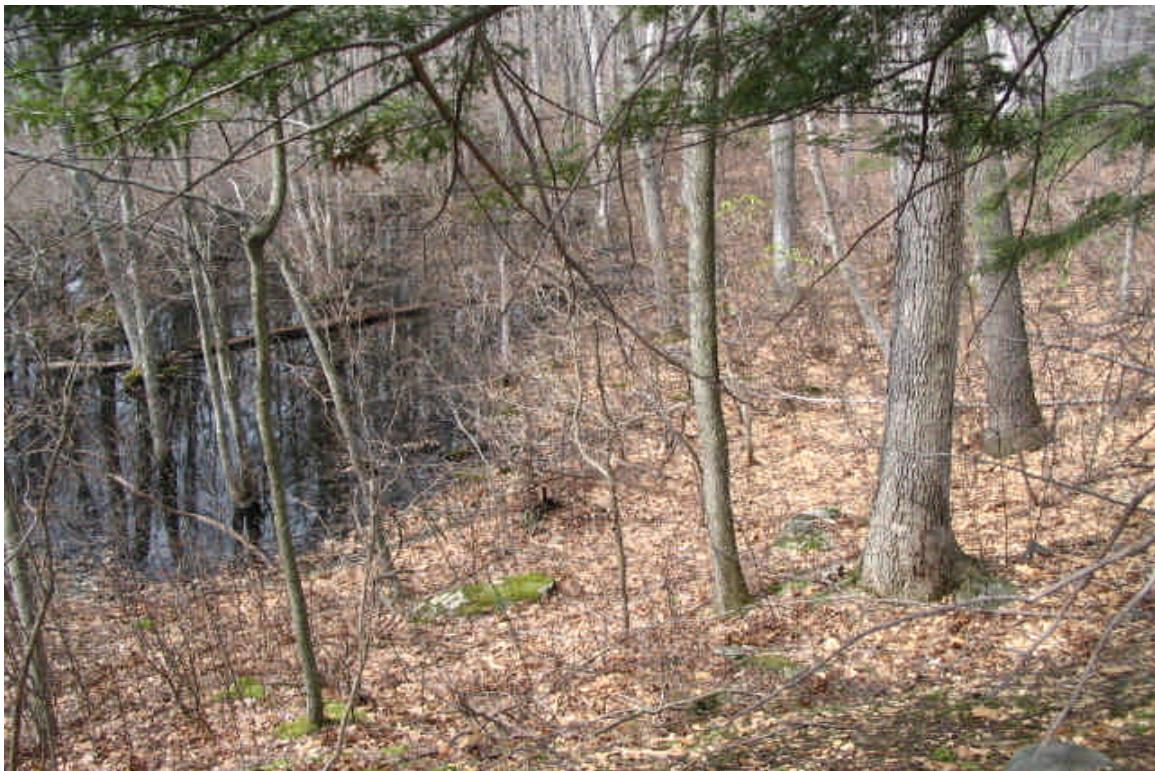
Photo shows a view of where the wood chips remain in the woods near the wetland at the 3rd structure in from Gallows Hill. CL&P is looking into a solution here. 3/23/06.

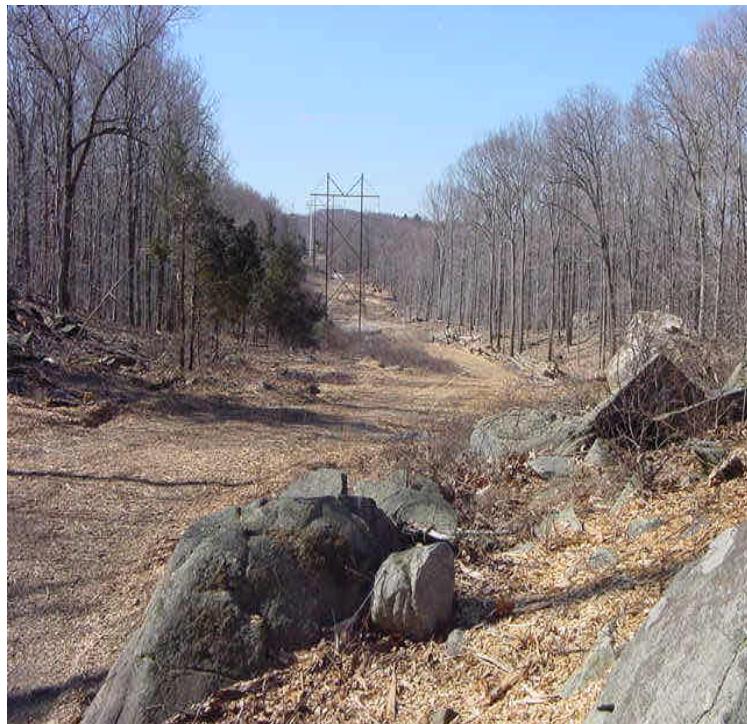
(345kV H-Frame): Photo on the left shows an overview of the Chestnut Ridge Section with several of the new H-frame structures installed. Photo on the right shows the mats installed at the stream and water main crossing between Poles 10-11 for accessing the rest of the ROW. 3/23/06.

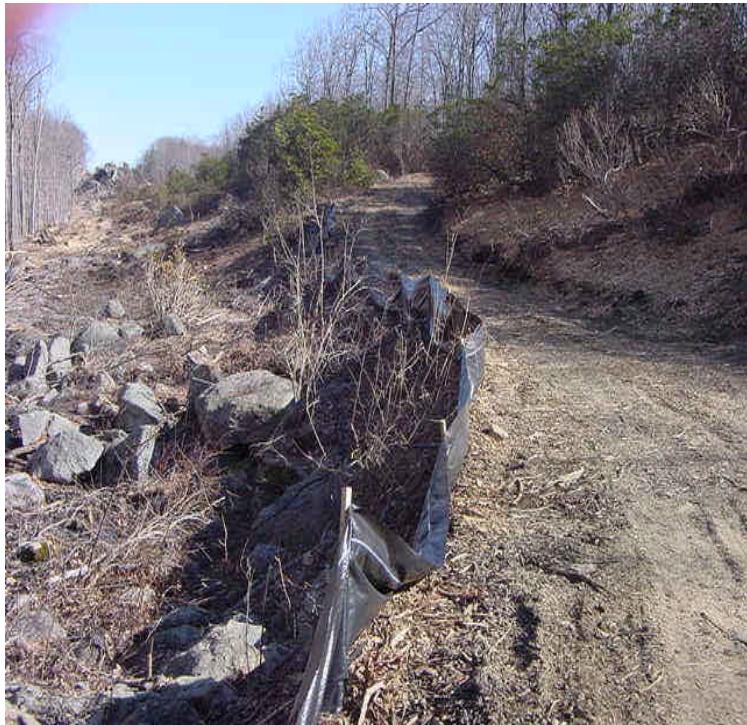
Photo on the left shows a view of the access road near Pole #19 where controls remain in good shape. Photo on the right shows the cleared area where pole #21 will be installed. 3/23/06.

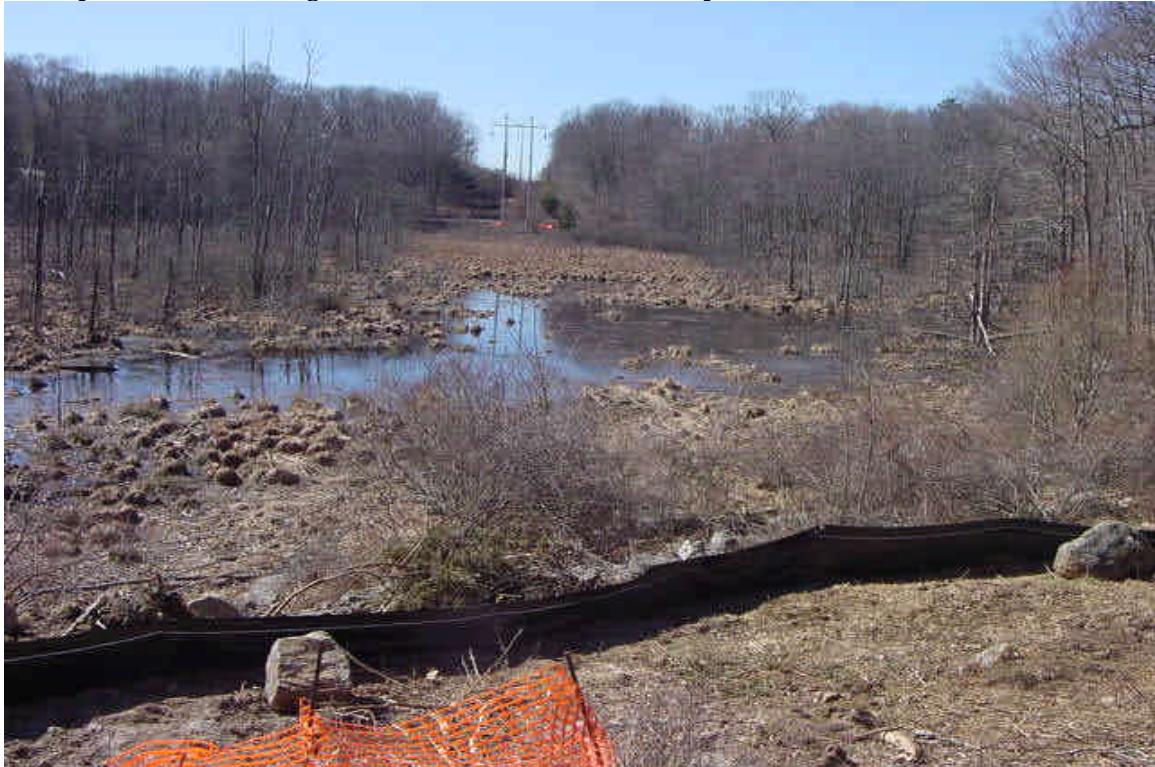
Photo shows a view of the extensive wetland near John Todd Way between poles #24-25. Silt fence is well installed at both sides of the wetland near the pole foundations. 3/23/06

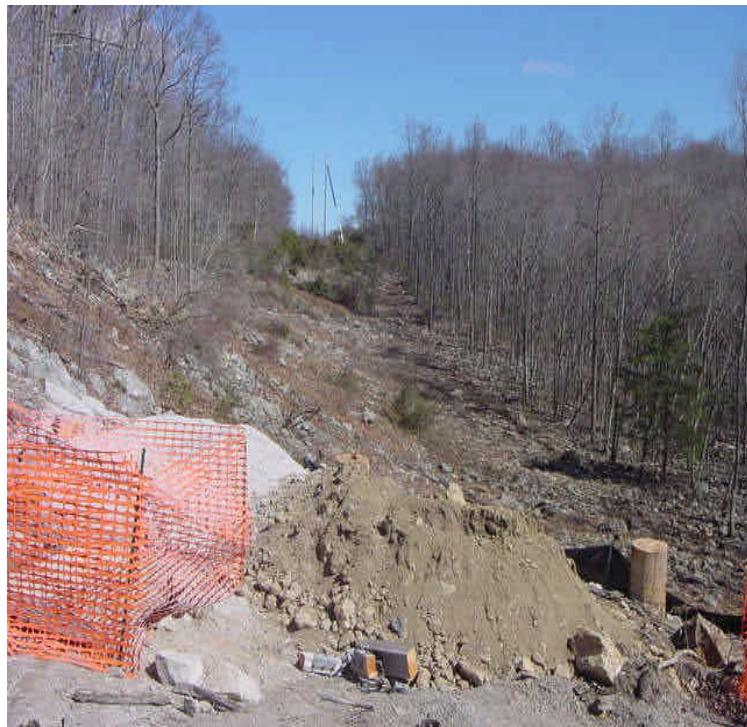
Photo on the left shows the excavation at a pole location off Costa Lane. A structure is being installed in the background of the photo. Photo on the right shows ongoing work at another pole location off Costa Lane. 3/23/06

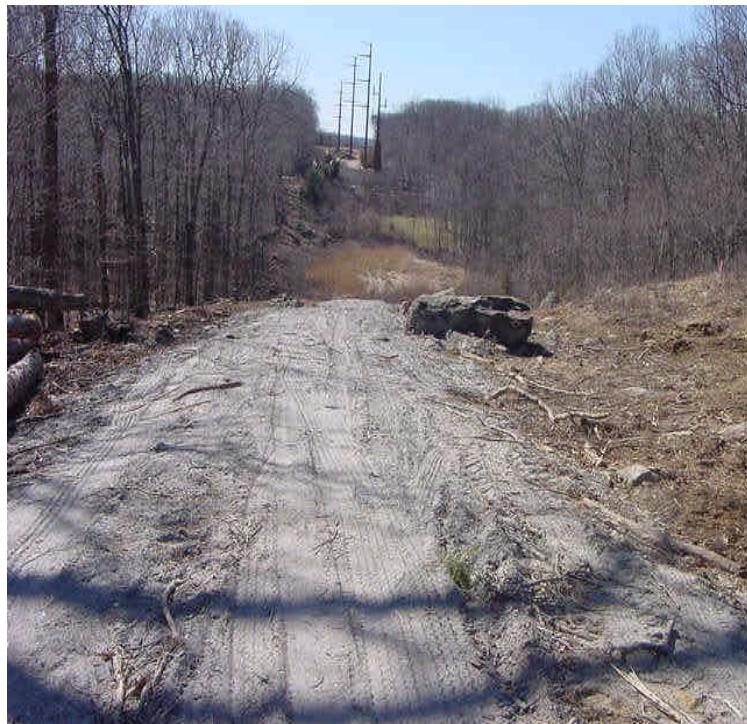
Photo on the left shows a view of the ROW off Costa Lane, looking towards the structures on Gallows Hill Rd. Photo on the right shows the ROW off Perry Ave in the Norwalk Section where work has commenced. Excavations for foundations were being drilled. 3/23/06
