Docket No. 217 – Development and Management Plan Inspection

Northeast Utilities Service Company Certificate of Environmental Compatibility and Public Need for the construction of a 345-kV electric transmission line and reconstruction of an existing 115-kV electric transmission line between Connecticut Light and Power Company's Plumtree Substation in Bethel, through the towns of Redding, Weston, and Wilton, and to the Norwalk Substation in Norwalk, Connecticut.

Date: March 29, 2006

Location: Overhead Line (Composite 345kV and 115kV Gallows Hill to Archers Lane,
345kV H-Frame Hoyts Hill to Gallows Hill, and Norwalk Section)

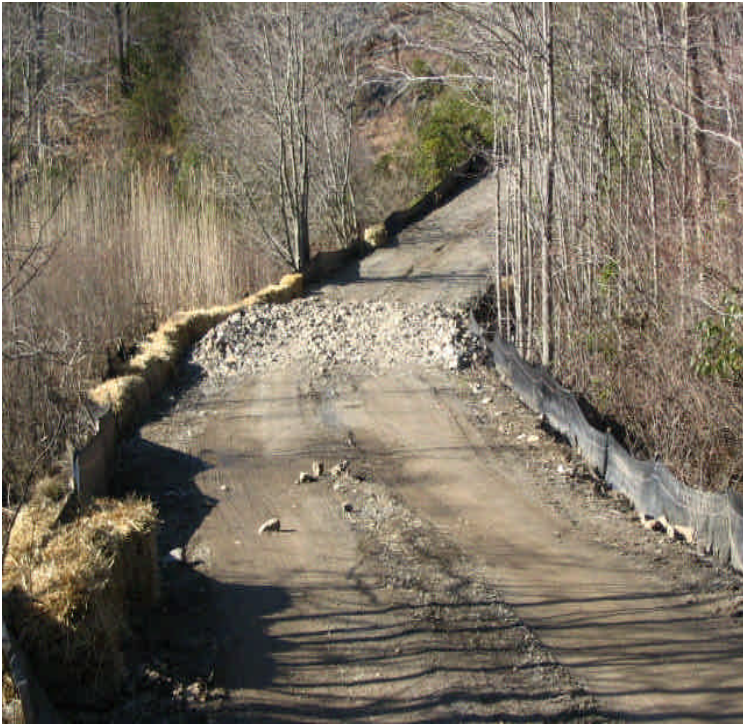
(Composite Section-Archers Lane): Photo on the left shows an overview of the 2nd crossing at Archers Lane where controls are in good shape. Photo on the right shows where the skidder slipped off the road at the 3rd crossing and ruts remain in the wetland. 3/29/06.

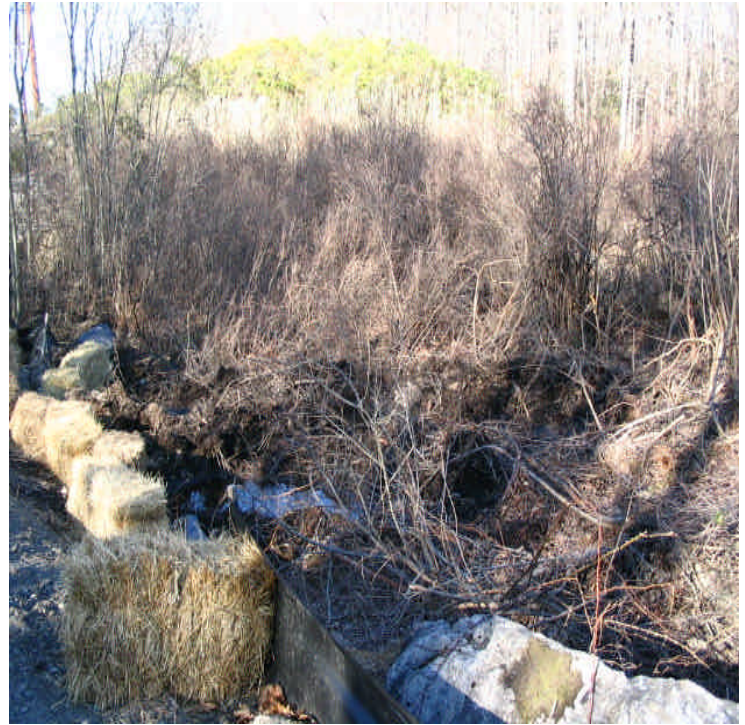
Areas of Inspection	Observation	Recommended Action	Corrective Action
345kV H-Frame	Haybales had been placed but ruts in the wetland remain. 3/9-3/29/06.	control section for more details. 2/16- 3/29/06.	erosion control section for more details.

- All previously existing structures and wire were down in these two sections. 3/29/06.	- None at this time. 3/29/06.	-N/A
	- The crossing between poles #10 and #11 is functioning well for pole delivery. 3/23-3/29/06.	-None at this time. 3/29/06	-N/A
Norwalk Section	- Existing poles are in the process of being removed from both the John Todd Way and Costa Lane sections of the ROW. Pole installation is also occurring along these sections. 3/29/06.	-None at this time. 3/29/06	-N/A
	-Foundation drilling and installation was occurring to the north and south of Perry Ave. 3/29/06.	-See dewatering and erosion controls section for recommendations here. 3/29/06.	
Erosion and Sediment Controls	- Water levels appear to remain low at the 2 nd wetland crossing along the Archers Lane access road. 2/16-3/29/06.	- None at this time. 3/29/06.	-N/A
Composite	- A skidder had slipped off the road into the 3 rd wetland area. Haybales had been placed but ruts in the wetland remain.	- Damage to the wetland should be repaired. 2/16-3/29/06.

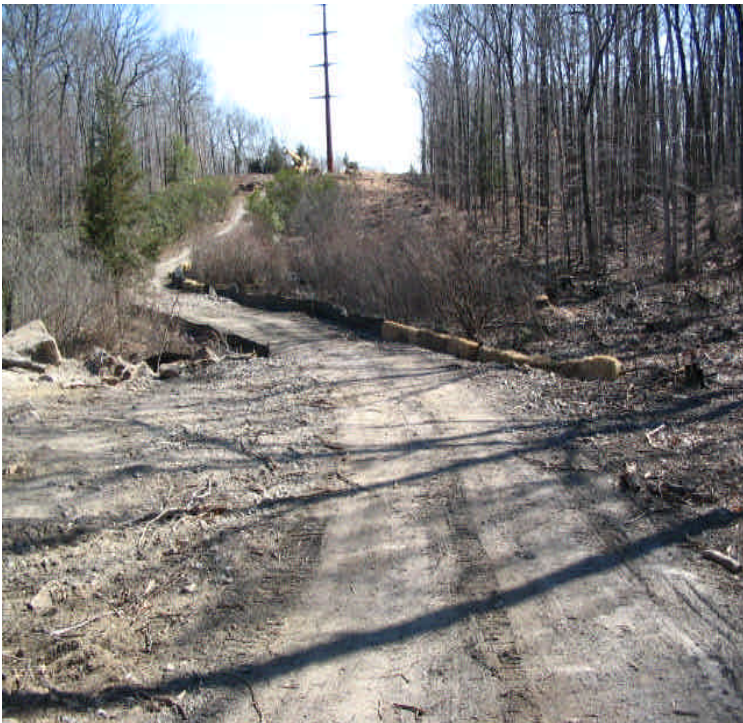
- The additional haybales along the access road and wetland at the 2 nd structure off Gallows Hill appear to be functioning to reduce sedimentation to the amphibian breeding habitat. 3/29/06.	-None at this time. Continue to monitor and keep activity out of the various wetland habitats as feasible. 3/29/06.	-Controls were extended here as recommended.
345kV H-Frame			
Chestnut Ridge Section	- Continue to provide good controls at the wetlands. Wood chips are in place along the access road and seem to have helped reduce sediment and mud issues. 3/23-3/29/06.	-Continue to maintain controls at the four "corners" of the approach to the mats and crossings. Watch for increasingly muddy conditions on the mats and install silt fence along the road as needed. 3/29/06.	-N/A at this time
	-The silt fence at the pasture near pole #7 was reinforced and in good shape. 3/29/06.	-None at this time. 3/29/06.	-Additional stakes were installed to reinforce the fence here.

(Composite Section-Gallows Hill): Photo on the left shows an overview of the wetland crossing at the 2nd structure. Controls are in good shape. Photo on the right shows where the wood chips remain in the woods off the ROW near the third structure. 3/29/06.

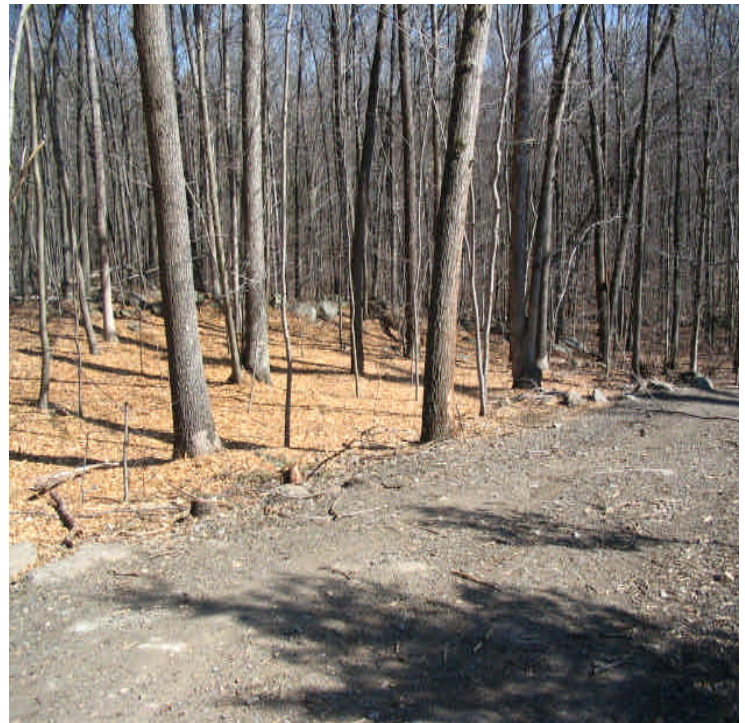
- A significant amount of chips were blown off the ROW into the upland and also along the wetland edge at the 3 rd structure off Gallows Hill. This could smother plants and reduce habitat. 2/22-3/29/06.	- Chips currently off ROW boundaries should be removed carefully to comply with the D&M plan. 2/22-3/29/06. Chips on ROW should be spread to a depth of 3". 3/29/06.	- CL&P is looking into this.
	-This was also noted several structures past Archers Lane. 3/15-3/29/06		
	-Clearing will need to continue along the ROW past Archers Lane and a number of trees are marked for removal in a wetland that serves as amphibian breeding habitat. 3/15-3/29/06.	- To avoid wetland damage, the trees will be sheared from the access road and felled out of the water. 3/15-3/29/06	- CL&P proposed the work under these specs.
345kV H-Frame	-Clearing continues along the Costa Lane, and John Todd Way sections. Wood chips were placed along the majority of the roads. 2/16-3/29/06.	- Chips spread on the ROW should be spread to a depth not more than 3" by the time the growing season is about to begin. 3/29/06.	-N/A at this time

- Wood chips had been blown into the uplands and wetland area at the third structure in from Gallows Hill Road. 2/22-3/23/06. A new area with deep wood chips off the cleared ROW was noted past Archers Lane. 3/15-3/29/06	-Make sure chips stay on the ROW. Contractors to should remove the off ROW chips since this is not allowed in the D&M plan. 2/22-3/23/06. - Wood chips on the ROW can remain at a depth of 3". Deeper piles should be spread out. 3/29/06	- CL&P is looking into a solution here.

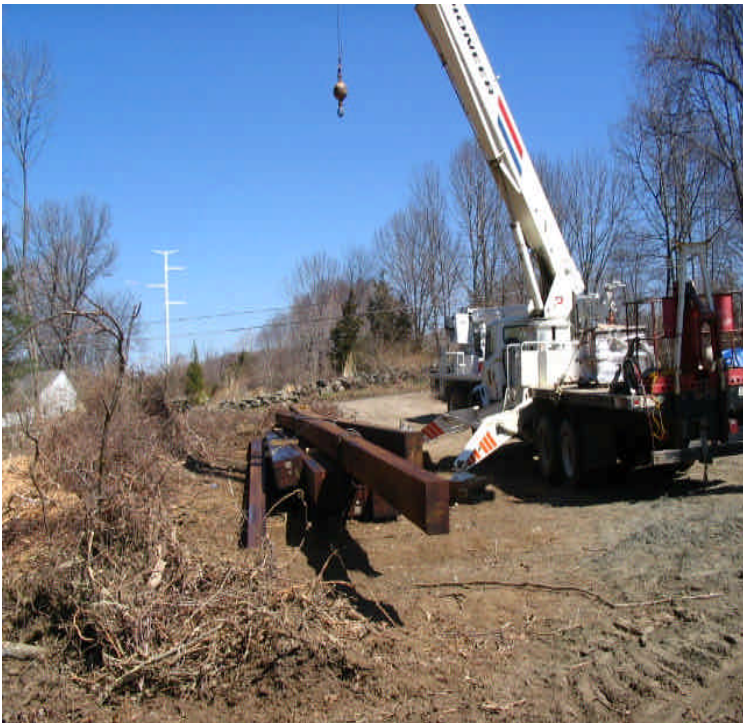
(345kV H-Frame): Photo on the left shows a view of the area near structure #10 where most poles have been removed for installation along the ROW. Photo on the right shows the mats installed at the stream and water main crossing between Poles #10-11 for accessing the remainder of the ROW. Mats were also installed over a 2nd wet area and controls were installed well. 3/29/06.

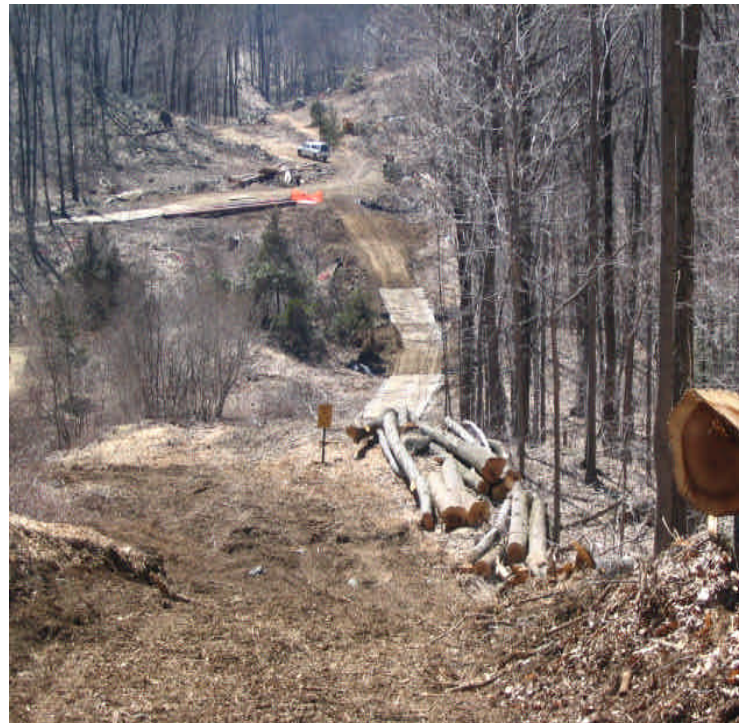
- A larger access road has been graded between poles #10-11 for access to bring in the poles. Mats were installed to create a bridge over the stream and water main 3/29/06.	- The streambed was well protected during the construction of the crossing and good controls were installed. 3/23-3/29/06.	-Mats were installed carefully over the streambed and erosion controls were installed at the "corners".
Norwalk Section	-There was no sediment tracking at the various road/ROW intersections. 3/9-3/29/06.	- Continue to monitor. Install stone at road access points or sweep the street as necessary. 3/9-3/29/06.	-N/A at this time

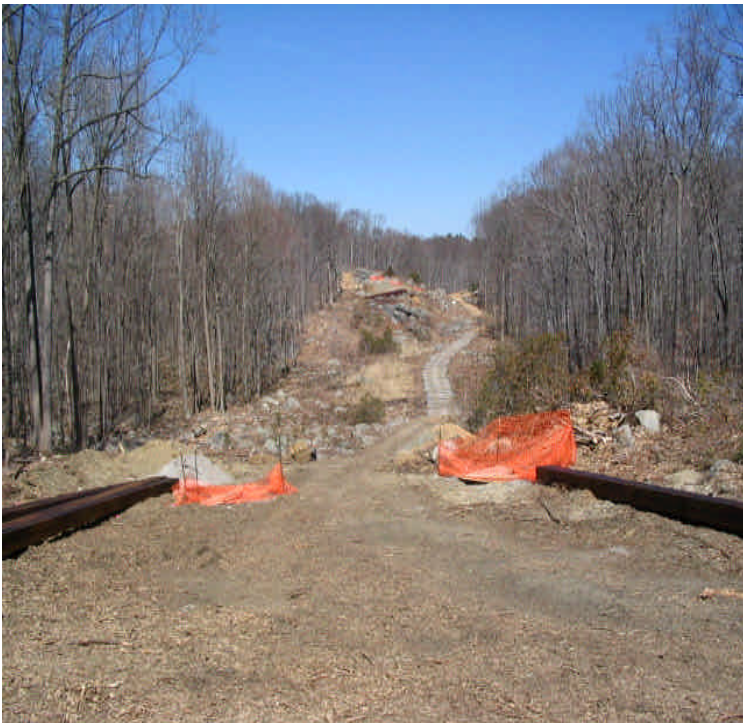
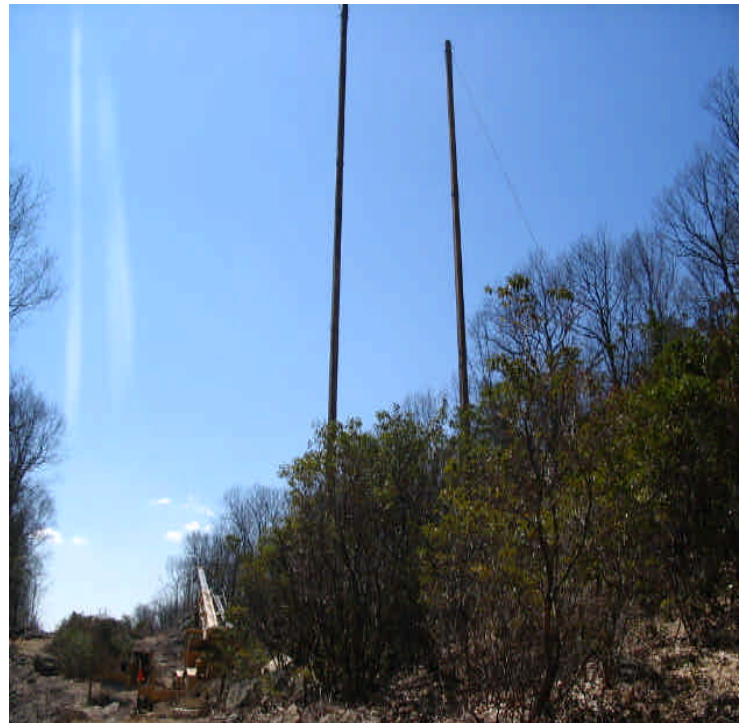
Photo on the left shows a portion of the Bethel Reservoir section where poles have been placed for installation. Photo on the right shows the ongoing installation of structures in this area as well. 3/29/06.

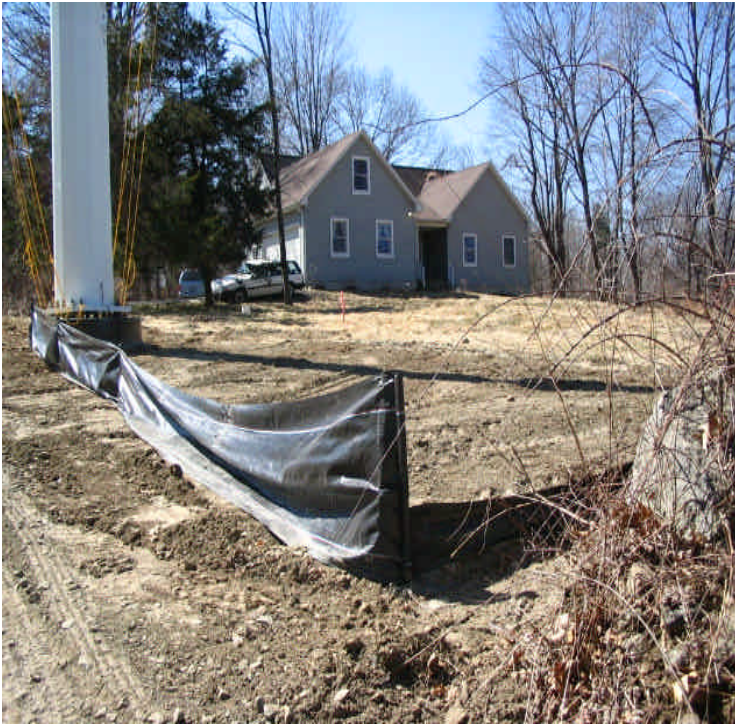
Areas of Inspection	Observation	Recommended Action	Corrective Action
Bethel Reservoir Section to Chestnut Ridge Rd.	<p>remainder of the pile is in a wetland area. 2/22-3/29/06. The temporary stockpile associated with pole installation had been removed. 3/29/06.</p> <p>- The stockpile near structure #9 has been removed, but the silt fence in this area is in need of repair. 3/29/06.</p> <p>- Silt fence and mats remain in place in a number of locations in this section. 3/29/06</p> <p>- Mats were installed over the stream between poles #10-11. Erosion controls were installed at the "corners". 3/29/06</p> <p>- Mats were installed at another wet area adjacent to the crossing and erosion controls were installed. 3/29/06</p>	<p>support this without further impact. 2/22-3/23/06.</p> <p>- Continue to monitor and maintain silt fence here until the area is stabilized. 3/29/06.</p> <p>- Continue to monitor for any muddy conditions or need for repairs. All observed controls remain in good condition. 3/29/06.</p> <p>- None at this time. Continue to maintain. 3/29/06</p>	<p>structure was installed.</p> <p>-The stockpile was removed. 3/29/06.</p> <p>- Erosion controls were installed proactively at the mats.</p>

Photo on the left shows the area at structure #9 where the soil stockpile was removed. Silt fence should be maintained here until the area is stabilized. Photo on the right is a view towards Hoyts Hill from structure #2. 3/29/06.

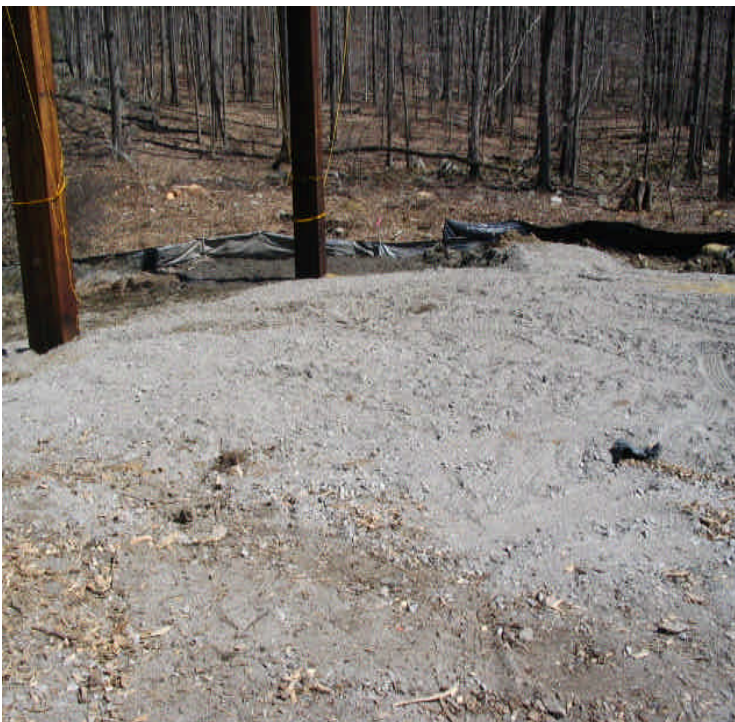
-Continue to work on removing the sediment near pole #6 as the	- Remove the soil here as soon as conditions can	- The temporary pile was removed after the

Photo on the left shows the area near structure #6 where the temporary stockpile was removed after pole installation. Remaining sediment will continue to be removed. Photo on the right shows the wetland in this area was not damaged during pole removal and installation. 3/29/06.

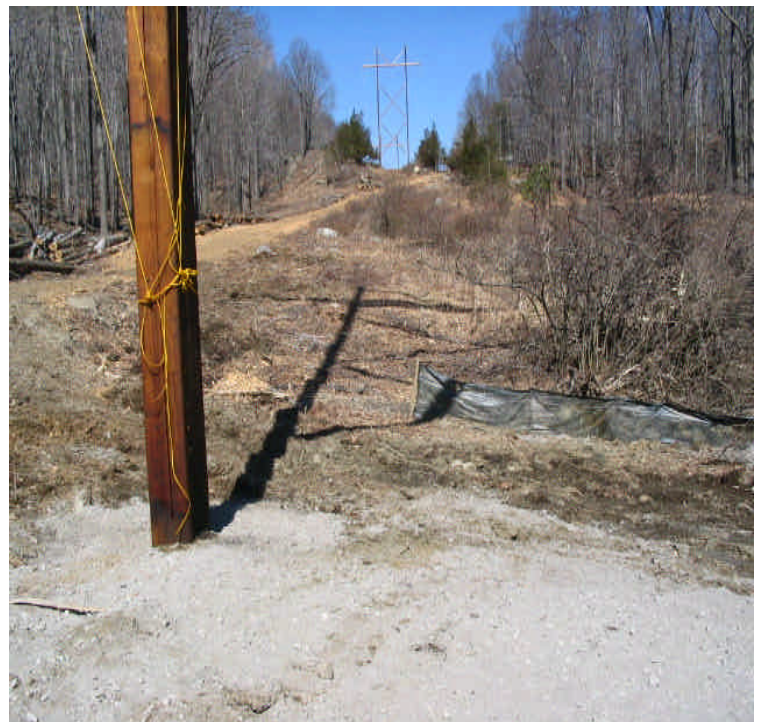
Areas of Inspection	Observation	Recommended Action	Corrective Action
	- Poles were removed from the wetland near structure #6.	fuel kits for worst case scenarios. - Report spills immediately, even if they are being controlled. - Avoid refueling in the areas near the wetlands. Use proper storage for all materials.	-The poles were removed carefully from the wetland between poles #5 and 6. The wetland was not damaged in the process. 3/29/06.
Additional Observations

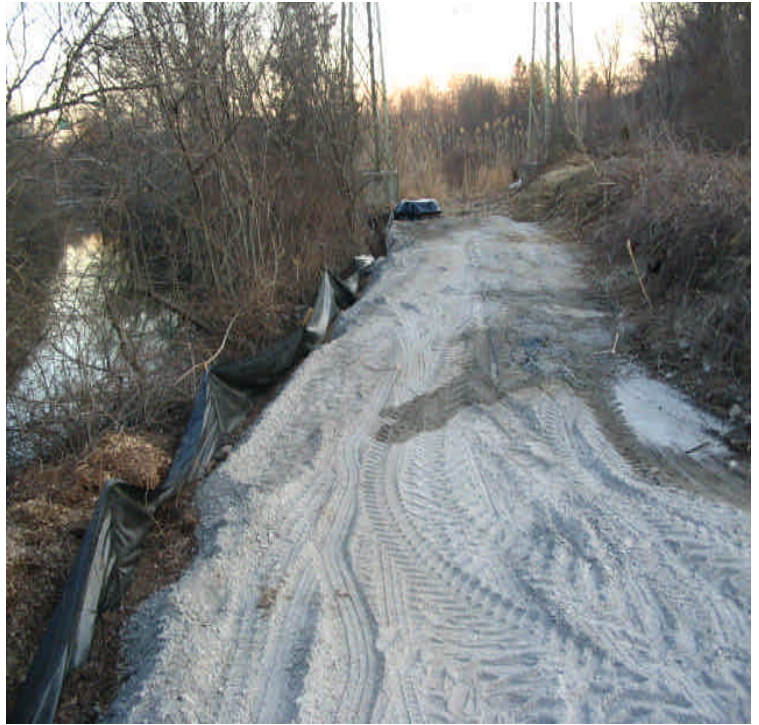
Photo on the left shows structures being installed in the area of Costa Lane. Norwalk Section:
Photo on the right shows the stone dust access road to a foundation. A concrete washout was noted here. A containment basin should be set up. 3/29/06

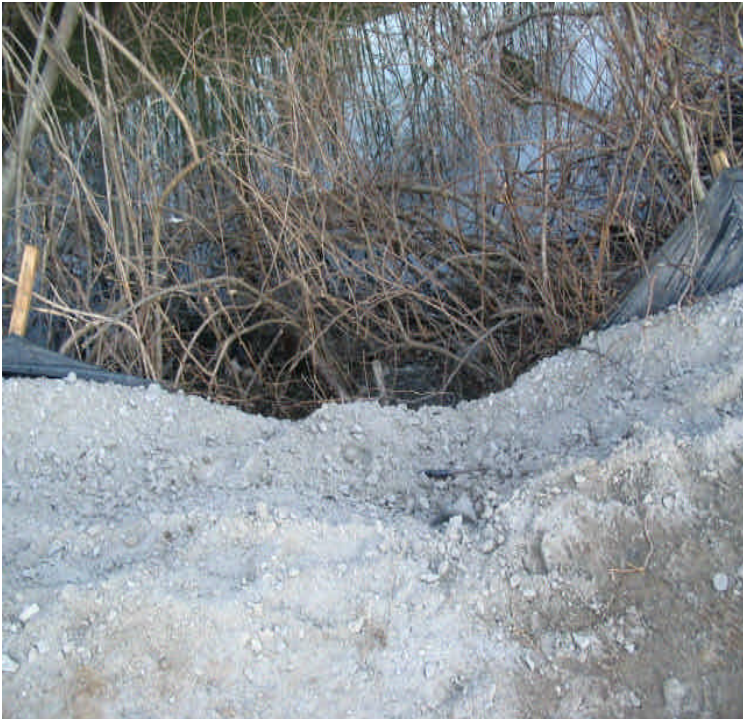
Areas of Inspection	Observation	Recommended Action	Corrective Action
Norwalk Section	<p>system. 3/15-3/29/06.</p> <p>-Dirt was pushed completely over the silt fence at the last foundation which is immediately adjacent to a waterway channel. 3/29/06.</p> <p>-Stone dust from the access road was pushed over the silt fence close to an area of ponded water. 3/29/06.</p> <p>-Evidence of concrete washing and/or dewatering was present along this section in the stone dust and adjacent to foundations. 3/29/06.</p>	<p>to its proximity to the wetland. 3/9-3/29/06</p> <p>-Carefully pull the dirt back and reinstall the silt fence in this area and utilize it as a limit of work. 3/29/06.</p> <p>-The stone dust should be pulled back ASAP and silt fence needs repair. 3/29/06.</p> <p>- Dewatering basins, concrete washout pits or other appropriate controls need to be installed.</p>	
<p>Inland Wetland and Watercourse encroachment and mitigation</p> <p>Composite</p>	<p>-The D&M plan approved stone on geotextile fabric at the wetland crossings had worked well, but at three areas near Archers Lane, turbidity issues have been present. Run-off from the road, the drainage pipe, and snow plow issues had led to sedimentation. 1/4-3/29/06.</p> <p>- Direct damage was noted in the wetland at the 3rd crossing as a result of equipment slipping. 2/16-3/29/06.</p> <p>- The rocks at the 1st crossing remain clogged with sediment and noticeable deposits were in the wetland. 1/4-3/29/06.</p> <p>- Use caution in clearing trees from wetland areas.</p>	<p>- As the access is considered temporary, the stone will be removed when final work ends so the wetlands can be restored. 1/26-3/29/06.</p> <p>- The damage to the 3rd wetland should be repaired. 3/29/06.</p> <p>- The 1st crossing could also use some clean stone. Sediment will have to be carefully removed. 1/4-3/29/06.</p> <p>- Retain shrubs and low growth as much as</p>	-N/A until evaluated at the end of work.

Photo on the left shows where stone dust was pushed over the silt fence. The stone dust should be pulled back and fence repaired ASAP due to proximity of the waterway. The photo on the right shows dirt piled completely over the silt fence. Fence needs repair ASAP, again due to the adjacent wetland. 3/29/06.
