Docket No. 217 – Development and Management Plan Inspection

Northeast Utilities Service Company Certificate of Environmental Compatibility and Public Need for the construction of a 345-kV electric transmission line and reconstruction of an existing 115-kV electric transmission line between Connecticut Light and Power Company's Plumtree Substation in Bethel, through the towns of Redding, Weston, and Wilton, and to the Norwalk Substation in Norwalk, Connecticut.

Date: June 14, 2006

Location: Overhead Line (Composite 345kV and 115kV Gallows Hill to Archers Lane,
345kV H-Frame Hoyts Hill to Gallows Hill, and Norwalk Section)

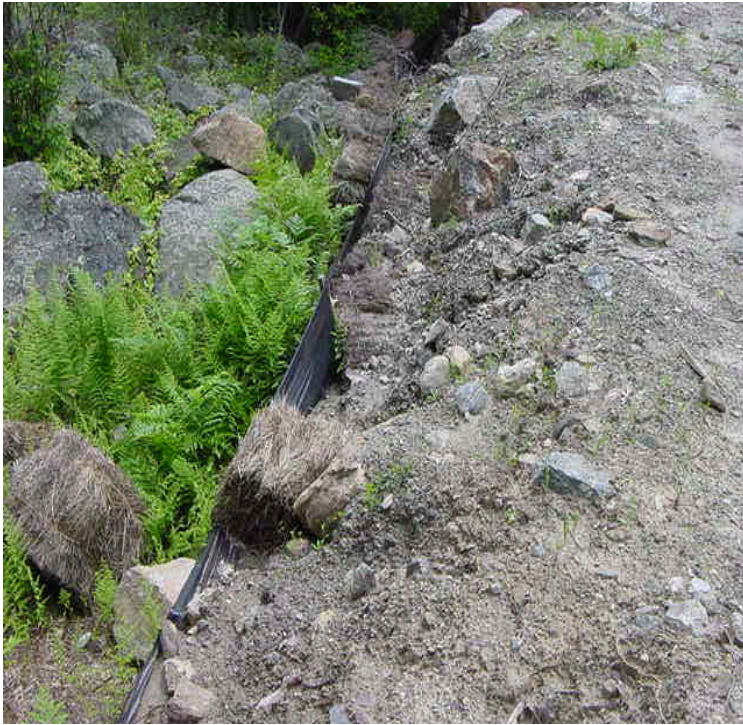
(Composite Section): Photo on the left shows the disturbed area remaining around structure #34 off Gallows Hill. Sediment is beginning to overtop the silt fence again. Photo on the right shows the spot along the Archers Lane ROW where the access road stone overtopped the fence. A new haybale was placed here but stone needs to be pulled back. 6/14/06

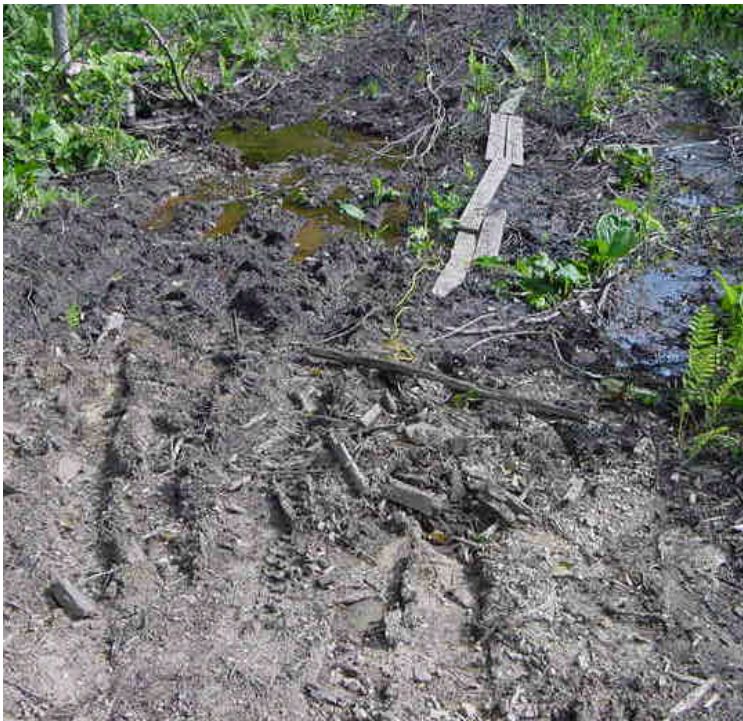
- Non project related vehicles continue to be noted in the wetland between #10-11. 6/7-6/14/06	- Ruts should be smoothed out and silt fence added in an attempt to discourage access. 5/25-6/14/06	-Needs attention (the majority of disturbance is from non project related vehicles)
Norwalk Section	-The pond, stream, and pooled area in the new ROW section off Kent Rd are fairly well protected by controls but silt fence should be extended at the stream. 6/14/06.	-Carefully remove some of the branches and debris noted in the stream and extend silt fence where recommended. 6/7-6/14/06.	-Needs attention see erosion control section
All Sections	- Many washout issues were repaired. A few spots of overtopped silt fence remain along Kent Rd (south). 6/14/06	- Remove sediment carefully from any wetland areas and pull back silt fence and repair. 6/7-6/14/06	- Many areas were repaired a few still need attention.

(345kV H-Frame): Photo on the left shows a view of the wetland between structures #10 and #11. Adjacent landowners have reported vehicles here which are not project related. Some silt fence across the access road may help to prevent this. Photo on the right shows haybales installed along the Bethel Reservoir access road. 6/14/06.

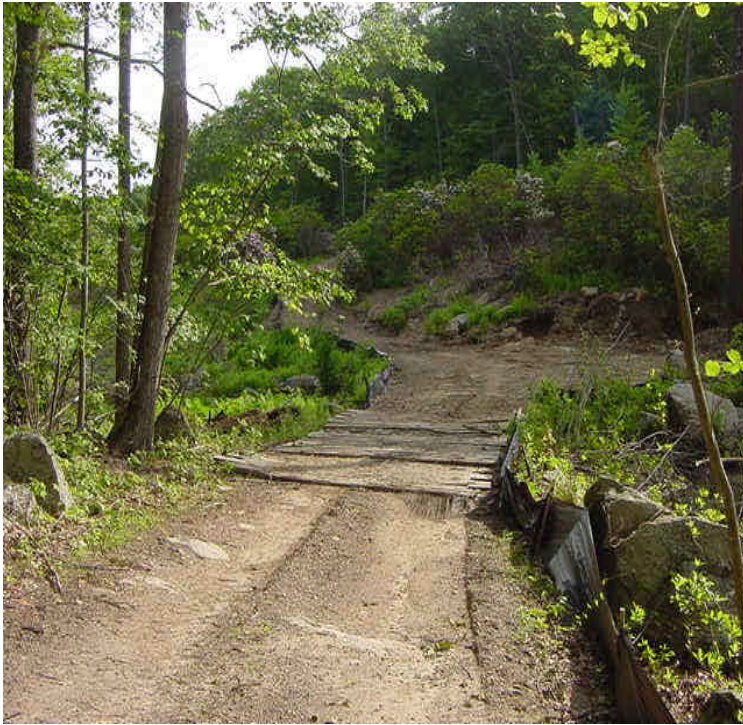
Photo on the left shows the crossing near structure #19 where silt fence was repaired. Photo on the right shows an eastern box turtle walking within the ROW off Chestnut Ridge Rd. 6/14/06.

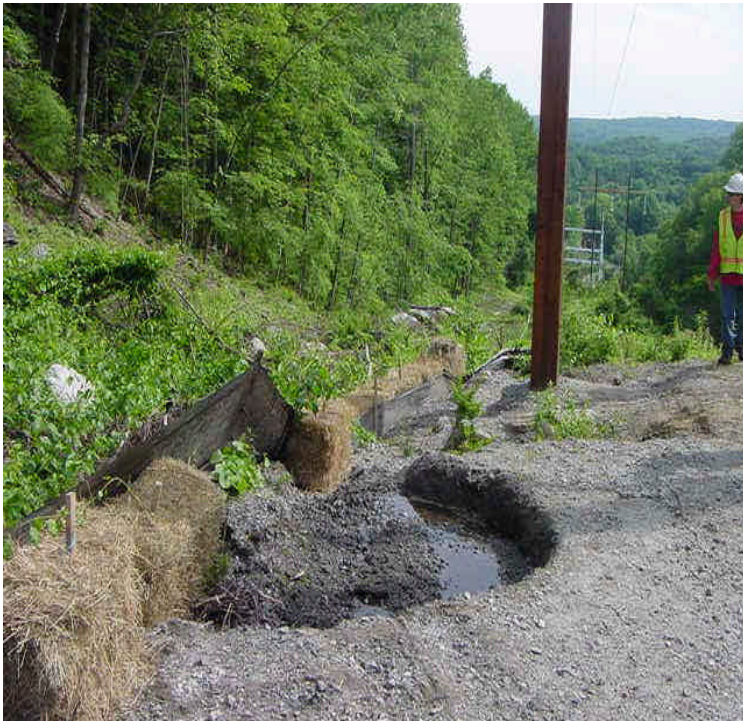
<ul style="list-style-type: none"> - Erosion remains in the stone dust near pole #2 but silt fence was repaired and reinforced with haybales. 6/14/06 -The majority of the pile at structure#6 has been removed but soil remains encroaching on wetlands 4/12-6/14/06. - Haybales were placed in the low spot at the access road near structure #6. 6/14/06 	<ul style="list-style-type: none"> - Continue to monitor; wetlands are not immediately adjacent but repair ruts if feasible. 6/14/06 - Remove the soil here as soon as conditions can support this without further impact. 2/22-6/14/06. - Continue to monitor. 6/14/06 	<ul style="list-style-type: none"> - Controls were restored and reinforced - Needs attention when feasible - Haybales were placed

Photo on the left shows the erosion near structure #2. Silt fence was repaired and haybales were placed to reinforce the area. Photo on the right shows where the silt fence was repaired near structure #24. Sediment was also pulled back from the wetland. 6/14/06.

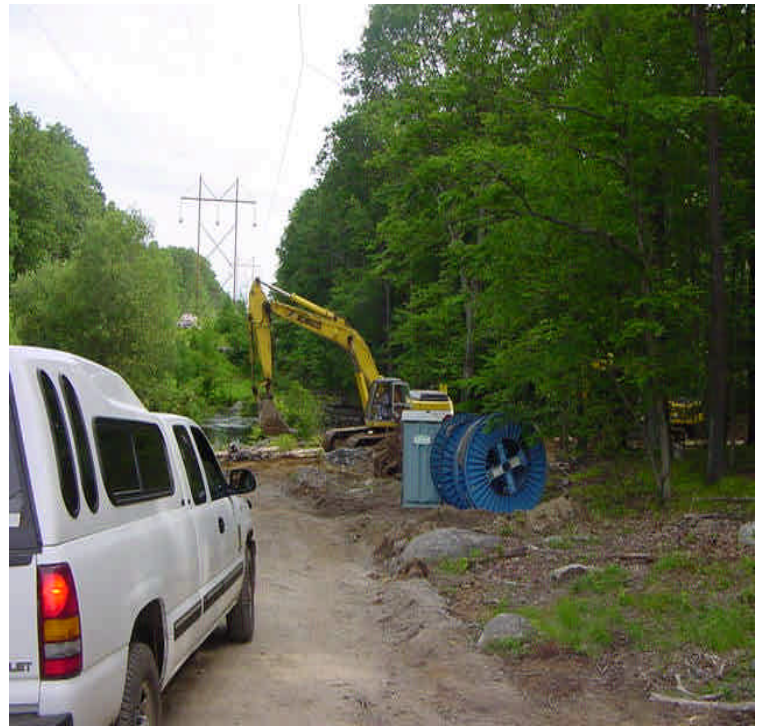
<p>- A contractor (unrelated to the project) remains in this area filling near the wetland for a driveway. Silt fence was not installed near the work. 6/7/06-6/14/06</p>	<p>- This is not project related but should be noted for the record in case there are issues here later. 6/7-6/14/06</p>	<p>- Not project jurisdictional</p>
	<p>-The area of silt fence near pole #11078 had sediment piled up against it again. 6/7-6/14/06.</p>	<p>-Controls need repair and sediment should be pulled back. 6/7-6/14/06</p>	<p>-Needs attention</p>
	<p>- The foundation near the Norwalk substation has good silt fence coverage. 5/17-6/14/06. Bare, exposed soil remains adjacent to the foundation. 6/7-6/14/06</p>	<p>-Continue to monitor due to proximity of the river. Restore the adjacent area with vegetation to reduce potential run-off, even if it is temporarily. 6/7-6/14/06</p>	<p>- Needs attention if feasible</p>
	<p>- Mats were installed at foundation #68 on North Seir Hill Rd. due to wet conditions. 6/1-6/14/06</p>	<p>-Install silt fence downgradient of the mats if necessary. 6/1-6/14/06.</p>	<p>-Needs attention if feasible.</p>

Photo on the left shows the machinery on site to pull wire in the area of John Todd Way. Photo on the right shows the separate contractor (unrelated to the project) placing fill for a driveway in the same area. This contractor is not using erosion controls. 6/14/06.

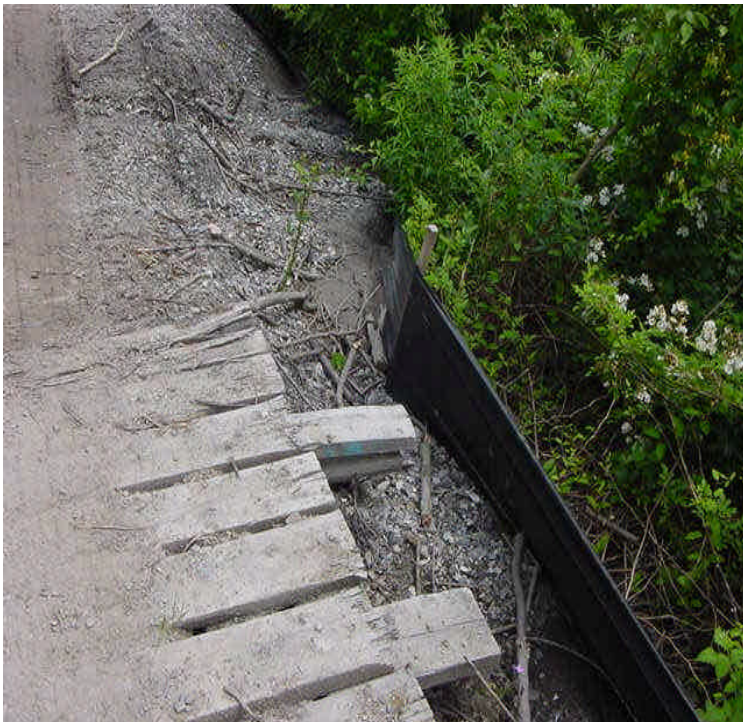
Photo on the left shows where silt fence was overtopped by stone and sediment along a wetland crossing at Kent Rd (south) as a result of the recent rains. The controls here should be repaired.

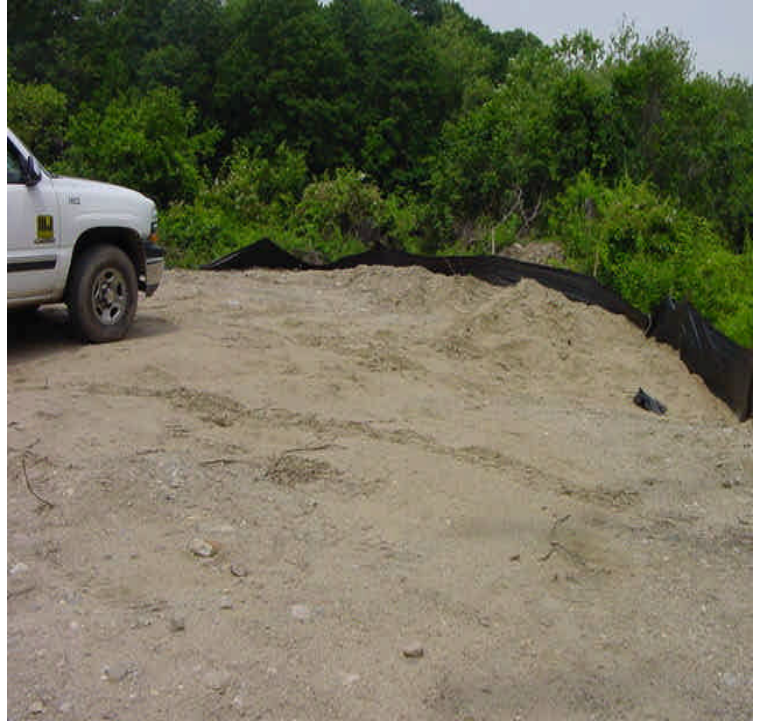
Photo on the left shows where old towers are down off Perry Ave. These will eventually be removed. Photo on the left shows silt fence to the north of Broad St at the end of the access road which should be maintained. 6/14/06

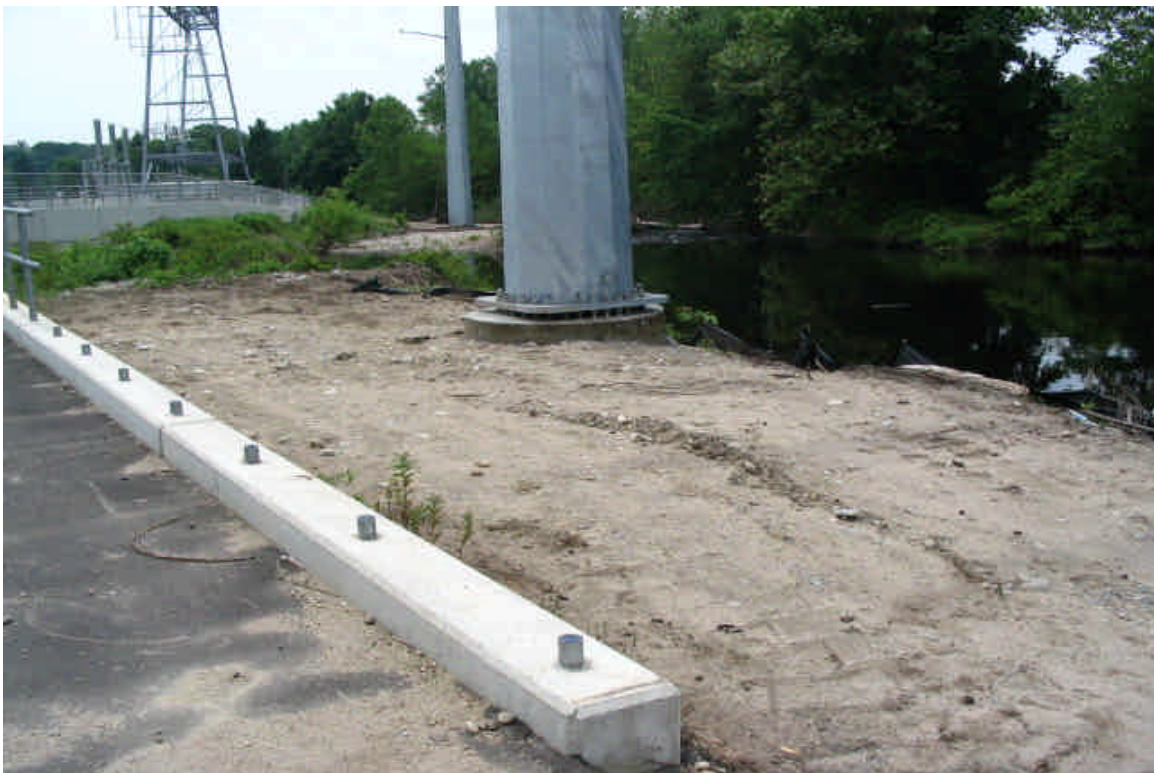
Photo on the left shows the structure near Norwalk Substation. Erosion controls remain in place but the area should be re-vegetated for further stability soon, even if it is only temporarily until the pole is accessed. 6/14/06
