**Docket No. 217 – Development and Management Plan Inspection**

**Date:** January 12, 2006

**Location:** Norwalk Substation Expansion

**Location:** Plumtree Substation Expansion, Bethel

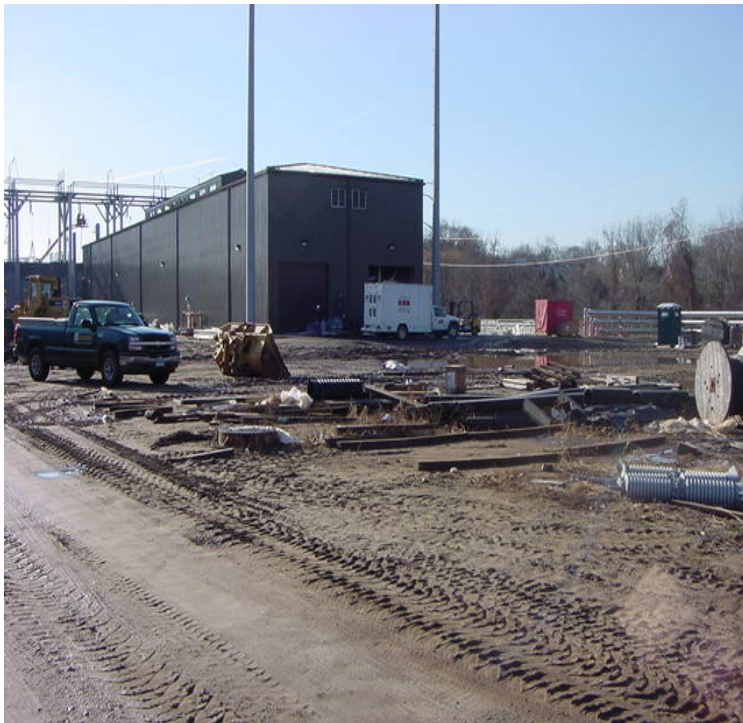
Norwalk Substation: Photo on the left is an overview of the yard looking towards the GIS building. Photo on the right shows a view of the constructed overflow channel. 1/12/06.

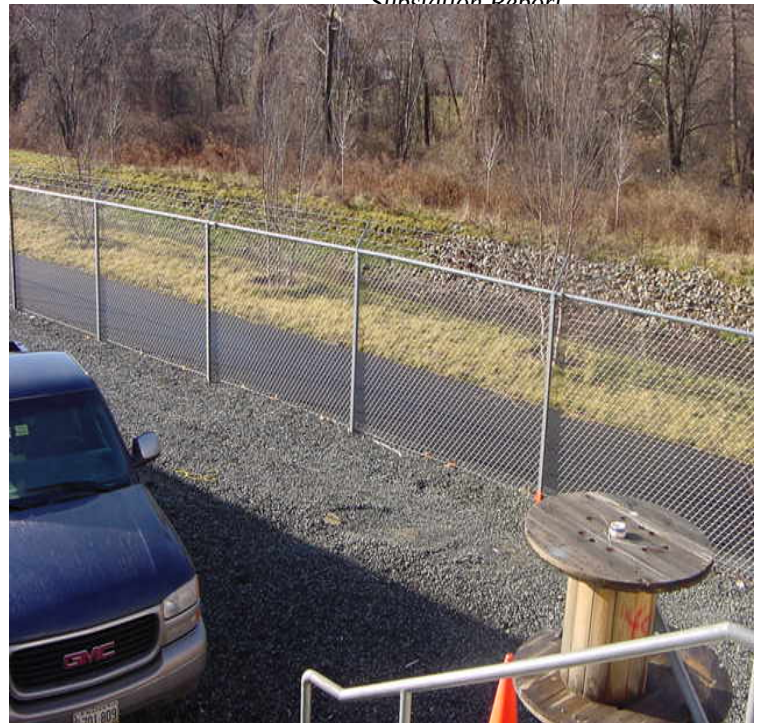
| Areas of Inspection | Observation | Recommended Action |
|---|---|---|
| Inland Wetland and Watercourse encroachment and mitigation | -Water was flowing fairly clear once again in both the natural and constructed overflow channel. Some minor erosion was noted along the top of slope 1/12/06. | - Sediment does deposit naturally along the channel. None at this time. 1/12/06 |

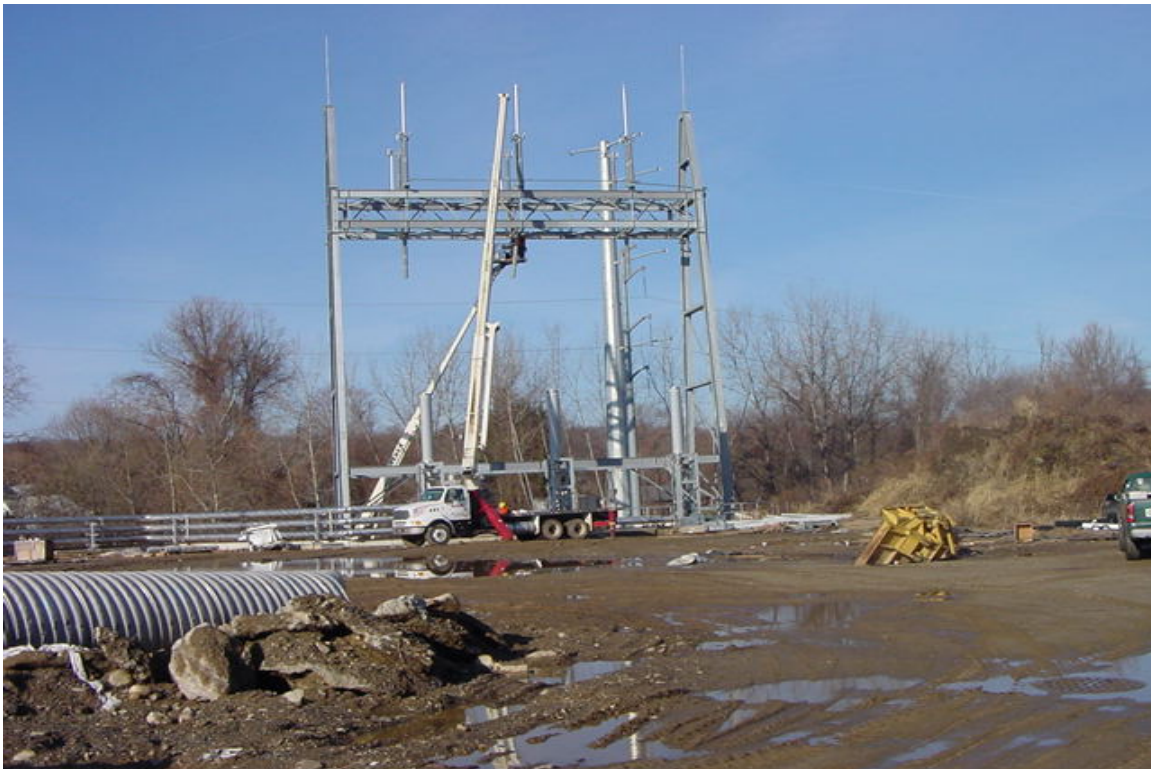
View of the ongoing work on the structures recently installed to the north of the GIS building near the retaining wall. 1/12/06.

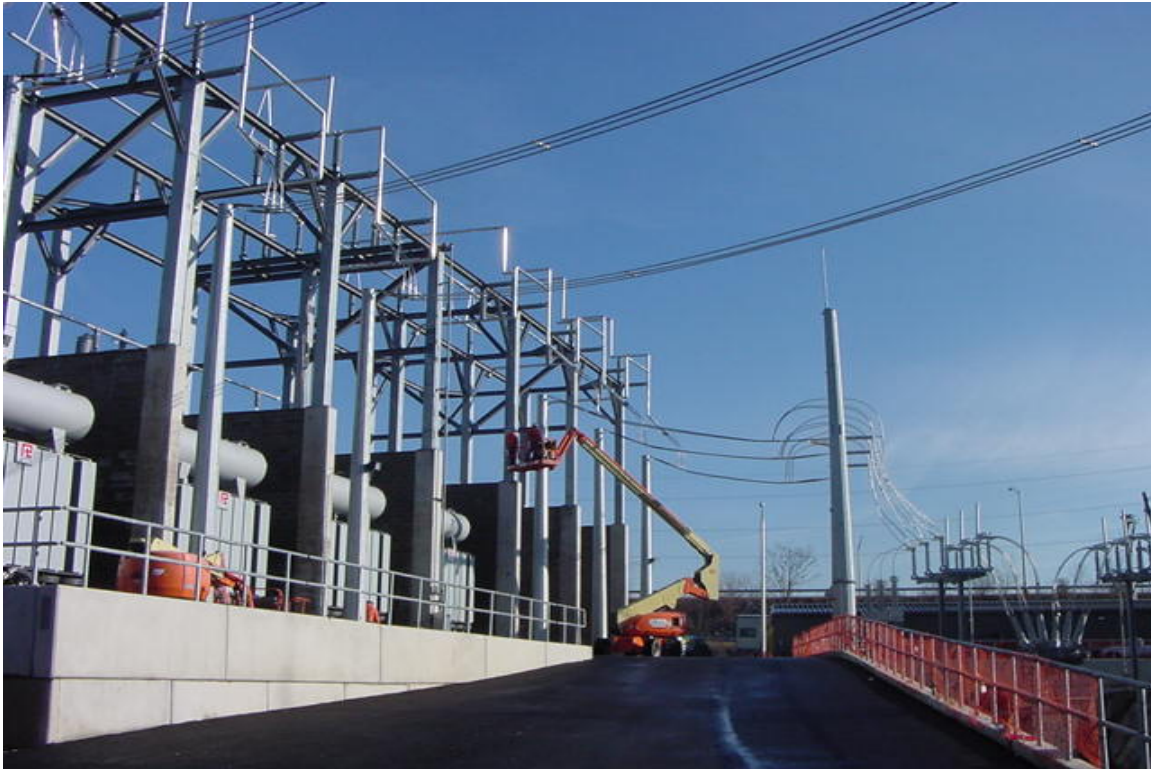
View of work occurring to the structures along the front bays of the GIS building. 1/12/06.

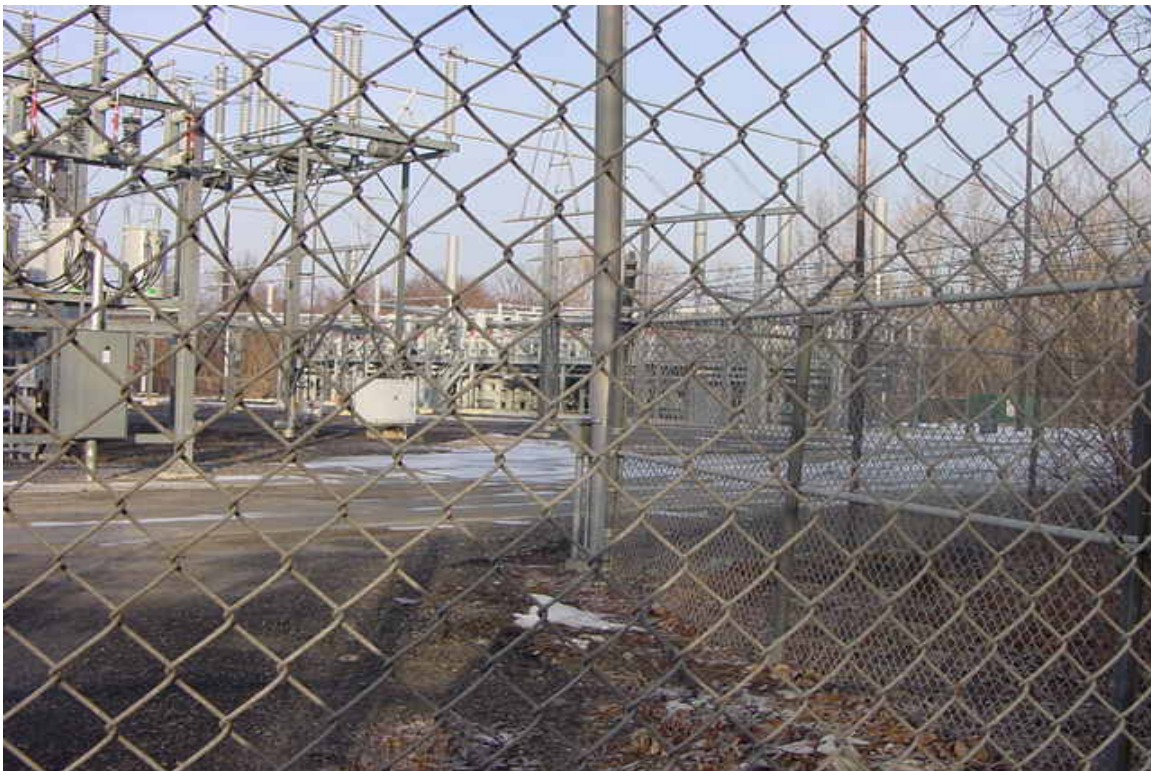
Plumtree Substation: View of the yard where external work has not occurred for some time. 1/12/06.
