**Docket No. 217 – Development and Management Plan Inspection**

Northeast Utilities Service Company Certificate of Environmental Compatibility and Public Need for the construction of a 345-kV electric transmission line and reconstruction of an existing 115-kV electric transmission line between Connecticut Light and Power Company's Plumtree Substation in Bethel, through the towns of Redding, Weston, and Wilton, and to the Norwalk Substation in Norwalk, Connecticut.

**Date:** January 26, 2006

**Location:** Norwalk Substation Expansion

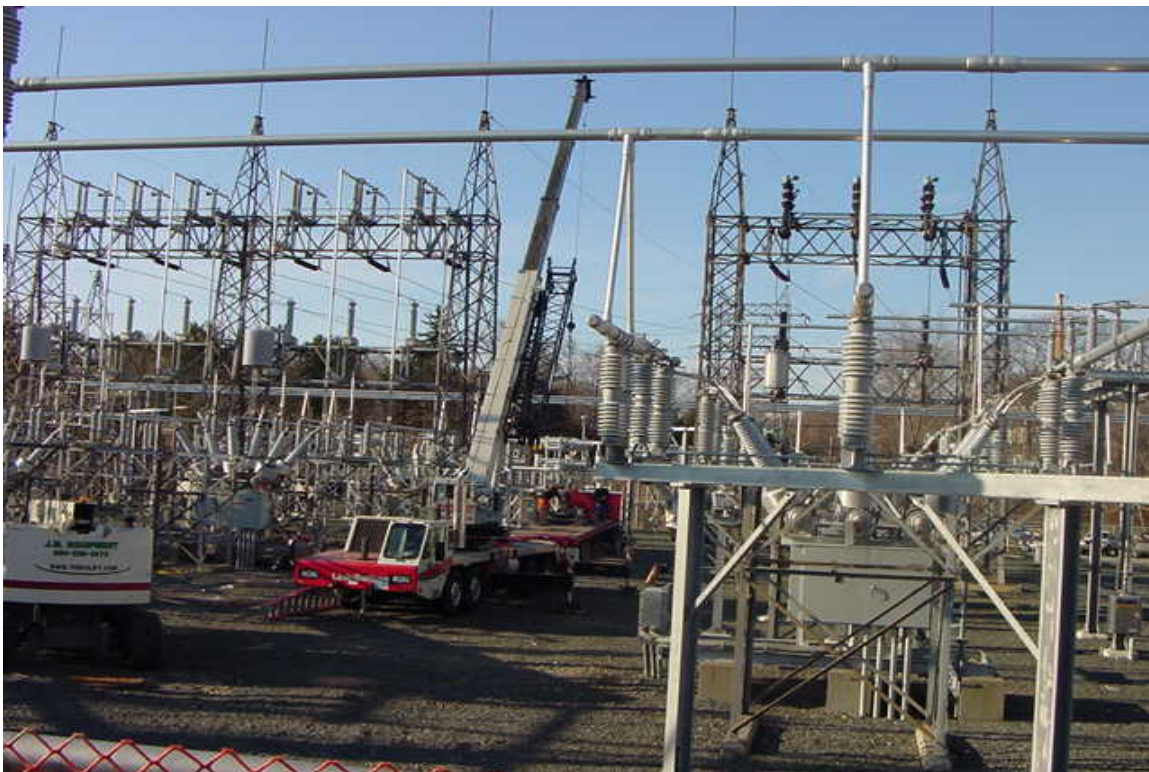
Norwalk Substation: Structures were being removed from the electrified yard. 1/26/06.

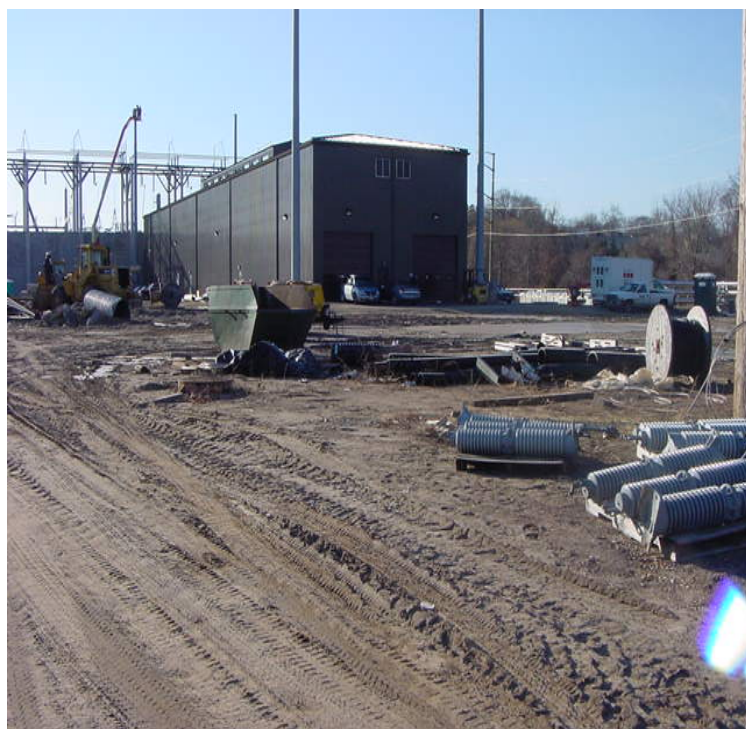
Photo on the left shows an overview of the yard and GIS building. Work was occurring on one of the poles here (bucket truck in background). Photo on the right is an overview of the yard at Plumtree Substation. 1/26/06.
