Docket No. 217 – Development and Management Plan Inspection

Northeast Utilities Service Company Certificate of Environmental Compatibility and Public Need for the construction of a 345-kV electric transmission line and reconstruction of an existing 115-kV electric transmission line between Connecticut Light and Power Company's Plumtree Substation in Bethel, through the towns of Redding, Weston, and Wilton, and to the Norwalk Substation in Norwalk, Connecticut.

Date: February 27, 2004

Location: Norwalk Substation Expansion

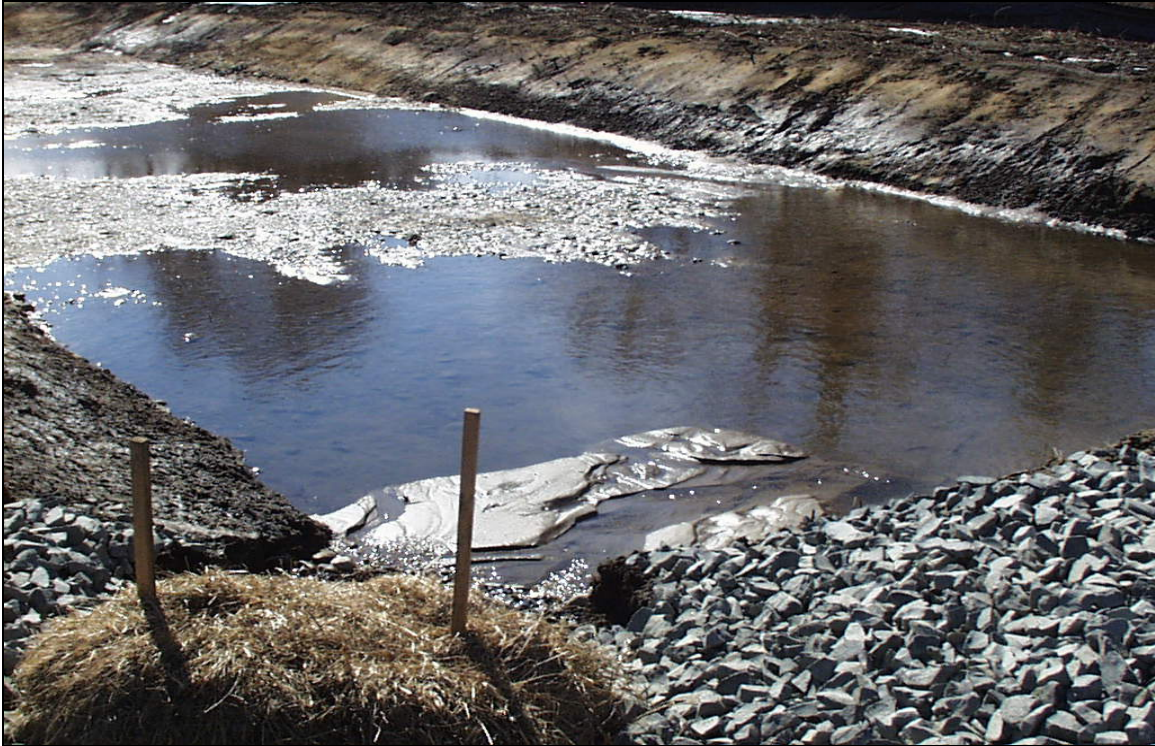
A VIEW OF THE SEDIMENT BASIN. THE DEWATERING DISCHARGE REMAINS CLEAR AND IS DIRECTED TO THE BASIN. A SMALL AMOUNT OF EROSION OCCURRED ALONG THE SWALE AND INTO THE BASIN. 2/27/04

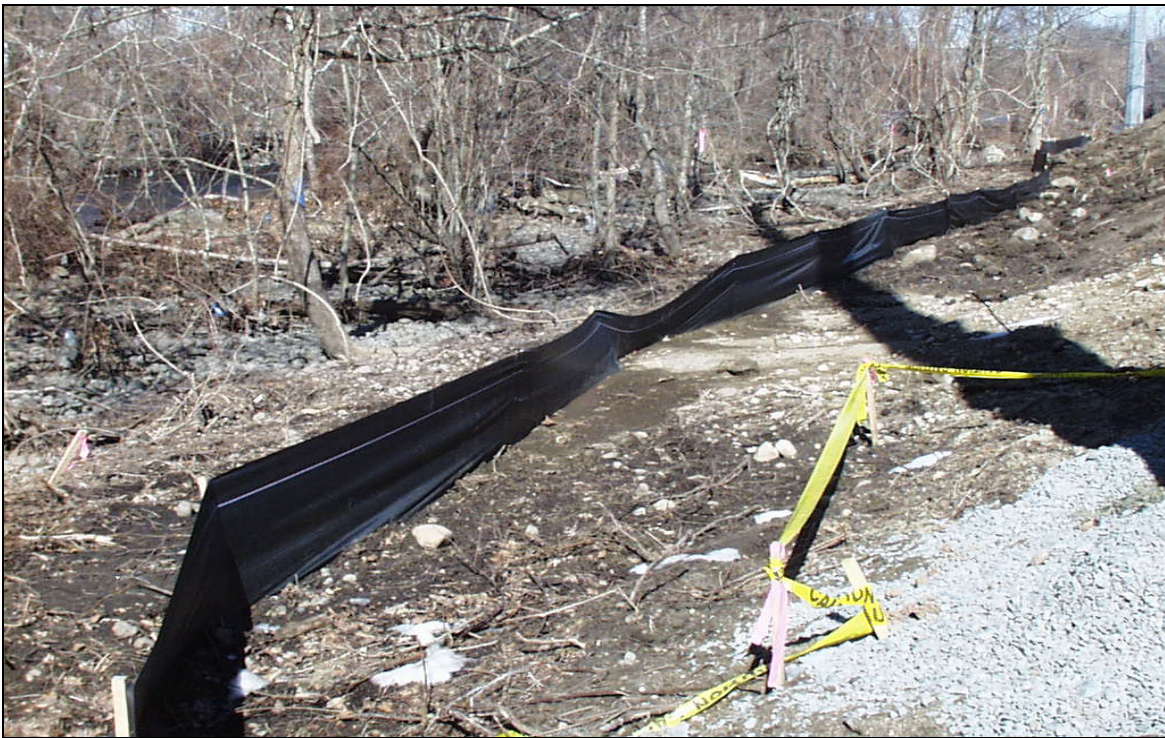
THE SNOW COVER IS GONE FOR THE MOST PART AND RAINS COULD BRING STRESS TO THE SILT FENCE. A SECOND BARRIER SHOULD BE INSTALLED AT THE BASE OF THE STOCKPILE 2/27/04

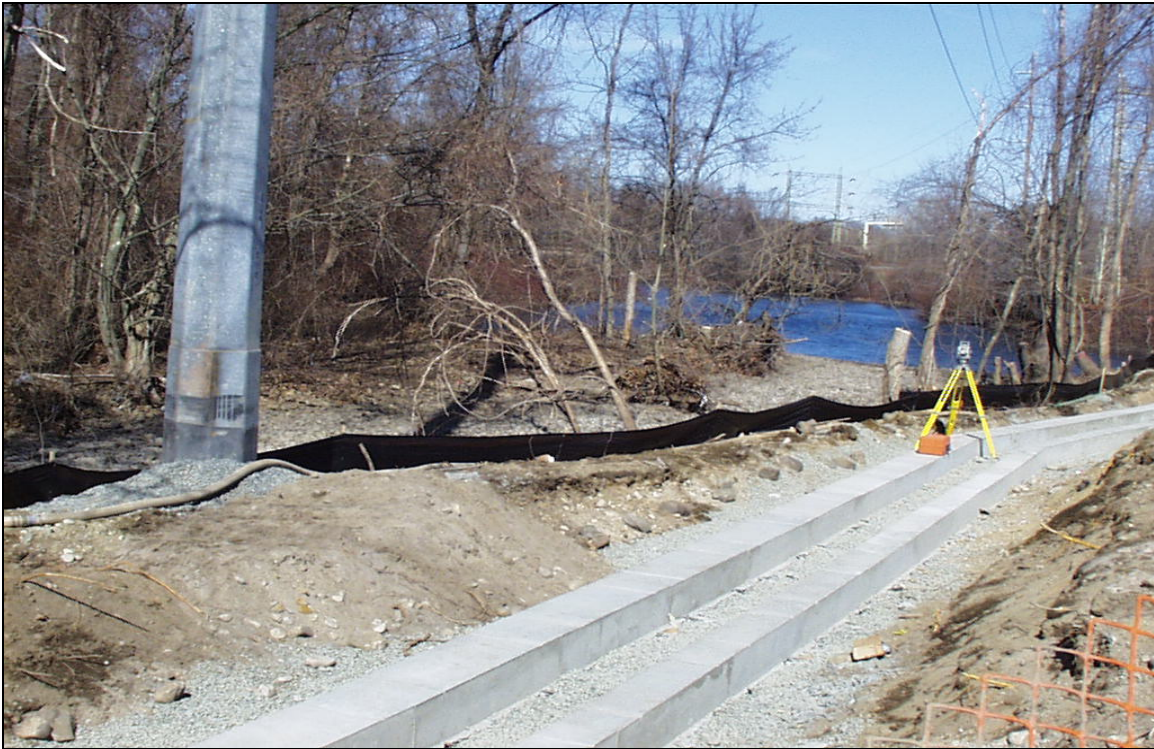
VIEW OF THE NEW RETAINING WALL FOUNDATION. THIS AREA IS WHERE DISCUSSIONS ARE ONGOING, REGARDING ADDITIONAL FUTURE BANK STABILIZATION ALTERNATIVES 2/27/04

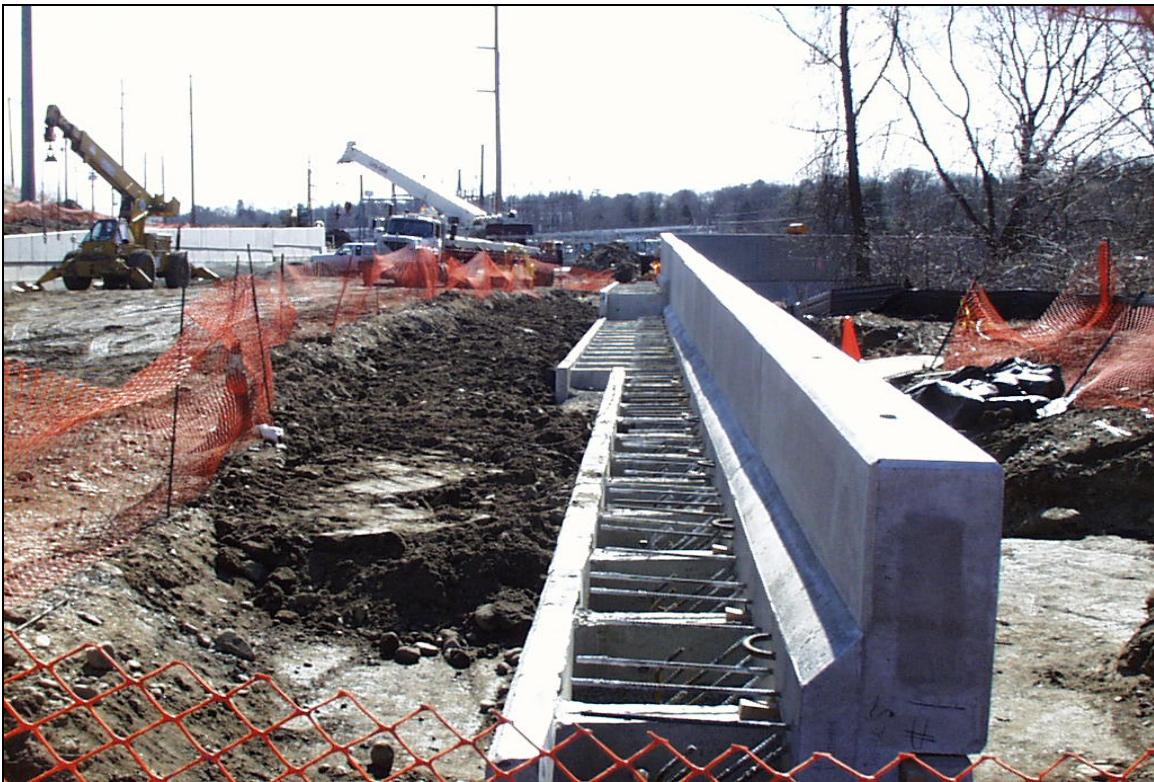
ADDITIONAL VIEWS OF THE RETAINING WALL NEAREST THE RIVERBANK. 2/27/04

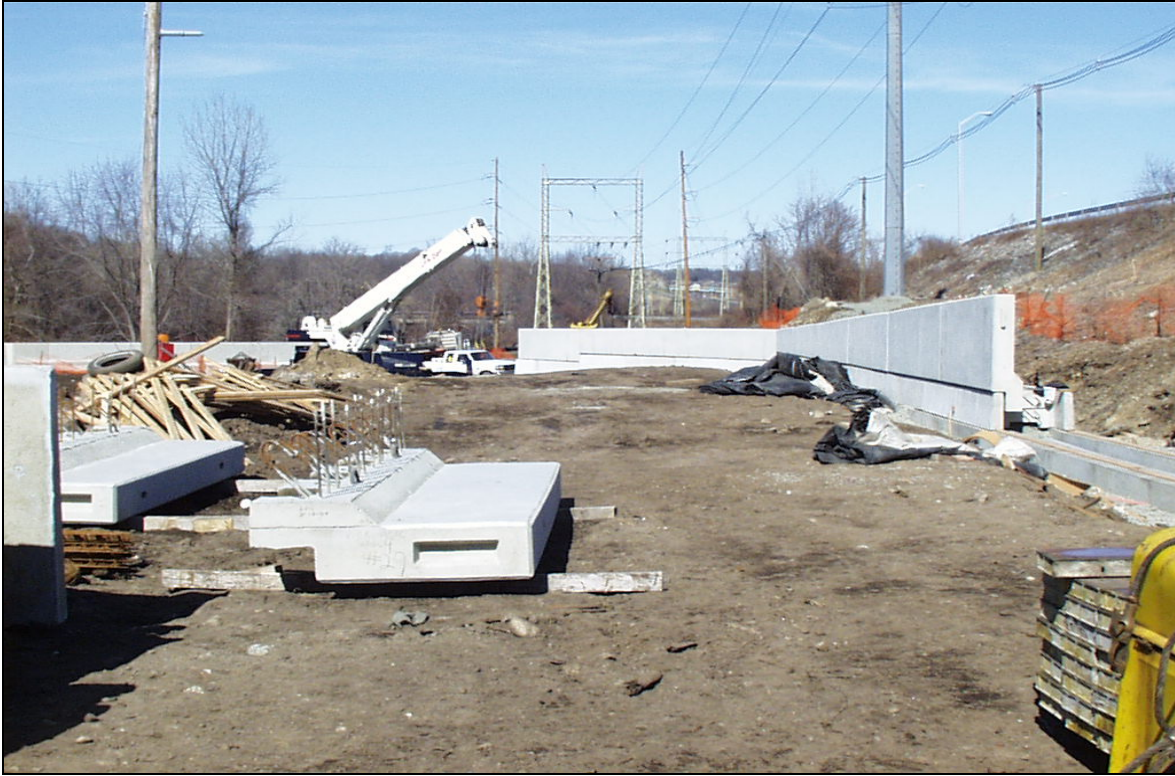
VIEW OF THE SITE AND THE PROGRESS BEING MADE ON OTHER RETAINING WALLS. 2/27/04

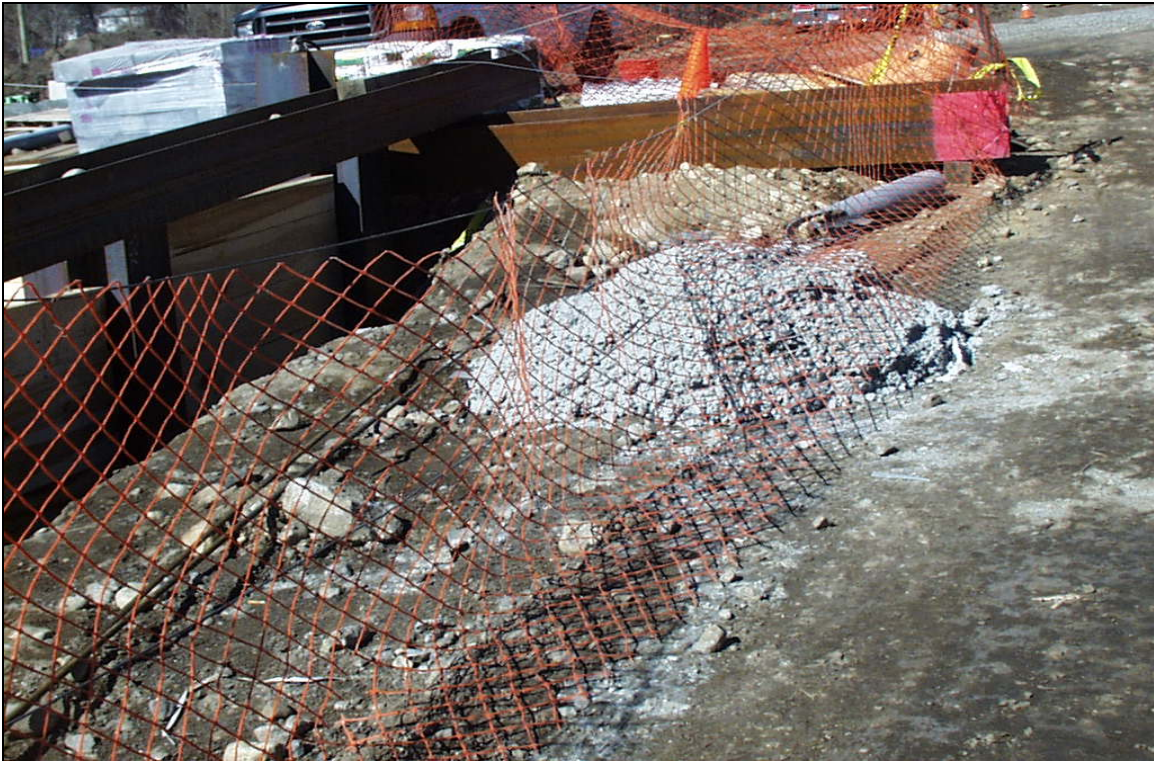
VIEW OF AN AREA WHERE A CONCRETE TRUCK HAD WASHED OUT. WASHOUTS
WILL BE LIMITED TO SEVERAL CONTROLLED AREAS AND WILL NOT BE
ALLOWED TO REACH THE RIVER. 2/27/04

<ul style="list-style-type: none"> - Discussions are ongoing regarding any necessary concrete washouts. No additional concrete was noted at the pervious washout area. A pile of extra concrete was seen up near the trailers but will be disposed or reused. 2/27/04 	<ul style="list-style-type: none"> - Continue to use one or a few fairly contained locations for all concrete washouts. Consider posting a sign or designating the area. Placing a few haybales around the area and possibly plastic sheeting on the ground for easier disposal may be appropriate. 2/20-2/27/04
