**Docket No. 217 – Development and Management Plan Inspection**

Northeast Utilities Service Company Certificate of Environmental Compatibility and Public Need for the construction of a 345-kV electric transmission line and reconstruction of an existing 115-kV electric transmission line between Connecticut Light and Power Company's Plumtree Substation in Bethel, through the towns of Redding, Weston, and Wilton, and to the Norwalk Substation in Norwalk, Connecticut.

**Date:** May 26, 2005

**Location:** Norwalk Substation Expansion

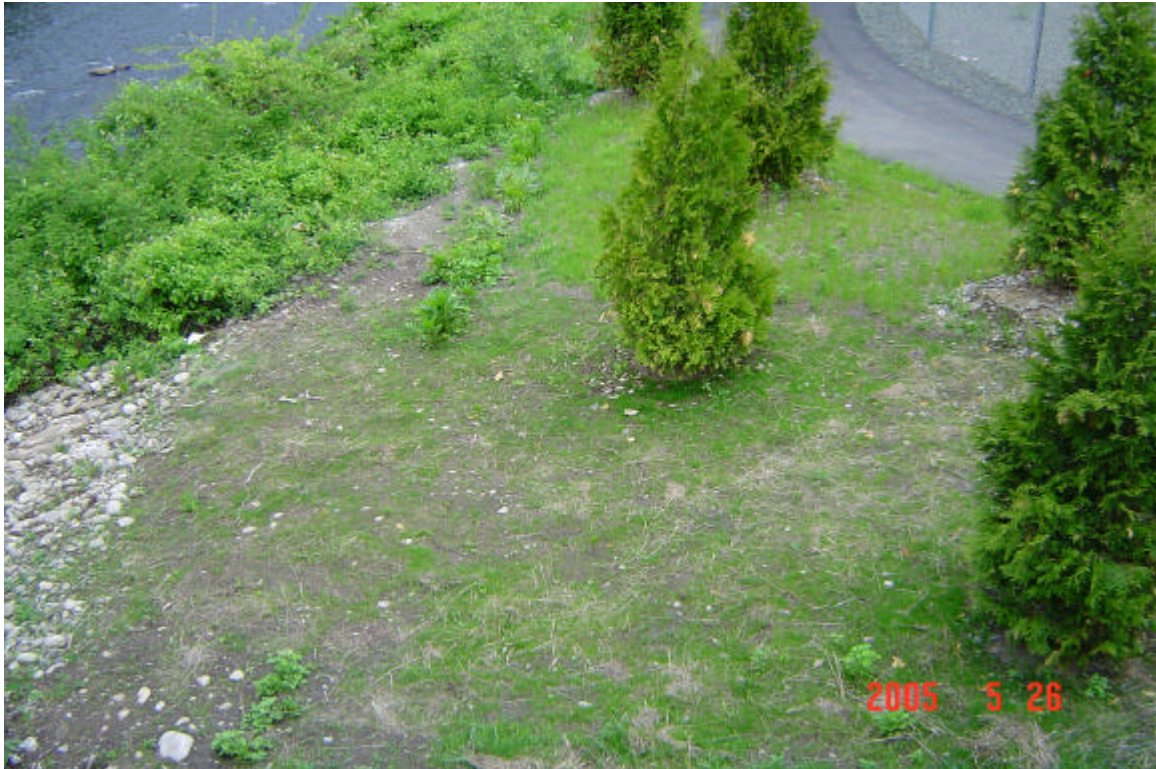
| Areas of Inspection | Observation | Recommended Action |
|---|---|---|
| Additional Observations | - As previously stated, the New Canaan Ave Bridge repair by the DOT is complete. The bank has been stabilized and vegetative growth has increased. 5/26/05 | - The work is unrelated to the Norwalk substation but should be noted as it is occurred in the adjacent area. 4/13-5/26/05 |

Norwalk Substation-Vegetation is increasing at the bank of the river where DOT had recently performed their work. (5/26/05)

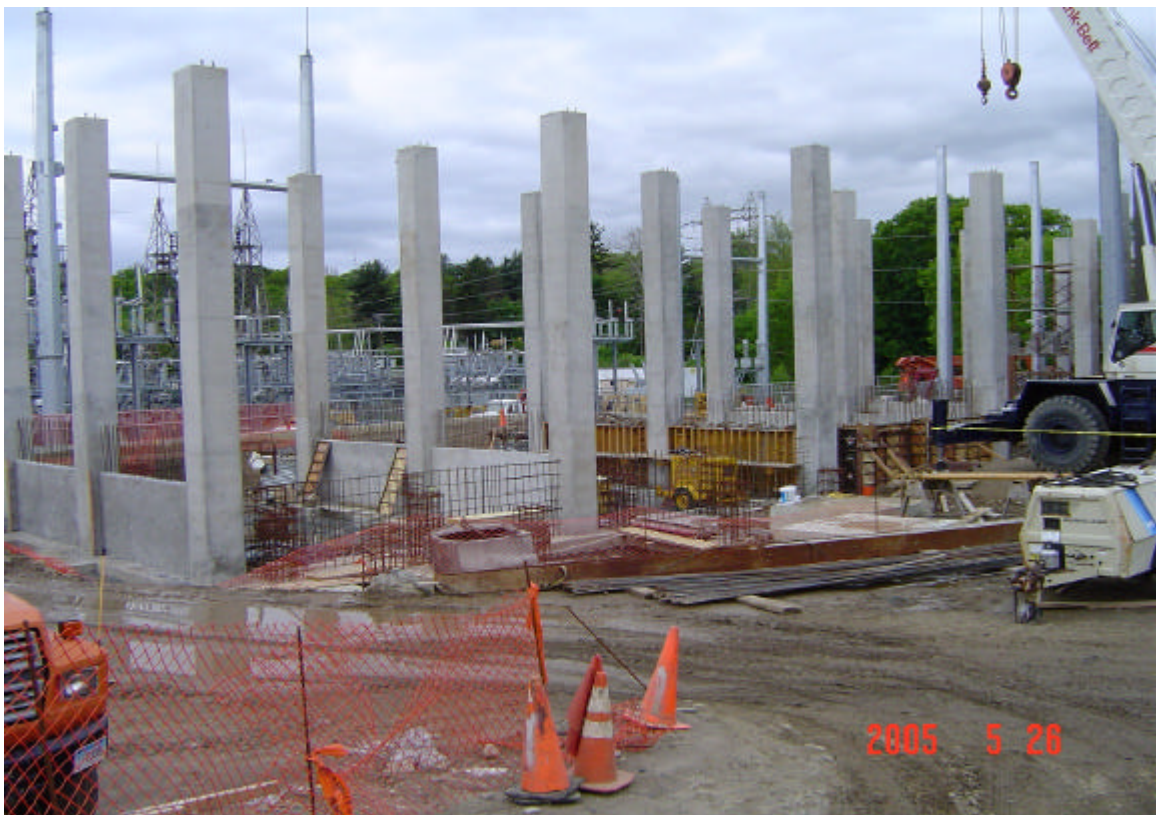
| Areas of Inspection | Observation | Recommended Action |
|---|---|---|
| Foundation construction | <ul style="list-style-type: none"> <li>-Siding work for the GIS building is complete and work is ongoing internally. 4/27-5/26/05</li> <li>-Significant work on the structures and excavation near retaining wall #3 and the control house is ongoing, including below grade framework. 5/26/05</li> </ul> | <ul style="list-style-type: none"> <li>- None at this time. 5/26/05</li> <li>- The excavation and work is well within the yard and areas are contained, no issues at this time. 5/26/05</li> </ul> |

View of the foundation and structure work near the GIS building and retaining wall #3. (5/26/05)

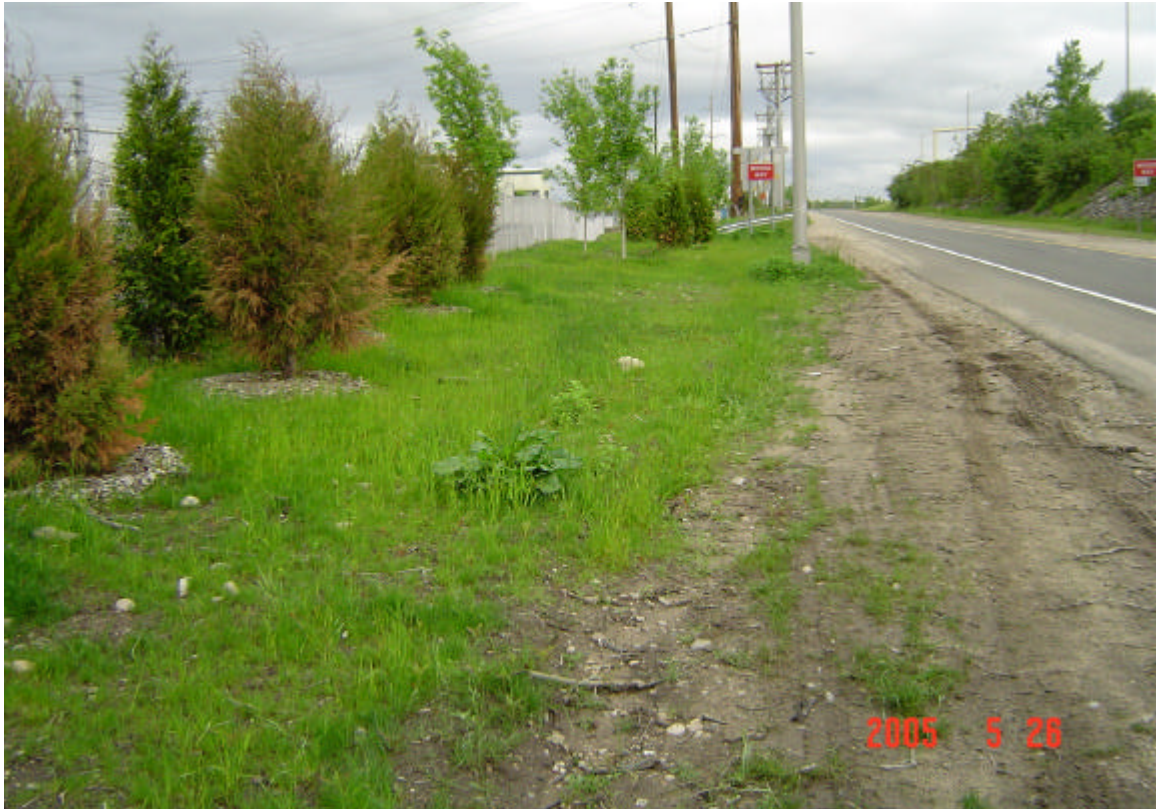
Vegetation is returning along the Rt. 7 ramp and within the earthen swale. (5/26/05)

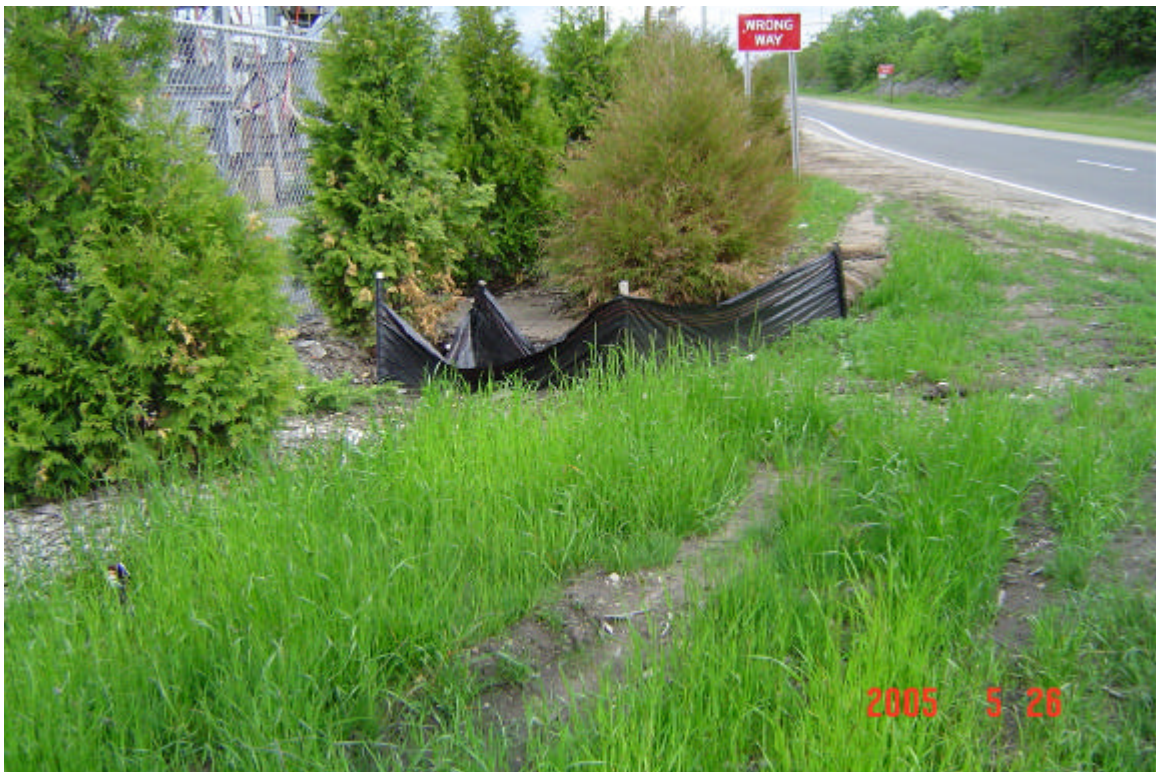
| Areas of Inspection | Observation | Recommended Action |
|---|---|---|
| Access Roads and Adjacent Roadways | <ul style="list-style-type: none"> <li>- Erosion at the base of the silt fence near the inlet near the Route 7 ramp has uncovered the base of the evergreen planting here. 5/13-5/26/05</li> <li>- Although vegetative cover has increased, some minor repair of erosion within the earthen swale may be necessary. 5/4-5/26/05</li> <li>- Grass growth continues to increase at the DOT disturbance area on the riverbank. It will continue to be monitored. 5/4-5/26/05</li> </ul> | <ul style="list-style-type: none"> <li>-The volume of water going to this inlet is causing erosion at the base of the silt fence. Soil should be placed here to cover up the exposed root ball of the planting. The area should be repaired/regraded. 5/26/05</li> <li>- Grass growth continues to increase here and will help to stabilize the area but it will potentially require additional stabilization. 5/26/05</li> <li>- DOT's work is not associated with the project but is mentioned as a potential source of off-site sediment. It will be monitored for stabilization. 5/26/05</li> </ul> |

| Areas of Inspection | Observation | Recommended Action |
|---|---|---|
| | - The flared inlet near the Rt 7 ramp is receiving obvious stormwater flows from off site roadway and on site sources. It is apparent that much of the sediment is roadway sand and much of the runoff is from the street based on presence of gullies.<br>- Vegetative growth is increasing here and will help with stabilization but the root ball of one of the evergreen plantings remains exposed due to the erosion. 5/13-5/26/05 | - Continue to monitor until stabilized as the vegetative cover is not yet uniform. Part of the sedimentation is from offsite street runoff which cannot be controlled by onsite actions. 5/26/05<br>- The area around the exposed root ball should be filled in with soil to protect the planting. The eroded area around the silt fence should be regraded/repared. 5/13-5/26/05 |

Vegetation is returning around the inlet however, erosion at the base of the silt fence is still occurring. (5/26/05)

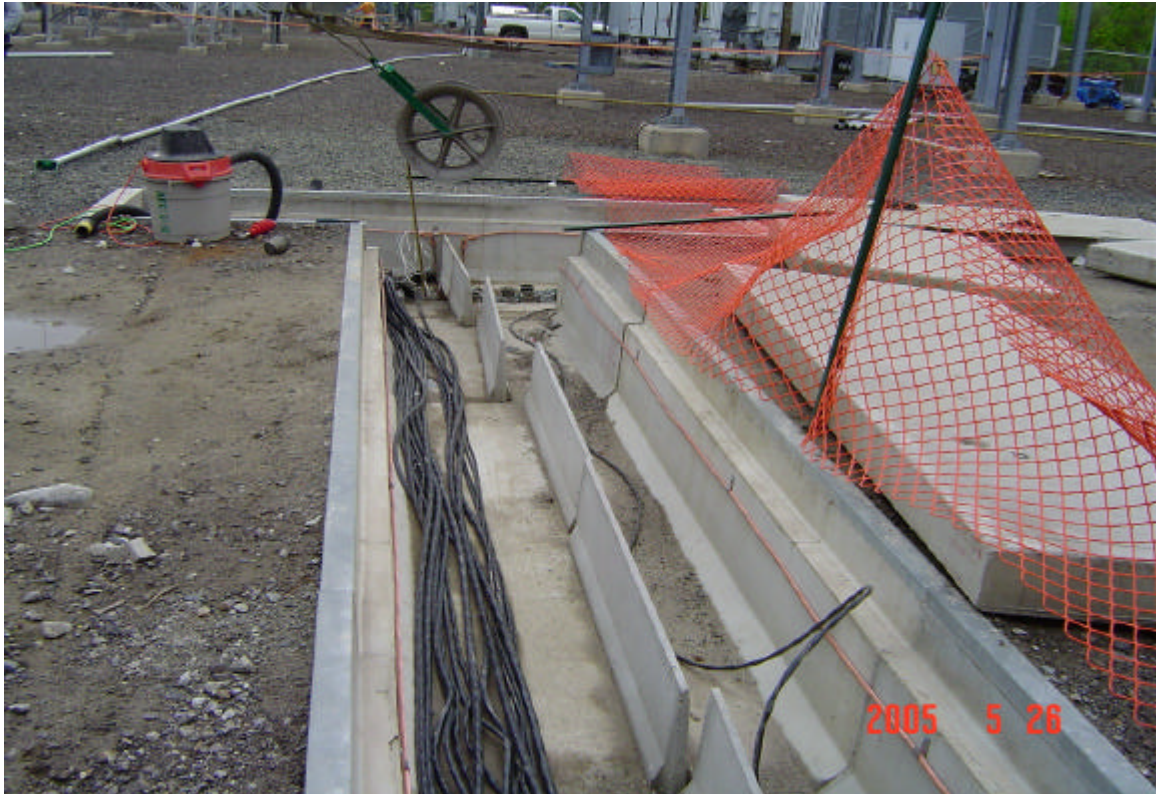
| Areas of Inspection | Observation | Recommended Action |
|---|---|---|
| Foundation construction | -The major work of connecting the equipment on the constructed slab to the existing equipment is on-going. 3/23-5/26/05<br>- The trenches have remained open and underground cable pulls were ongoing in several locations at the time of the inspection. No soil movement is involved due to the concrete lids. 5/18-5/26/05 | - The areas are all contained at this time and there is little ongoing work that involves soil disturbance. 4/6-5/26/05 |

Plumtree Substation- Cable is being pulled in the trenches surrounding the slab. (5/26/05)

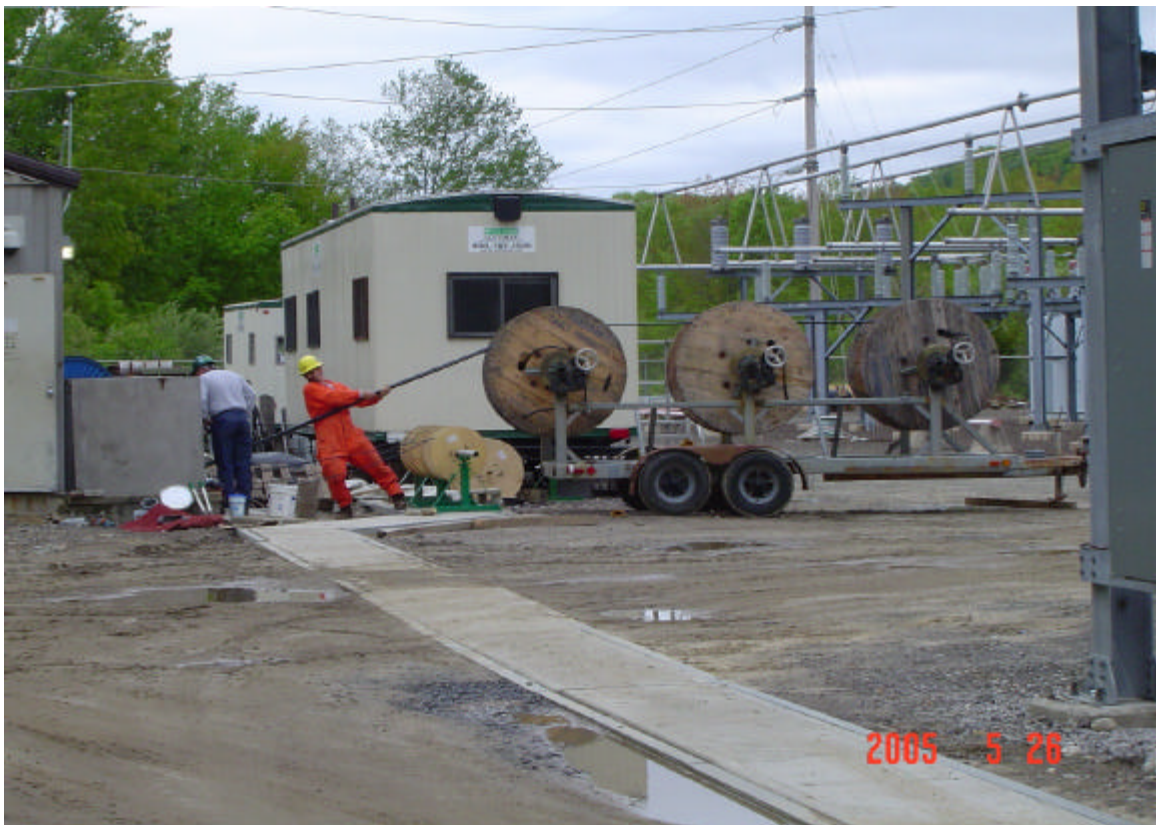
Active cable pulling is occurring in several locations throughout the site. (5/26/05)
