**Docket No. 217 – Development and Management Plan Inspection**

**Date:** August 19, 2005

**Inspector:** Diana Walden

**Location:** Norwalk Substation Expansion

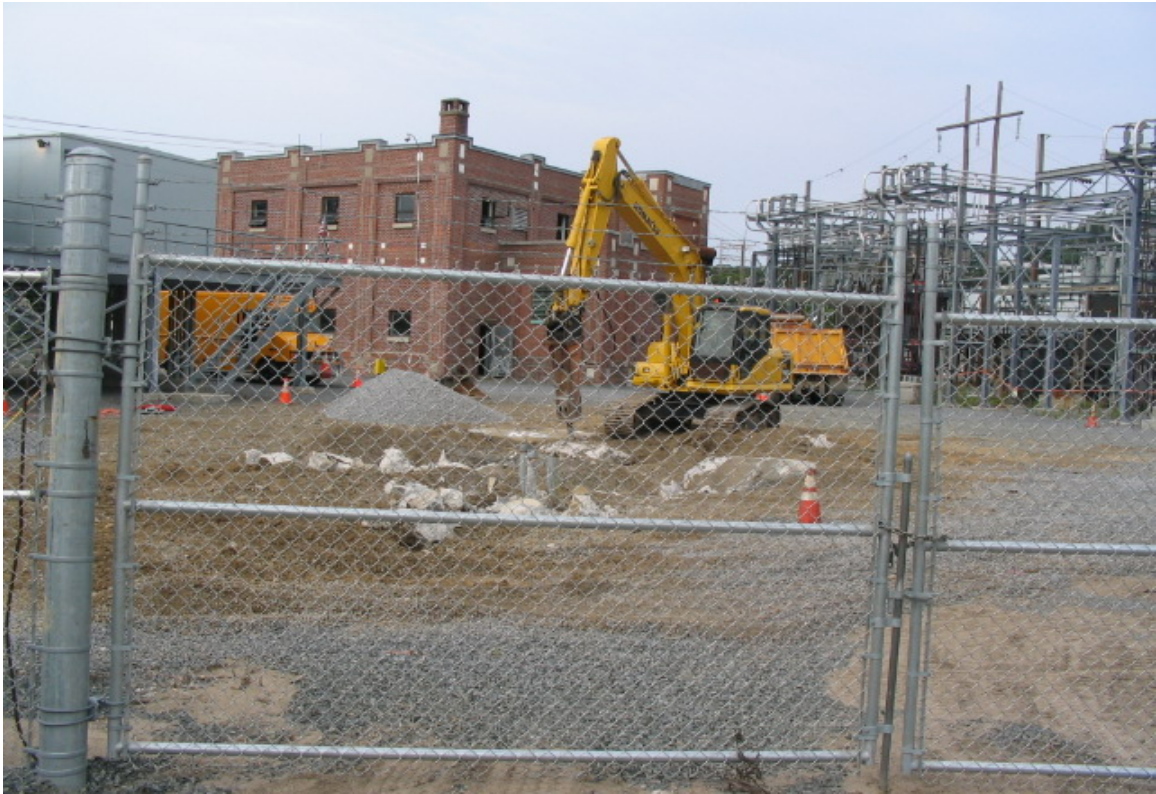
Norwalk Substation: Excavation and breaking up and removal of concrete continues within the live yard. (8/19/05)

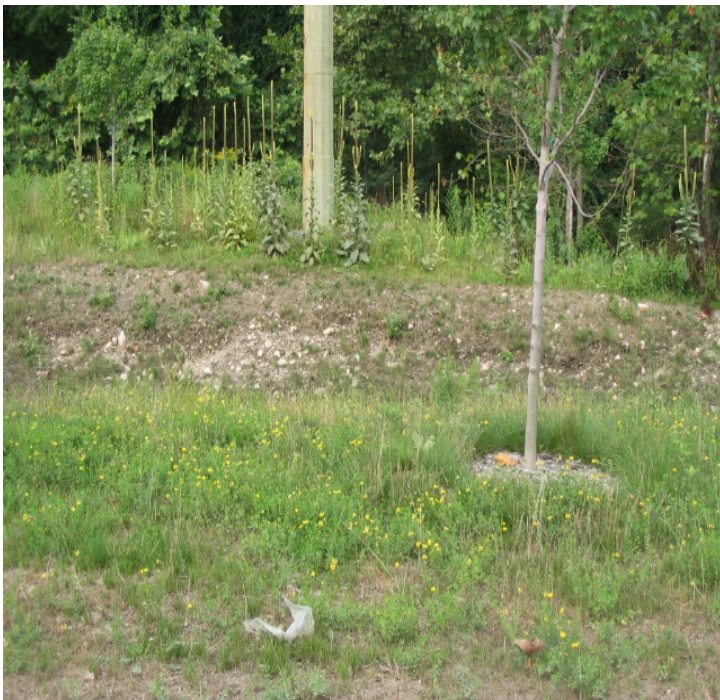
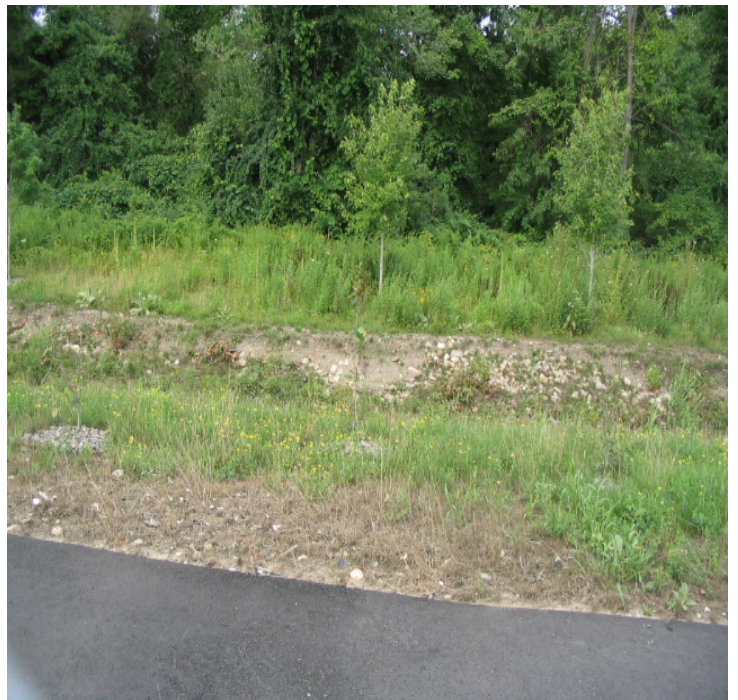
Areas of Inspection	Observation	Recommended Action
Erosion and Sediment Controls (includes inspection within 24 hours of a storm event)	-Some bare/sparse areas of vegetation remain along the sides of the channel. 7/22-8/19/05.	- These areas will be seeded outside of the dry summer period so the vegetation will have a better chance to establish. 8/19/05

View of several areas along the overflow channel where vegetation has not returned sufficiently. The slopes will be reseeded following the dry period of the summer to ensure better results. (8/19/05)

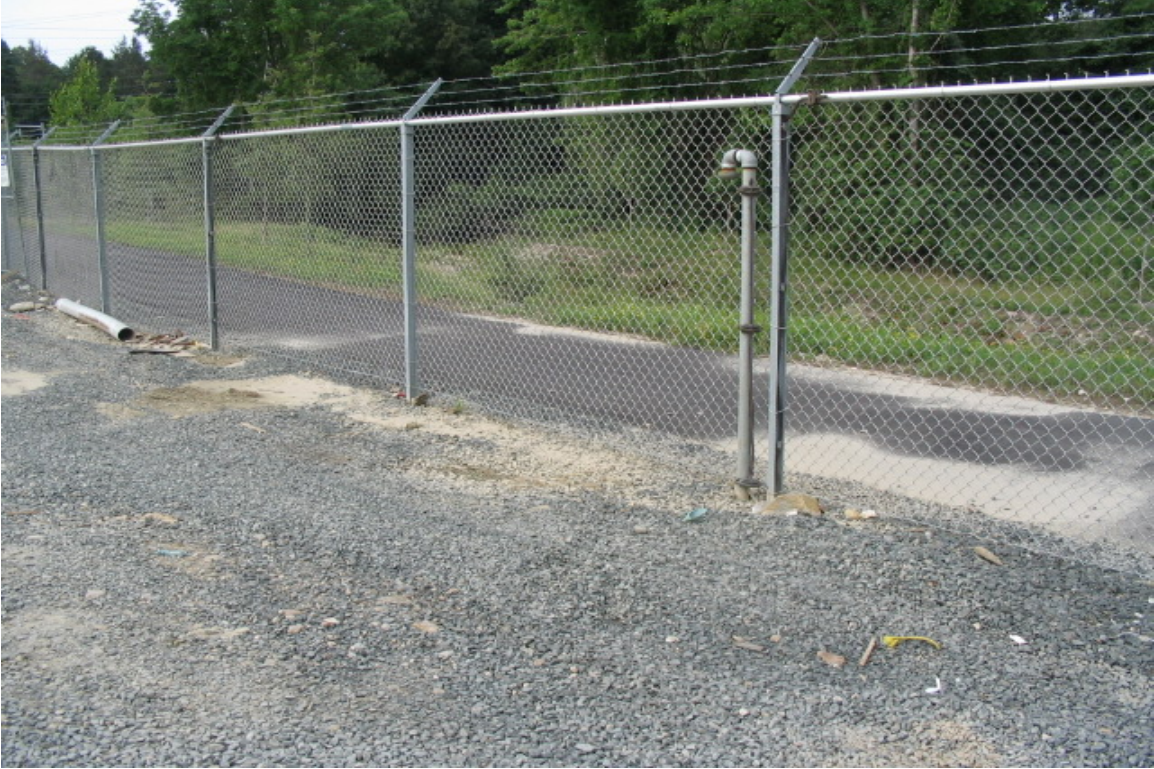
The yard has some slight sedimentation on to the bike path from the access road. The stone berm should be continued to help keep sediment on site. (8/19/05)

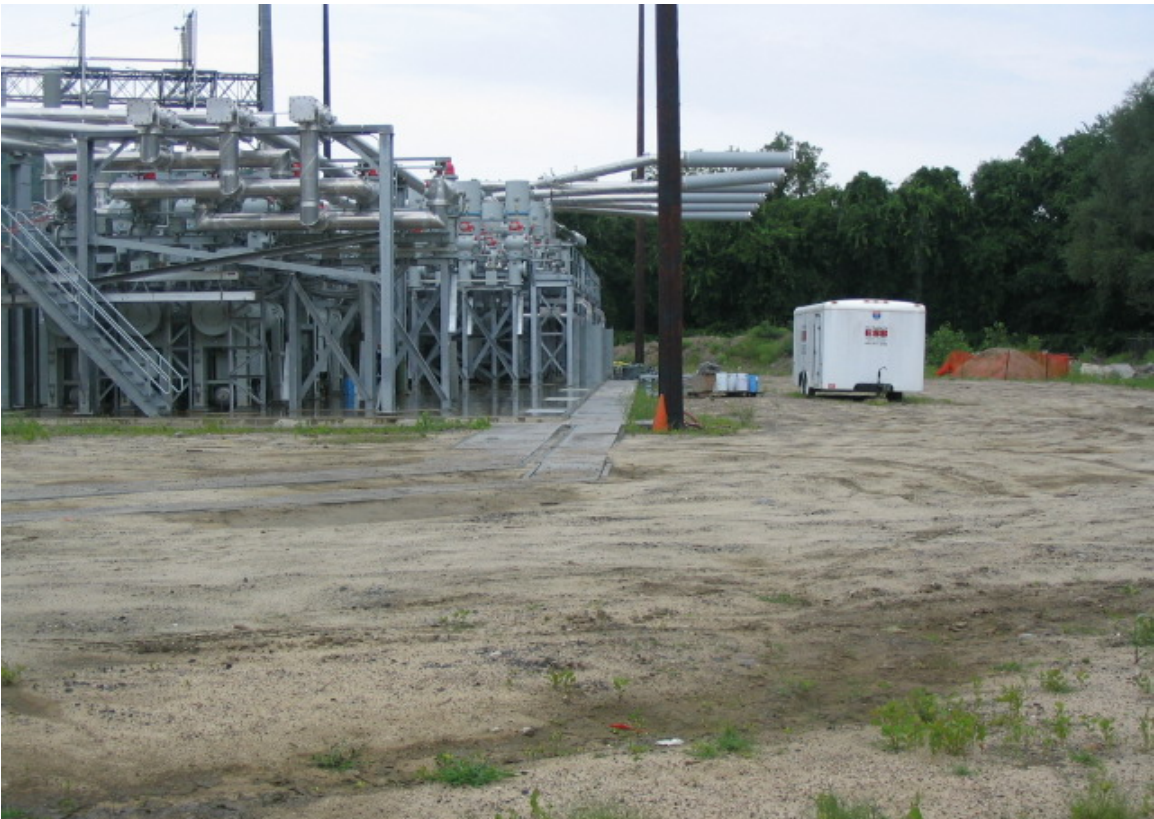
Plumtree Substation: General view of the site. No soil disturbing activities have been occurring. (8/19/05)
