**Docket No. 217 – Development and Management Plan Inspection**

Northeast Utilities Service Company Certificate of Environmental Compatibility and Public Need for the construction of a 345-kV electric transmission line and reconstruction of an existing 115-kV electric transmission line between Connecticut Light and Power Company's Plumtree Substation in Bethel, through the towns of Redding, Weston, and Wilton, and to the Norwalk Substation in Norwalk, Connecticut.

**Date:** September 1, 2005

**Location:** Norwalk Substation Expansion

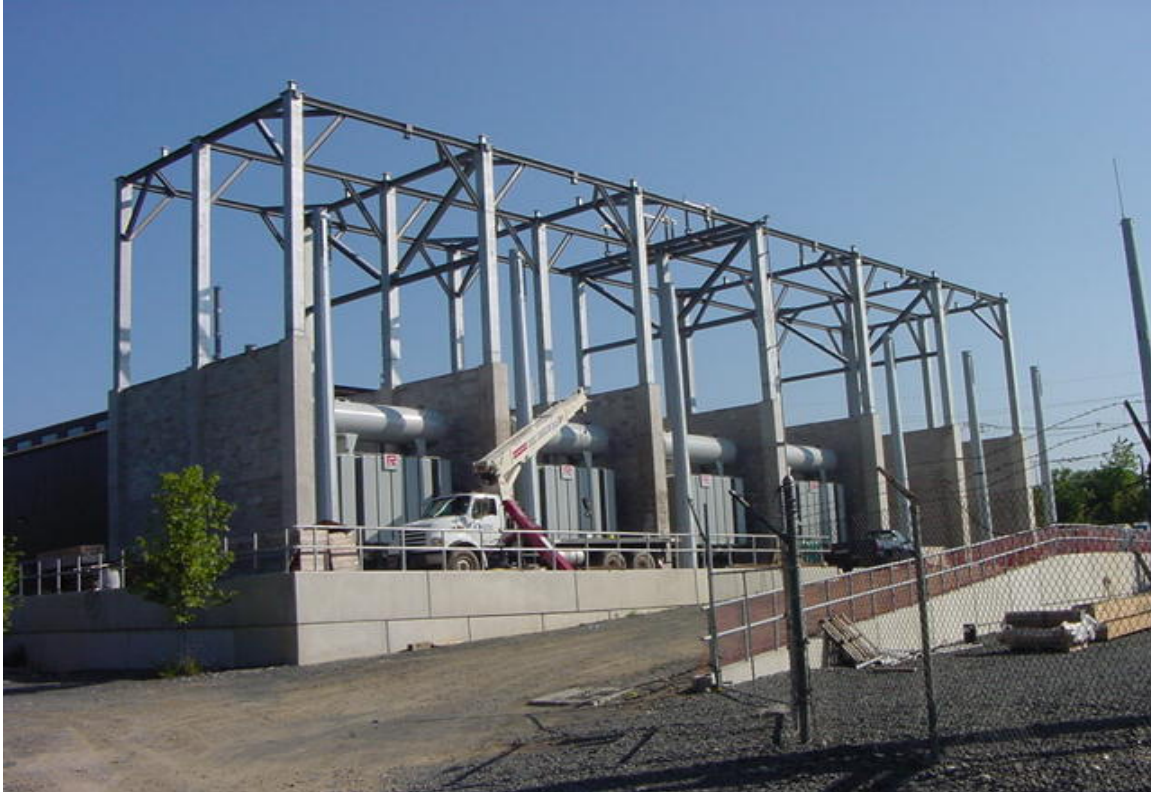
Norwalk Substation: Work continues on the transformers and equipment adjacent to the GIS building. (9/1/05)

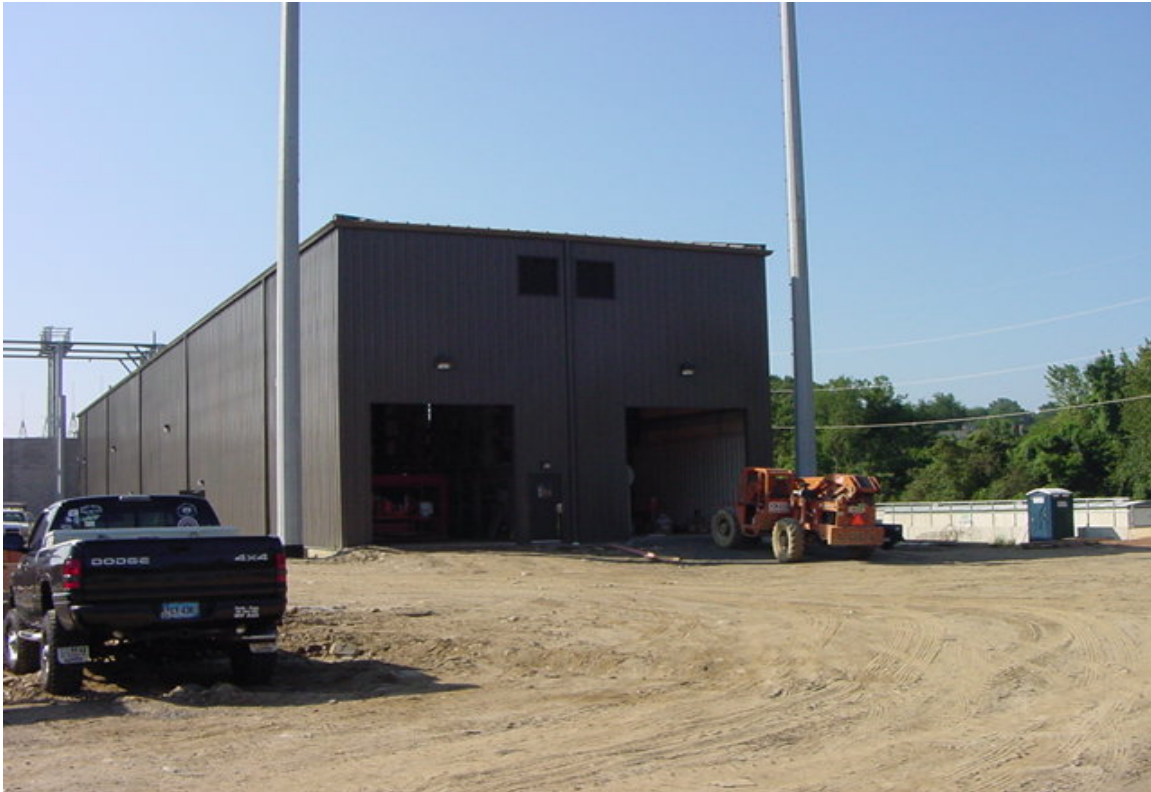
View of the back of the GIS building where work is ongoing, placing the equipment inside. (9/1/05)

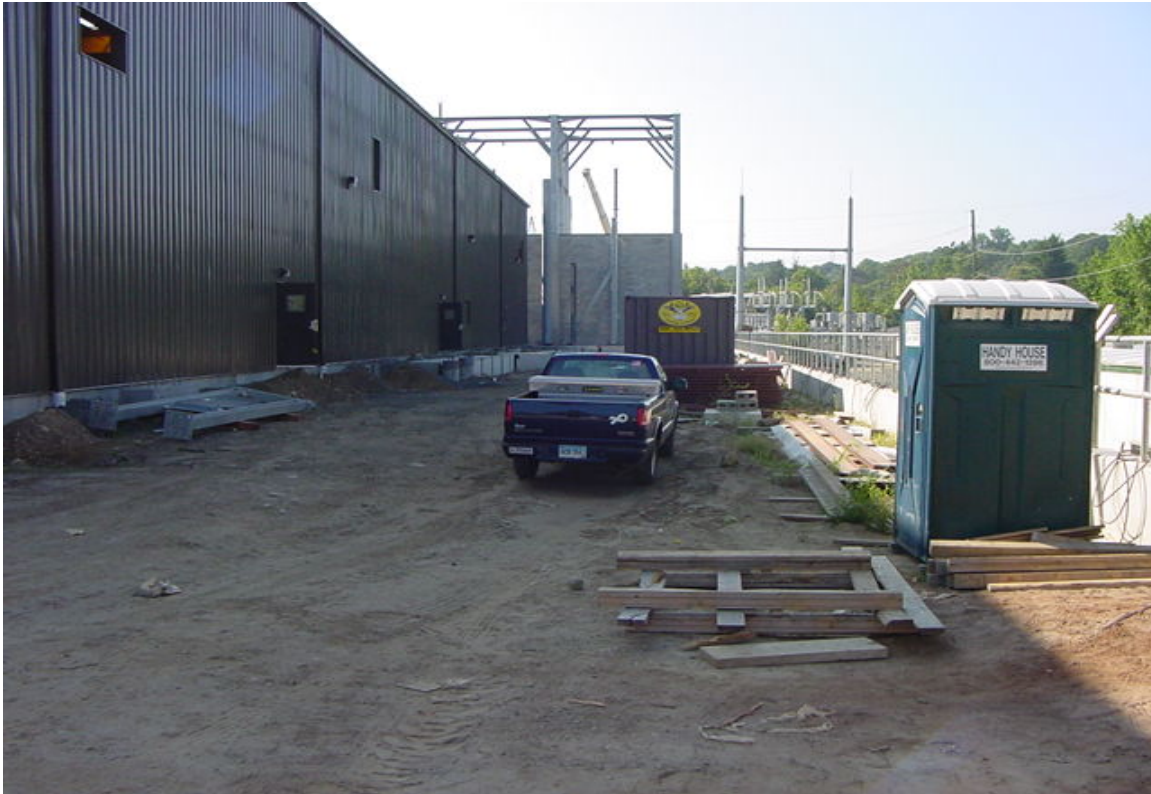
Work on the concrete cable boxes/trays continues around the GIS building while cable is being pulled within the yard. (9/1/05)

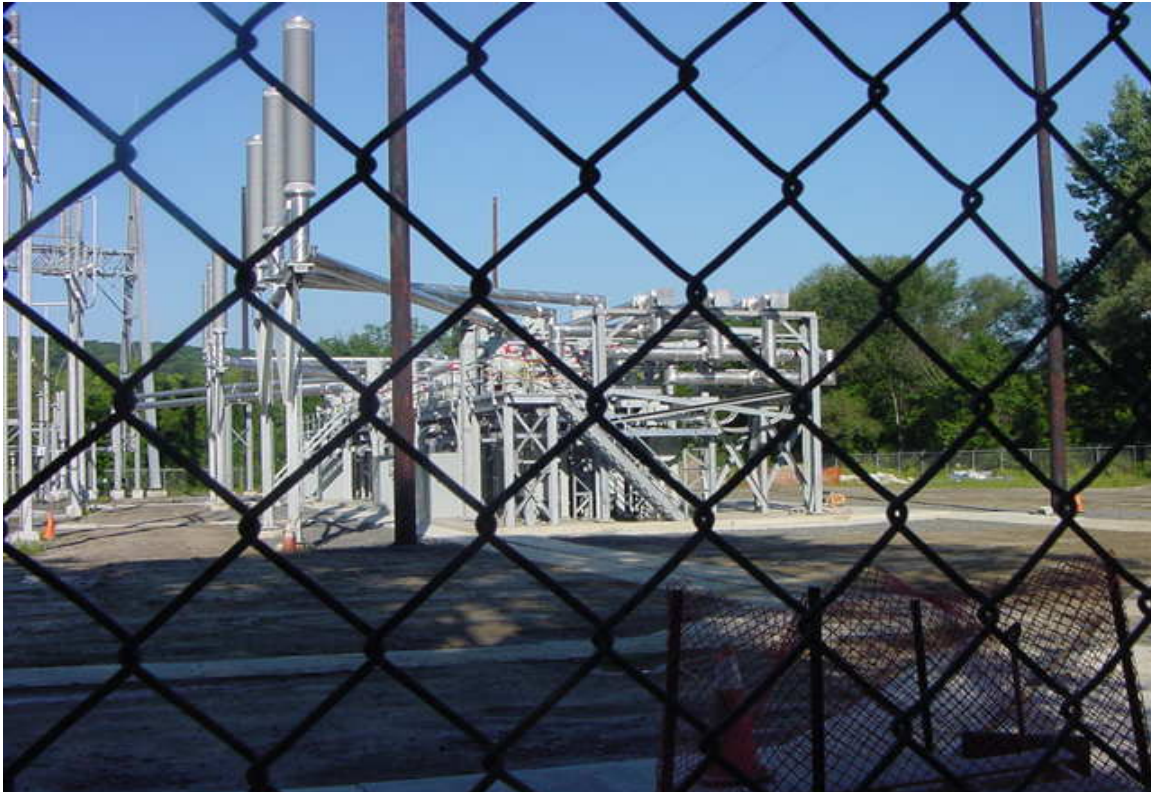
Plumtree Substation: General view of the site from the perimeter fence. No soil disturbing activities have been occurring. (9/1/05)
