Docket No. 217 – Development and Management Plan Inspection

Northeast Utilities Service Company Certificate of Environmental Compatibility and Public Need for the construction of a 345-kV electric transmission line and reconstruction of an existing 115-kV electric transmission line between Connecticut Light and Power Company's Plumtree Substation in Bethel, through the towns of Redding, Weston, and Wilton, and to the Norwalk Substation in Norwalk, Connecticut.

Date: September 16, 2004

Location: Norwalk Substation Expansion

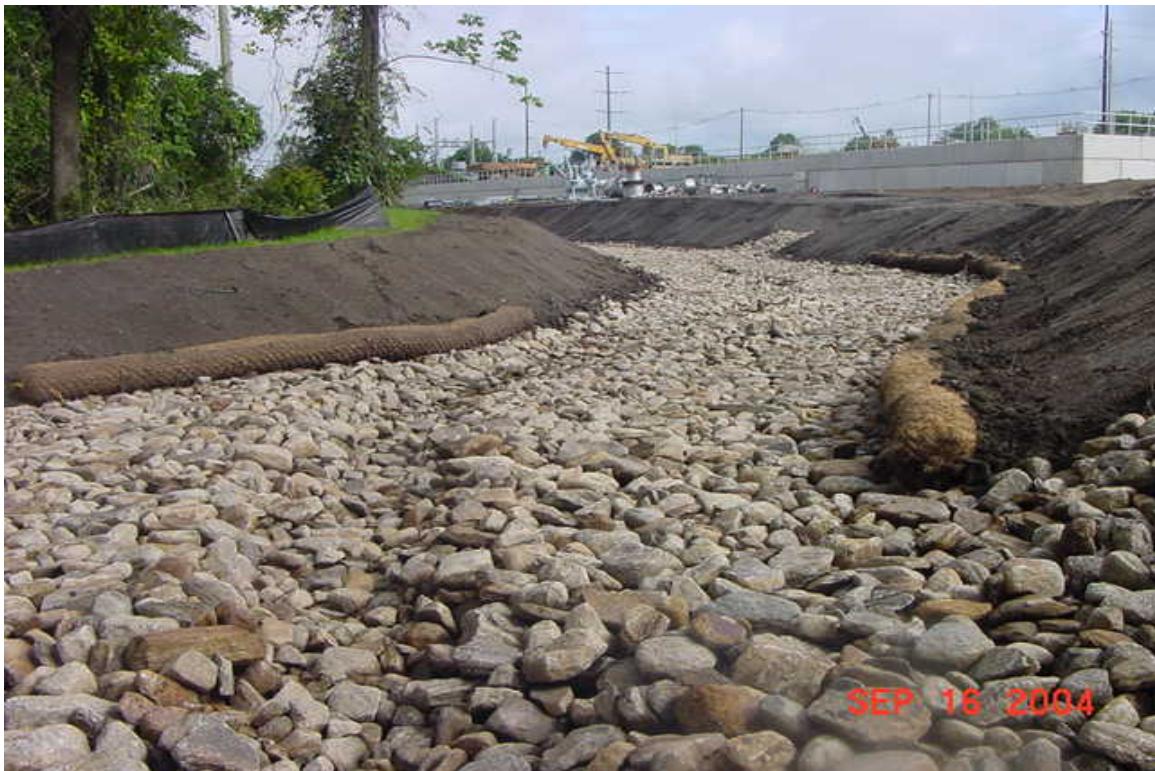
<ul style="list-style-type: none"> -Some areas adjacent to the overflow channel still have fairly sparse vegetative cover. 8/12-9/16/04 	<ul style="list-style-type: none"> -Getting seed and cover to establish here will be important before the growing season is over. 8/26-9/16/04
Inland Wetland and Watercourse encroachment and mitigation	<ul style="list-style-type: none"> - Most areas have sufficient vegetative cover but a few areas remain sparse. The area adjacent to the channel especially requires stabilization as the storms cause some erosion here. 9/10/04 	<ul style="list-style-type: none"> - Continue to monitor silt fence and repair as necessary, especially in the portions closest to the river. 9/10/04
State species of concern, threatened and endangered species	<ul style="list-style-type: none"> - No species of concern are located in this area of construction. 	<ul style="list-style-type: none"> - N/A

View of the overflow channel following placement of topsoil and seed on the sides and banks of the channel. The biologs remain in place here. 9/16/04

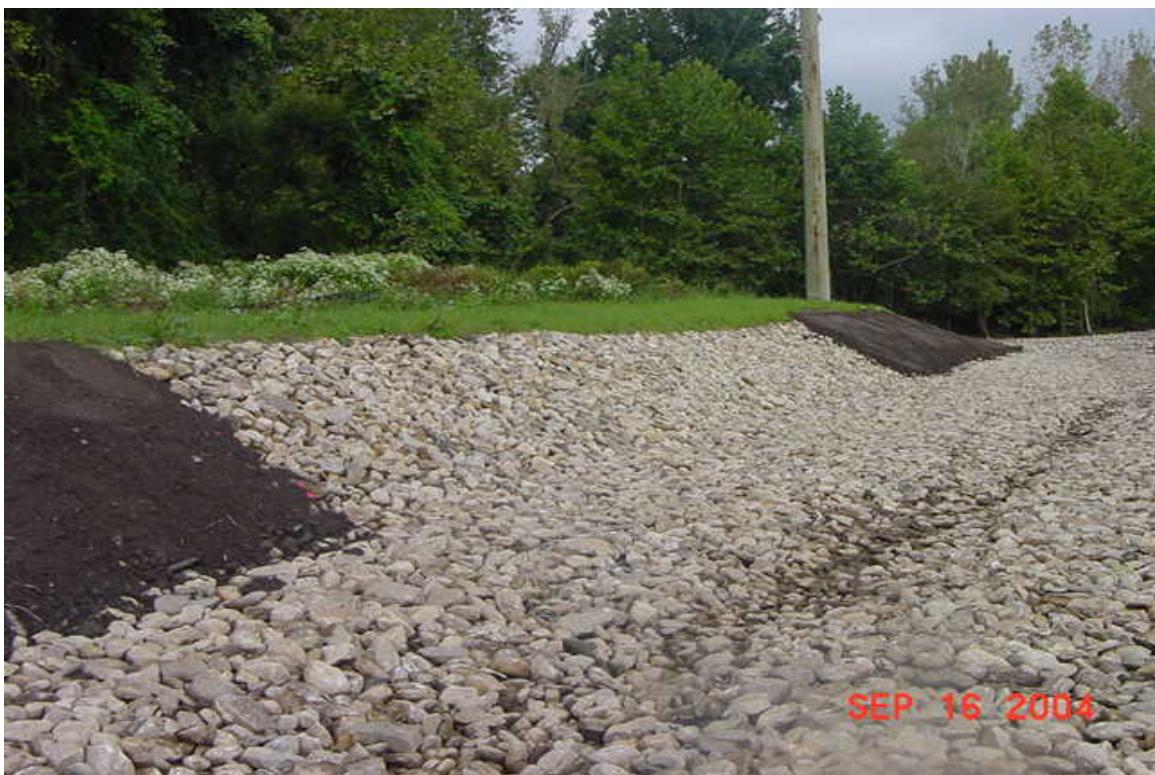
Portions of the channel will remain with bare stone as according to the approved plans. 9/16/04

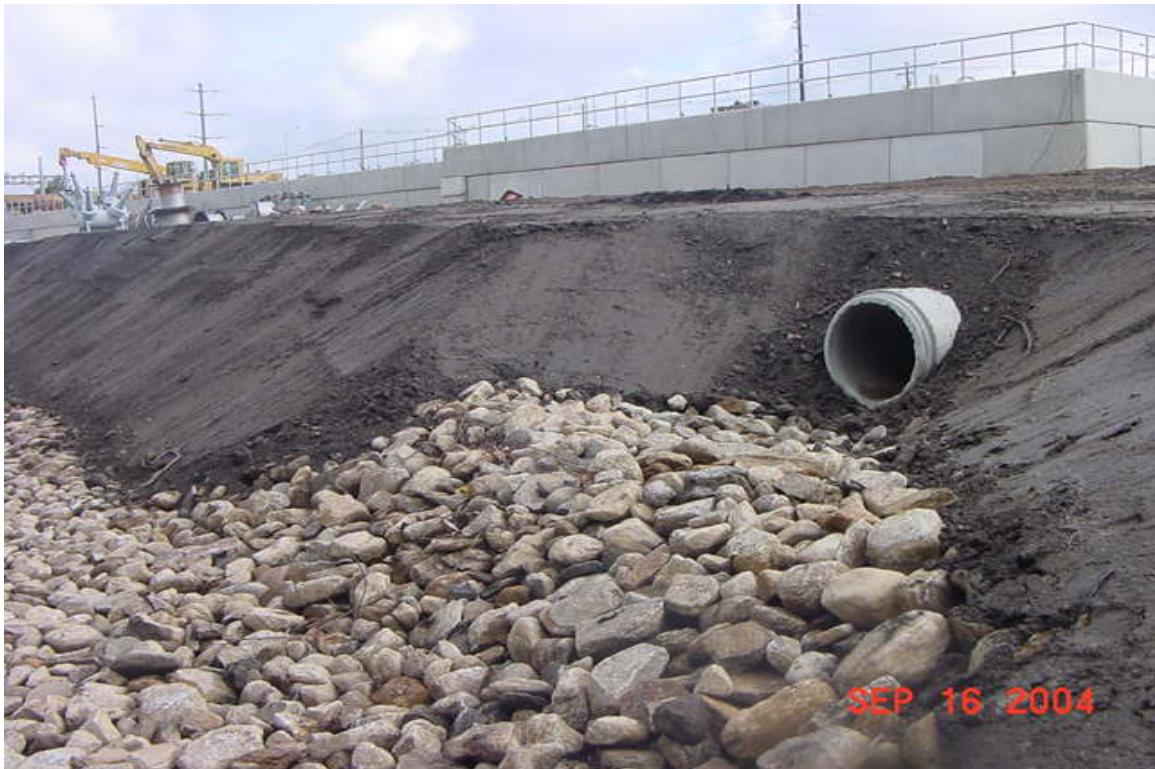
View of the outlet at the overflow channel following placement of topsoil. The catch basin inlet to this pipe is not yet at grade or active. 9/16/04

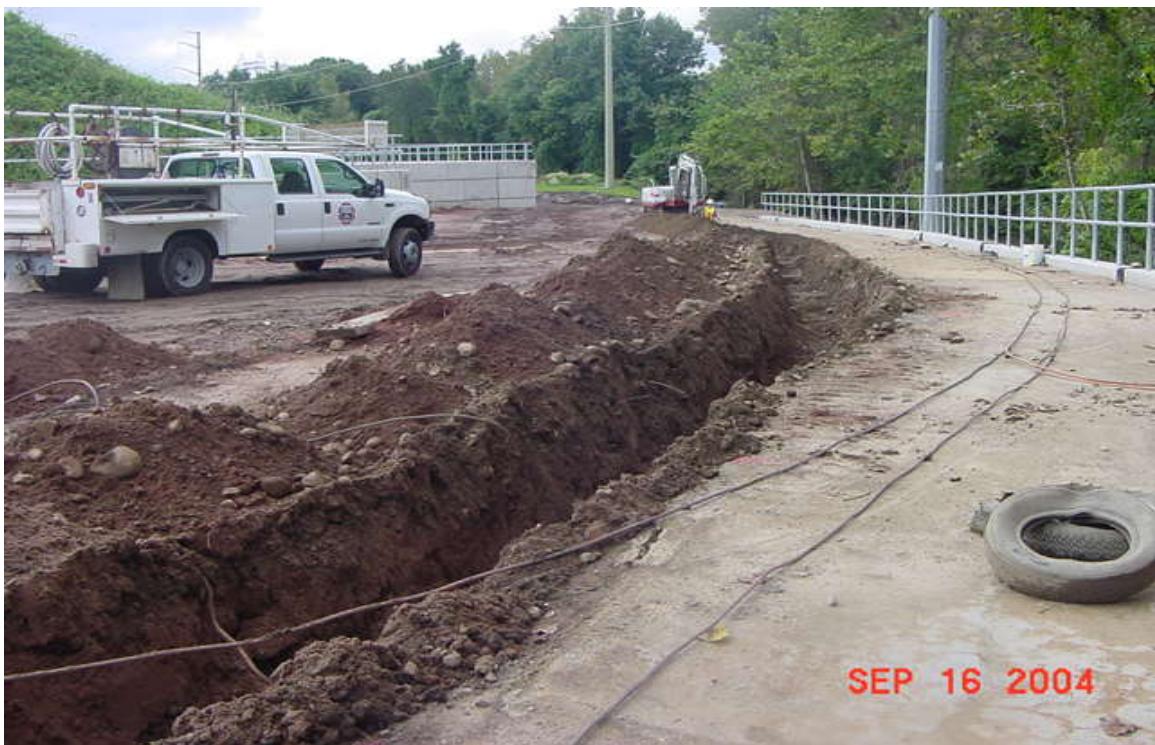
Areas of Inspection	Observation	Recommended Action
Erosion and Sediment Controls continued	<ul style="list-style-type: none"> - The area adjacent to the bike path in the northern portion of the site is being excavated for placement of a fence. 9/16/04 	<ul style="list-style-type: none"> - The area is contained at this time but with recent tendencies for sheet flow to wash down the bike path, a check dam should be placed here following construction. 9/16/04
	<ul style="list-style-type: none"> - The topsoil stockpile remains well contained along the retaining wall and fill activities continue to the east of wall #2. 6/30-9/16/04 	<ul style="list-style-type: none"> - The pile will continue to be used where necessary in areas to be grassed in the future and all soil is well contained. 6/30-9/16/04
	<ul style="list-style-type: none"> -Topsoil and seed have been placed along most portions of the sides and banks of the overflow canal as shown on approved plans. Coconut biologs remain in place below the soil. 9/16/04 - The amount of seed appeared conservative and it might be necessary to reseed depending on results. 9/16/04 	<ul style="list-style-type: none"> - Vegetative cover should be established on the area adjacent to the channel as soon as possible to help minimize erosion. 9/16/04

View of excavation in progress along the bike path at the northern end of the site. A fence will be installed here. 9/16/04

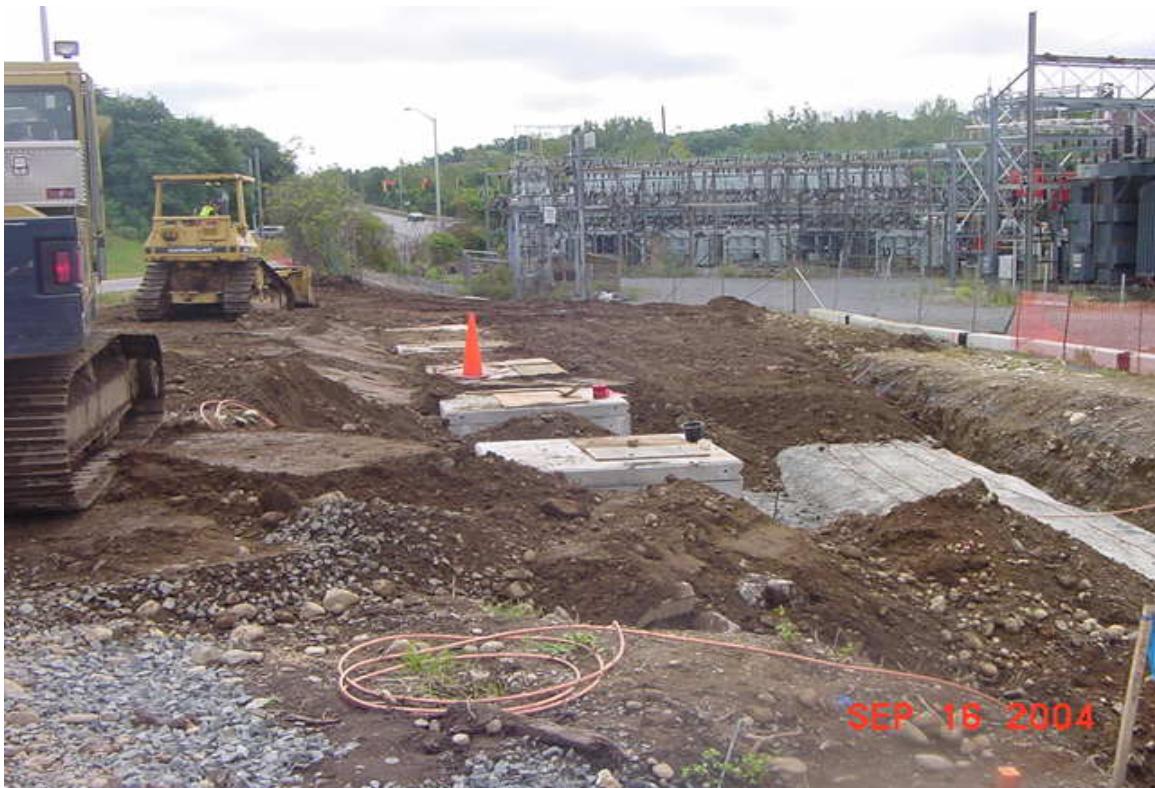
View of form footings near the control building. The conduit bank has also been covered in concrete and are being backfilled. 9/16/04

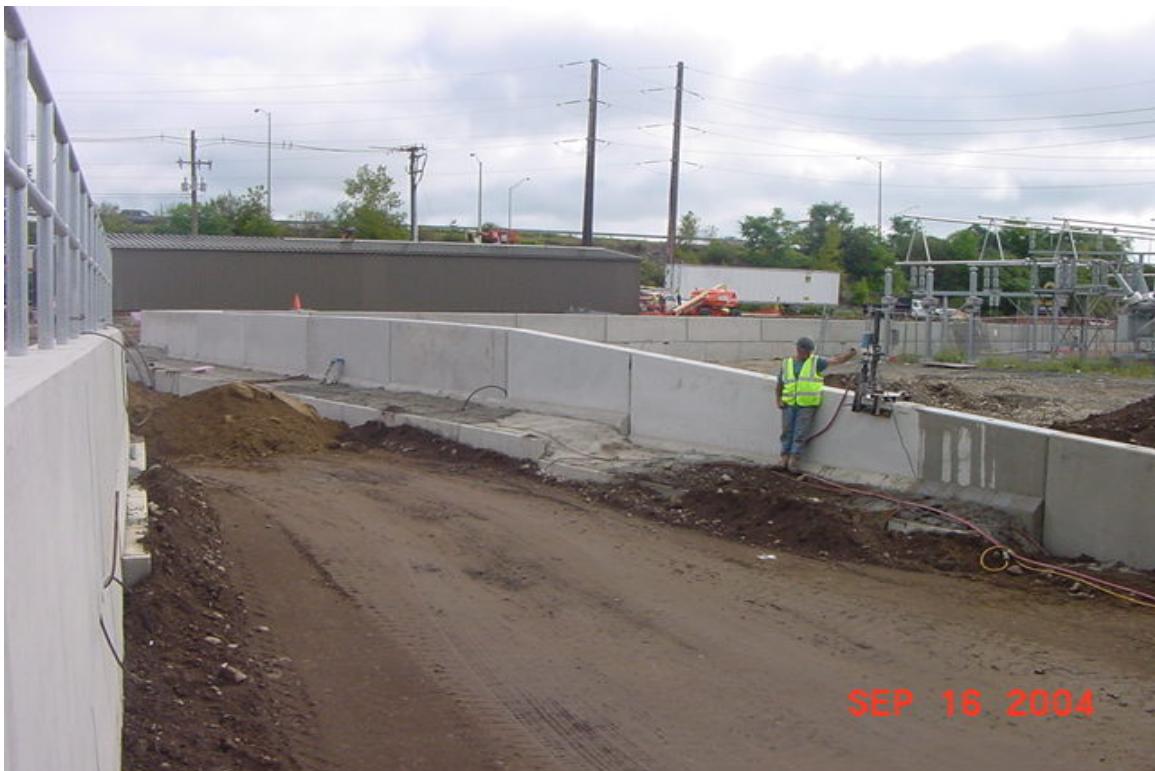
Retaining wall #3 is nearly completed with only superficial (railing installation) work remaining. The control building is seen in the background of the picture. 9/16/04

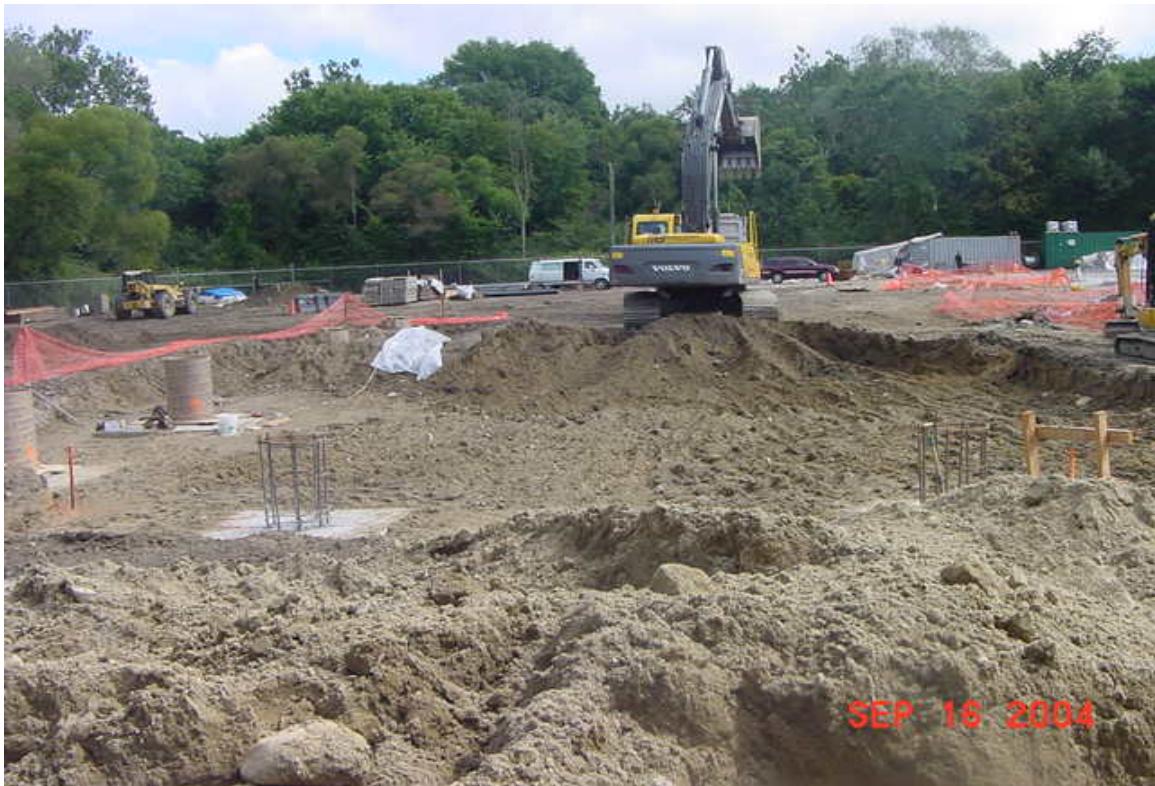
Areas of Inspection	Observation	Recommended Action
Access Roads	- No new access roads have been constructed at this time 9/16/04	- None at this time. 9/16/04
Foundation construction	-Footing excavation and construction continues and more significant excavation has started on the GIS building foundation. 9/16/04 - Soil is being actively hauled off site at this time. Remaining excavate is being combined into stockpiles for backfill and covered. 9/16/04	- The areas are well contained at this time. 9/16/04
Erosion and Sediment Controls (includes inspection within 24 hours of a storm event)	- The site is drying out to some degree but dewatering continues. All areas remains contained on site 9/16/04	- None at this time 9/16/04

Plumtree Substation: View of the excavation for the GIS concrete pad. Soil is being hauled off site and the remainder is being stockpiled. 9/16/04

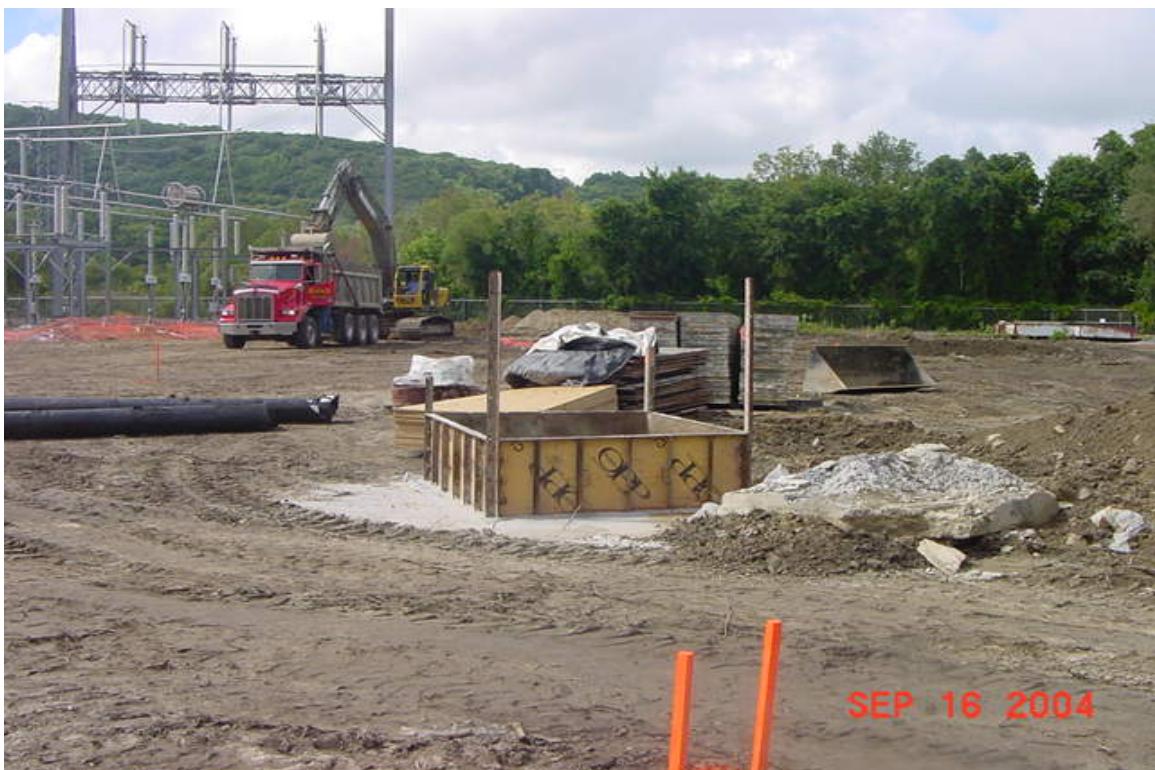
Overall view of the yard including the concrete washout station and soil being loaded into a truck to be hauled off site. 9/16/04
