Docket No. 217 – Development and Management Plan Inspection

Date: September 21, 2005

Location: Norwalk Substation Expansion

Location: Plumtree Substation Expansion, Bethel

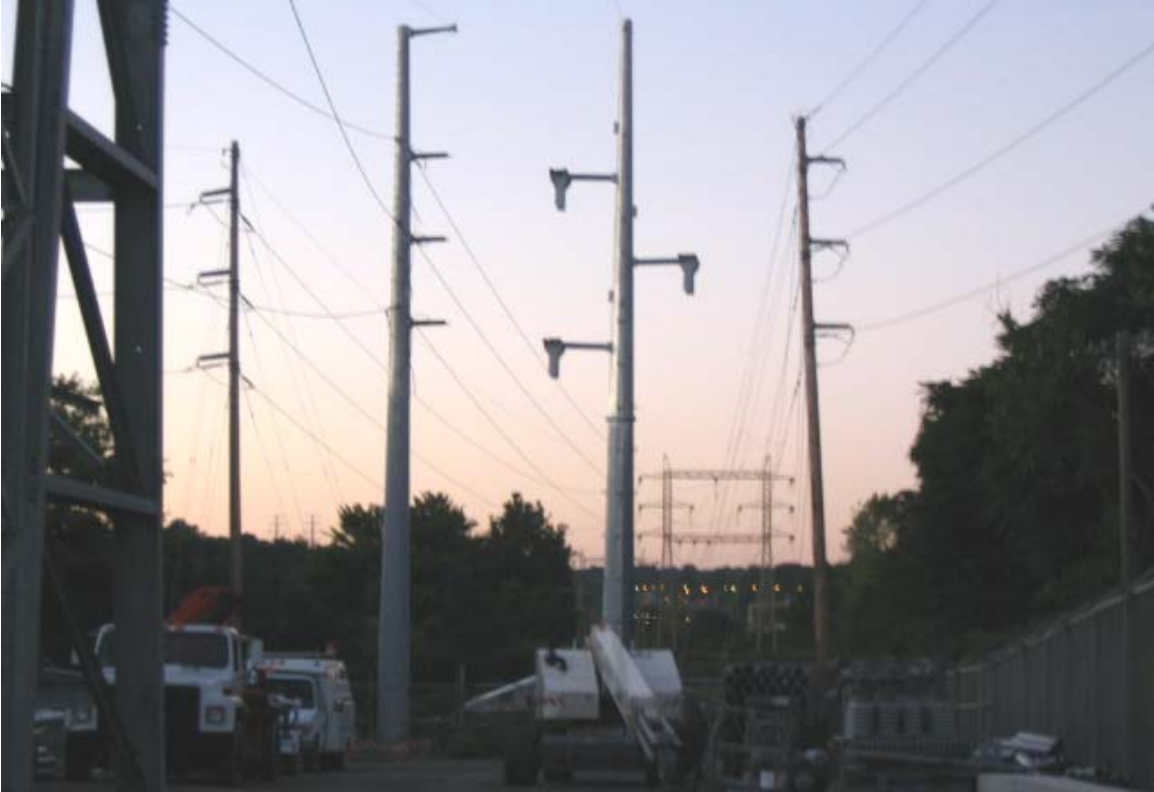
Norwalk Substation: View of the newly installed/constructed 986 and 987 structures at the edge of the ROW at the northern end of the substation. (9/21/05)

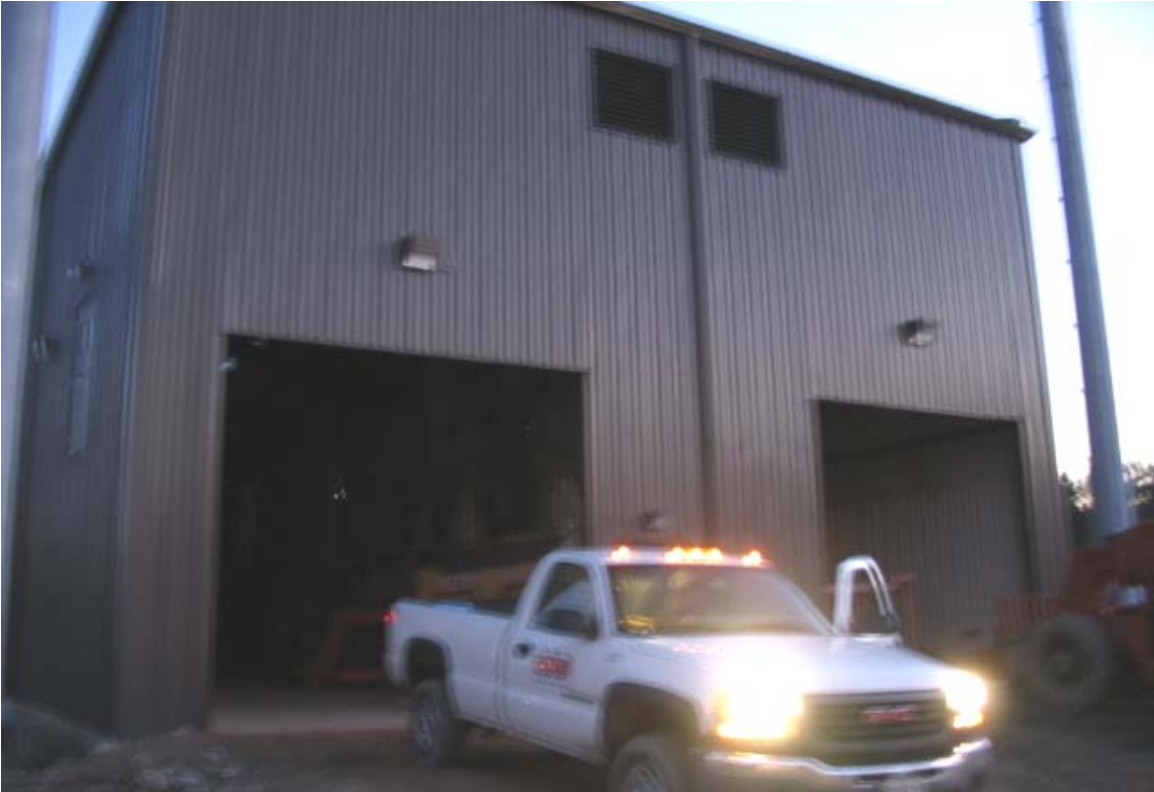
View of the back of the GIS building where installation of equipment is ongoing. (9/21/05)

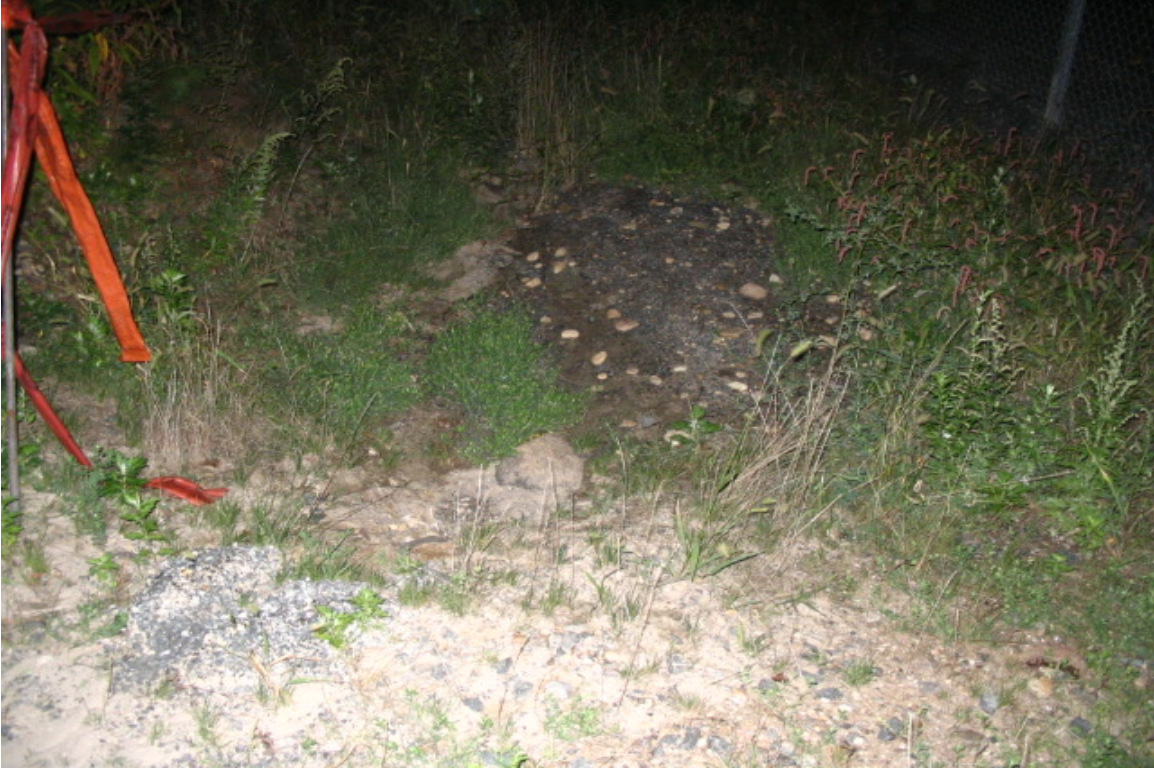
Areas of Inspection	Observation	Recommended Action
Erosion and Sediment Controls continued	<ul style="list-style-type: none"> - Sedimentation from the access road off the Rt. 7 ramp was noted in the vegetated perimeter swale but it did not leave the site. 9/15-9/21/05 - Large amounts of stormwater from the Rt. 7 ramp as well as portions of the perimeter of the site continue to flow to the inlet but the vegetation and stone aid filtration. 8/19-9/21/05 - Preparation will begin soon on the erosion controls and access to the work across the overflow channel. 9/21/05 	<ul style="list-style-type: none"> - Sedimentation and gravel remain contained within the swale. The access road will be paved eventually which will remove the problem. Continue to monitor area until final stabilization. 9/21/05 - Continue to monitor the area and the silt fence could be removed as the stone is now in place. 9/21/05 - This are will be monitored when work begins. 9/21/05

The access road off the Rt. 7 ramp is leading to some sedimentation to the perimeter swale but it remains contained on site and the drive will be paved eventually. (9/21/05)

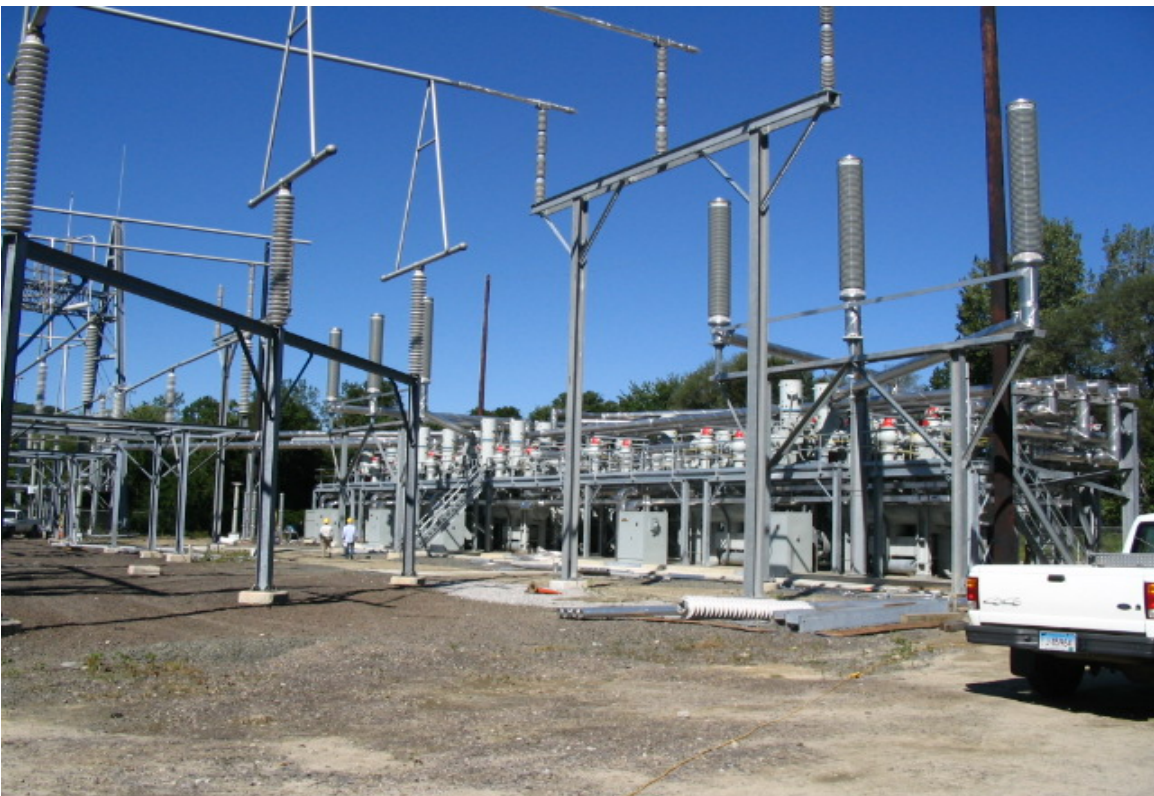
Plumtree Substation: Work continues on structures connecting to the equipment on the concrete pad. (9/21/05)
