Docket No. 217 – Development and Management Plan Inspection

Northeast Utilities Service Company Certificate of Environmental Compatibility and Public Need for the construction of a 345-kV electric transmission line and reconstruction of an existing 115-kV electric transmission line between Connecticut Light and Power Company’s Plumtree Substation in Bethel, through the towns of Redding, Weston, and Wilton, and to the Norwalk Substation in Norwalk, Connecticut.

Date: September 23, 2004

Location: Norwalk Substation Expansion

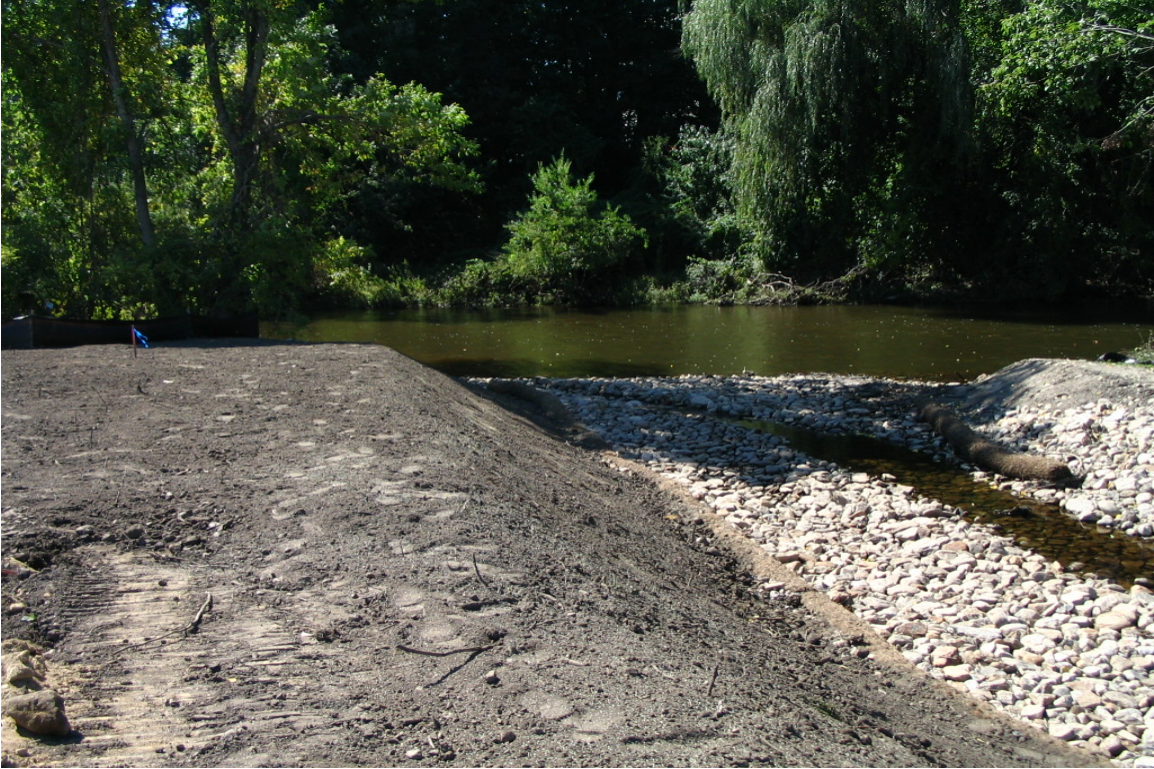
- The topsoil stockpile remains well contained along the retaining wall and portions have been used on site. 9/23/04	- The pile will continue to be used where necessary in areas to be grassed in the future. 6/30-9/23/04
	-Portions of the topsoil and seed that was placed along the banks of the channel was washed away due to high flows from the several inches of rain from the remnants of the hurricane. The timing of the storm was unfortunate as vegetation had not had a chance to establish 9/23/04	- The remaining soil was being raked into the crevices and reseeded. And the biologs remained in place. 9/23/04 - Getting vegetation to establish here is a priority for stability and straw mulch should be placed over the seed. 9/23/04
	-Some areas adjacent to the overflow channel still have fairly sparse vegetative cover. 8/12-9/23/04	-Getting seed and cover to establish here will be important before the growing season is over. 8/26-9/23/04

Portions of the soil placed on the overflow channel had been washed away during the high flows caused by Hurricane Ivan before vegetation could establish. The remaining soil was raked into place and reseeded 9/23/04

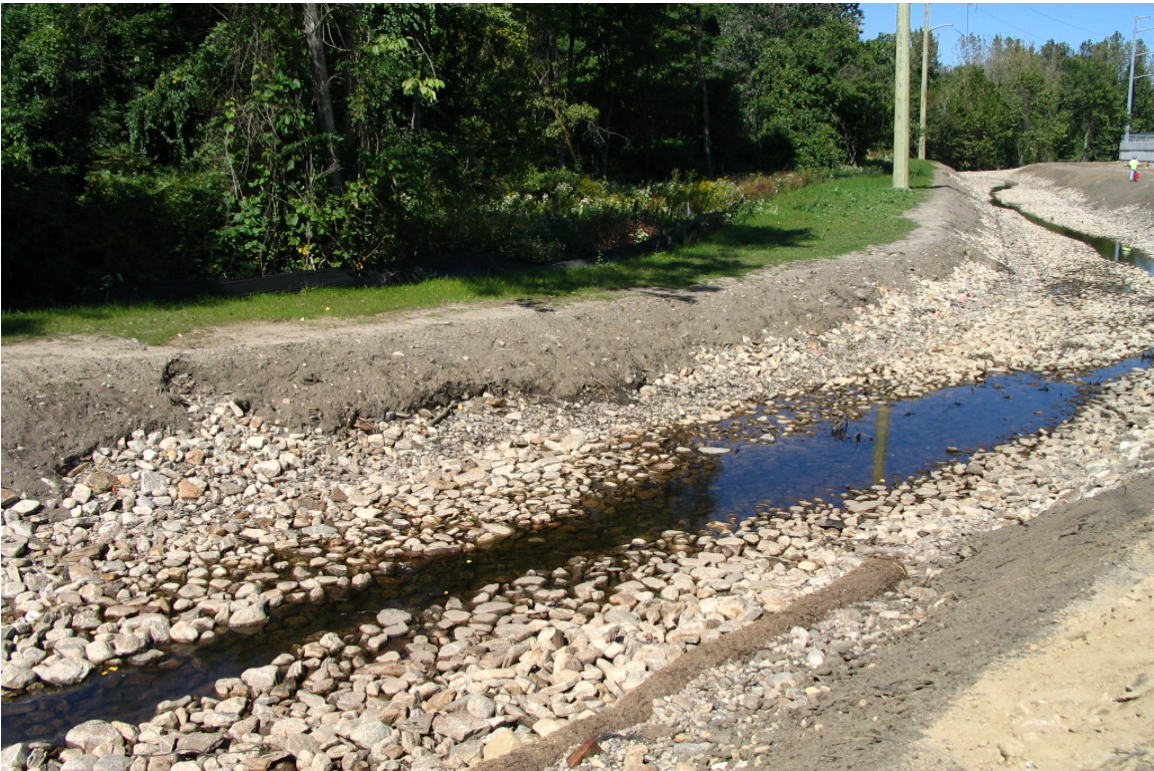
Inland Wetland and Watercourse encroachment and mitigation	- Most areas have sufficient vegetative cover but a few areas remain sparse. The area adjacent to the channel especially requires stabilization as the rains caused a loss of soil here. 9/23/04	- Continue to monitor silt fence and repair as necessary, especially in the portions closest to the river. 9/23/04
State species of concern, threatened and endangered species	- No species of concern are located in this area of construction.	- N/A
Vegetative clearing limits (including trees to save or danger trees noted)	-There should be no need for further clearing for most of the site. Landscaping is planned for along the bike path and native species are to be used. 9/23/04	- The old scour area was not impacted by the floodwaters during this storm. The vegetation had established enough to prevent any erosion here. 9/23/04

View of the channel with the visible erosion. It is a priority to get vegetation to establish here. Straw mulch should be placed over the seed. 9/23/04

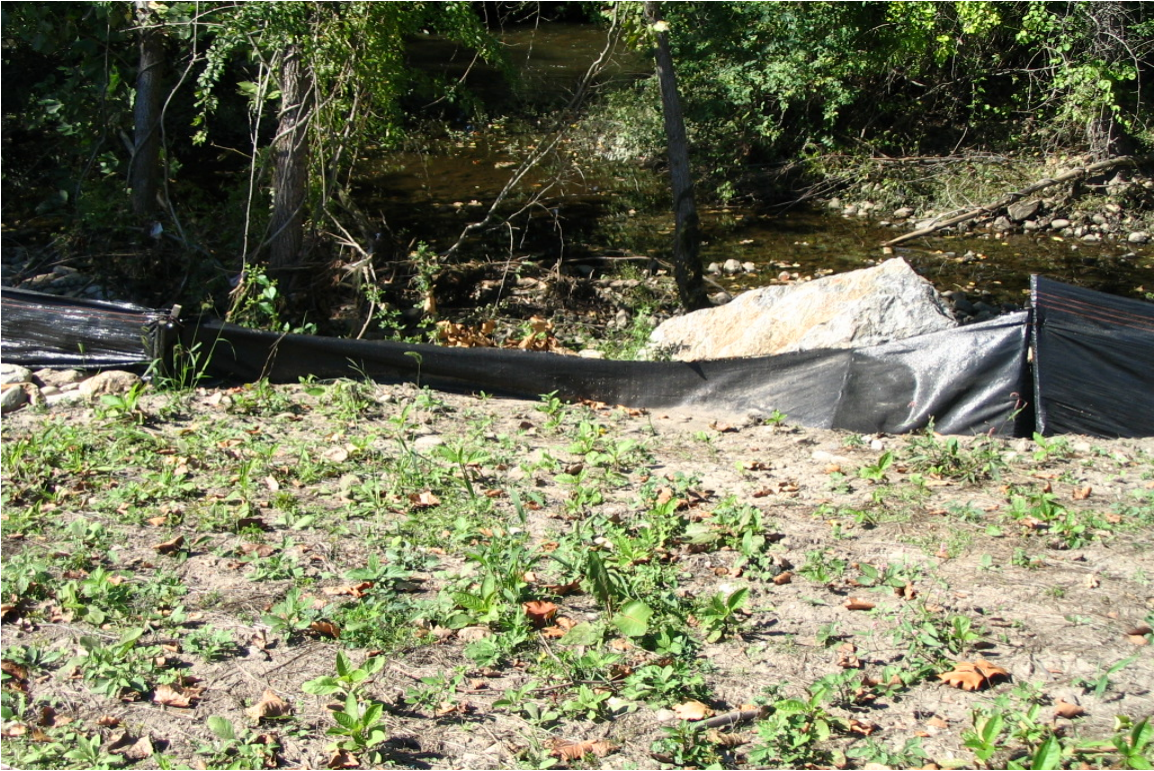
Erosion and Sediment Controls (includes inspection within 24 hours of a storm event)	<ul style="list-style-type: none"> - The silt fence is sufficient in most areas with vegetative cover present in many locations. 9/23/04 - One spot of fence near wall #5 could use reinforcement or repair as it is under strain from sedimentation 9/23/04 	<ul style="list-style-type: none"> - Continue to be proactive in silt fence repair and maintenance.

View of a spot near retaining wall where the silt fence could use reinforcement/repair due to strain from sedimentation. 9/23/04

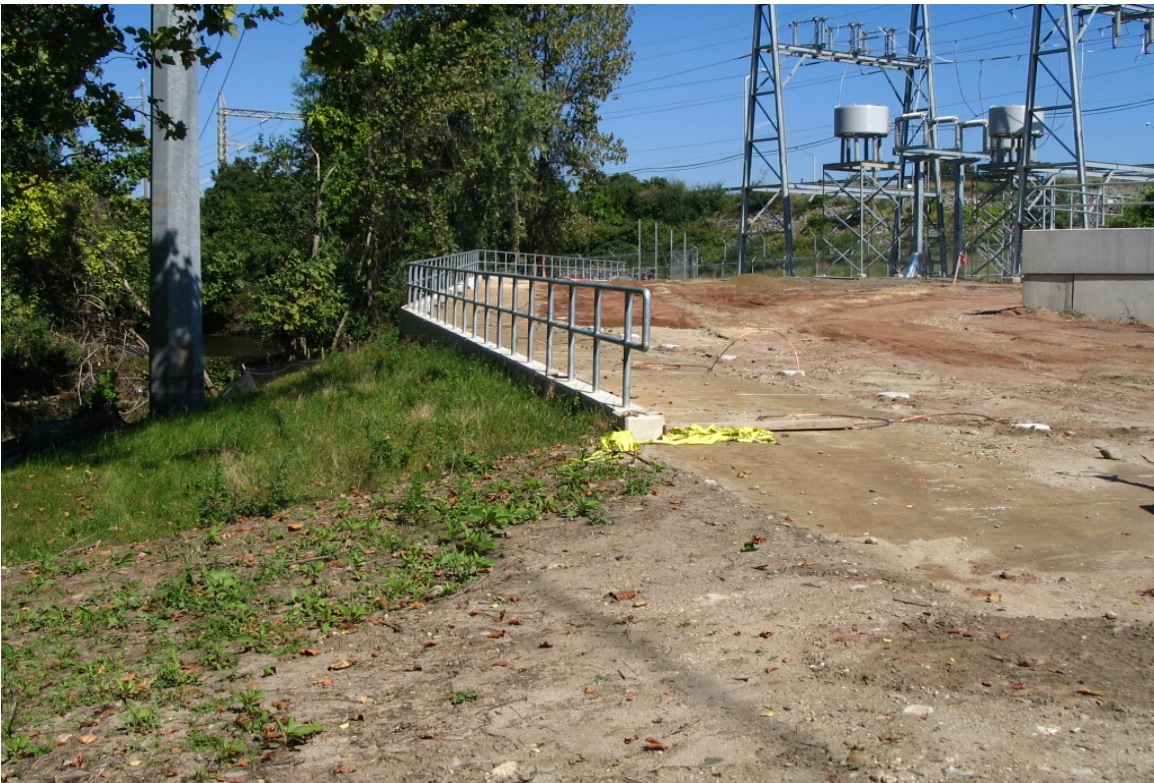
View of the area scoured in the spring which did not erode despite the floodwaters that came over the area. The vegetation was established enough to hold the soil. 9/23/04

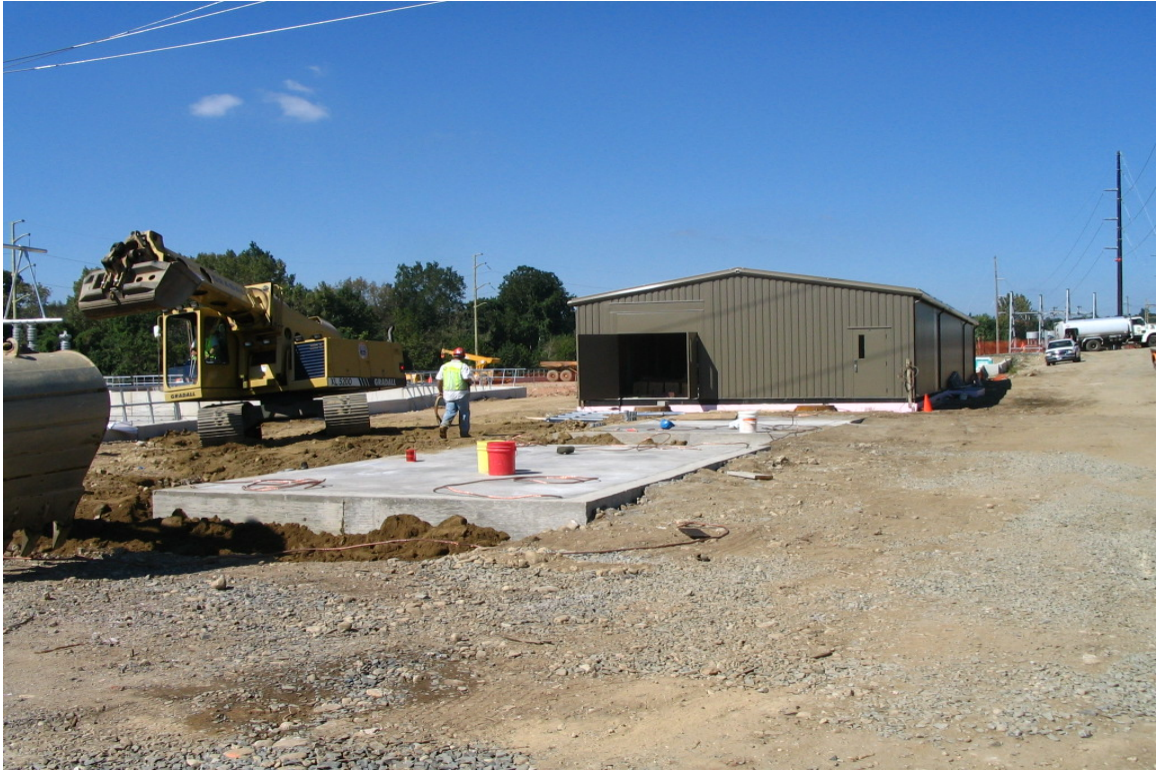
The control house is nearing completion and the conduit bank has been encased in concrete. The stockpiles in the area have been backfilled into the trench. 9/23/04

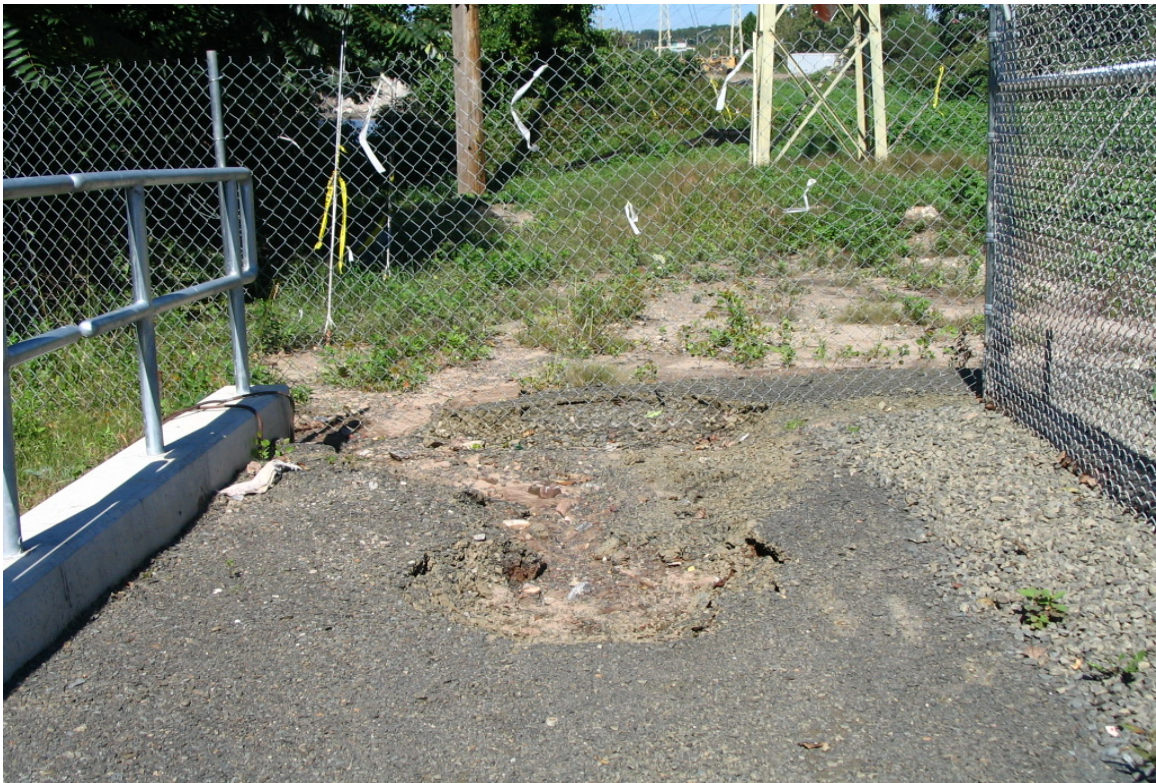
Areas of Inspection	Observation	Recommended Action
Erosion and Sediment Controls continued	- The erosion at the northernmost portion of the site at the end of the bike path has worsened and is encroaching on the site. 9/23/04	- The area is contained and is not impacting resource areas. It will also be paved in the coming week and this should solve the problem. 9/23/04

The erosion at the end of the bike path appears to be getting worse and encroaching into the yard. No resource areas are affected and the area will be paved in the coming week. 9/23/04

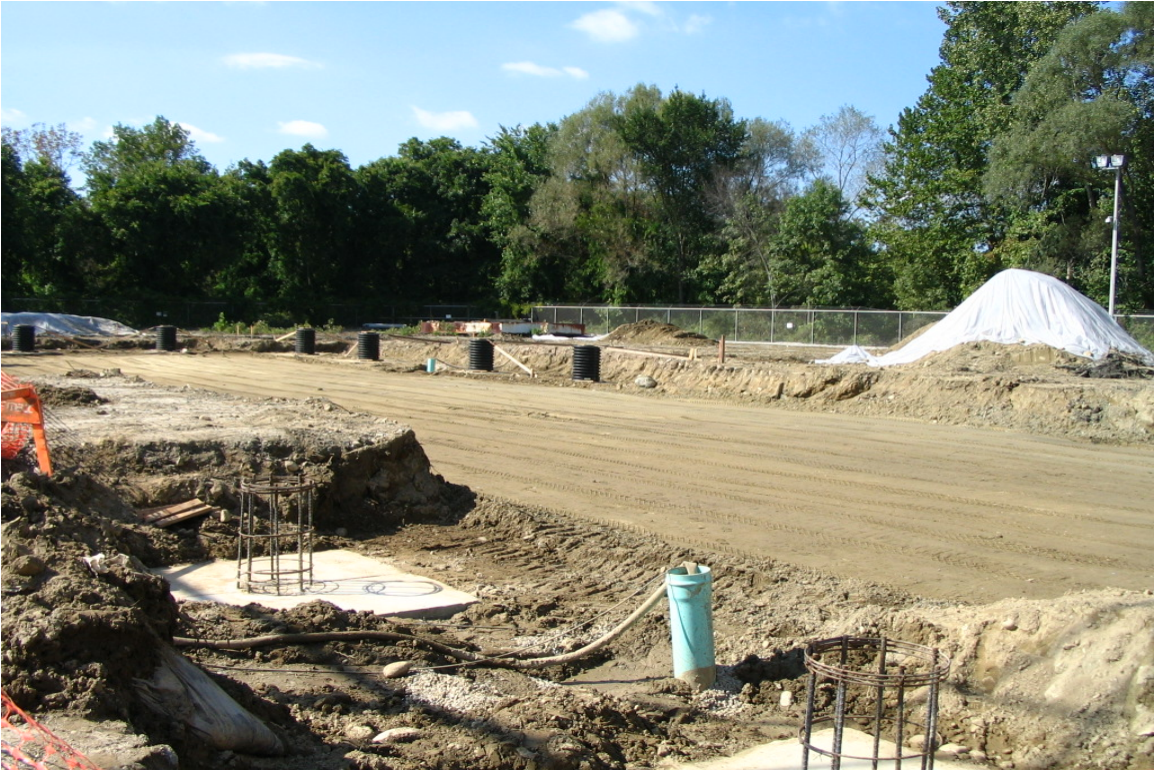
Areas of Inspection	Observation	Recommended Action
Access Roads	- No new access roads have been constructed at this time 9/23/04	- None at this time. 9/23/04
Foundation construction	-The GIS slab excavation is ongoing but had experienced set backs due to the rain. 9/23/04 - Soil is being actively hauled off site at this time. Remaining excavate is being combined into stockpiles for backfill and covered. 9/16-9/23/04	- The areas are well contained at this time. The rainwater did not discharge to any areas off site. 9/23/04
Erosion and Sediment Controls (includes inspection within 24 hours of a storm event)	- The site contained areas of ponded water following the rains but there were no off site discharges. 9/23/04	- None at this time 9/23/04

Plumtree Substation: View of the excavation for the GIS concrete pad. The rain had caused delays and problems within the forms and excavations but did not affect areas outside the yard. 9/23/04

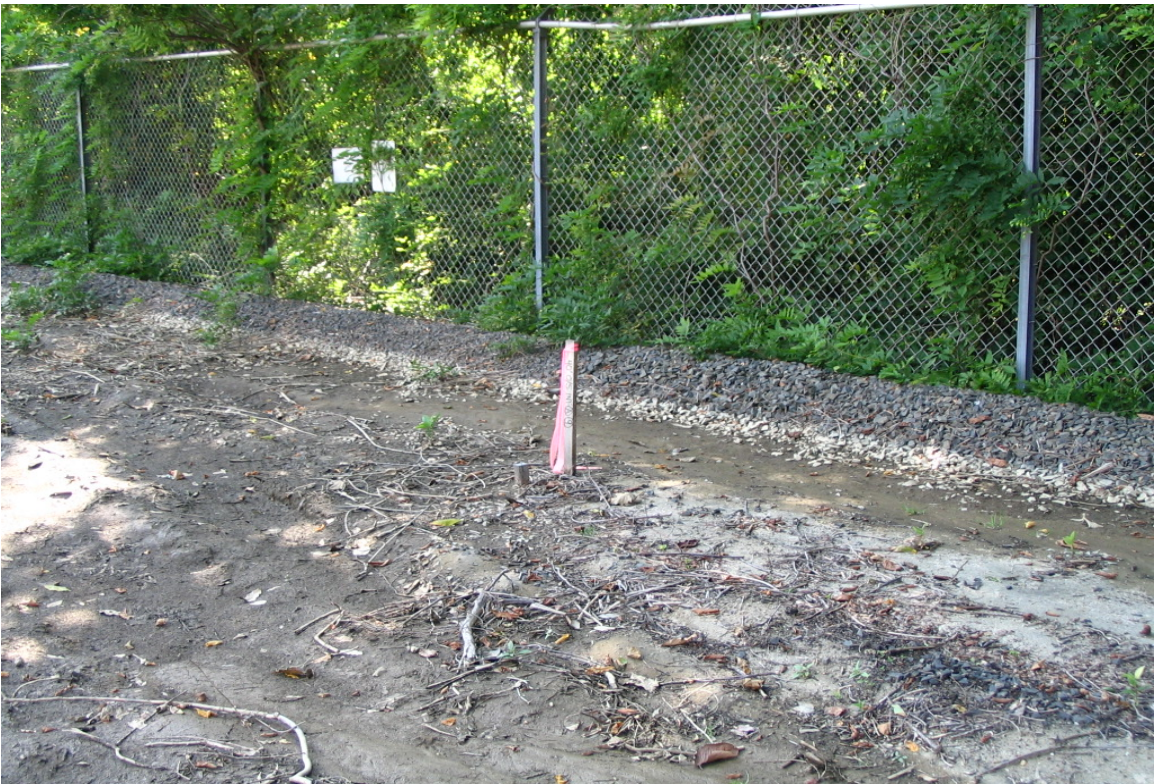
<p>Inland Wetland and Watercourse encroachment and mitigation</p>	<p>- Wetlands are located around the outskirts of the substation yard. Work is closer to the perimeter fence than before but there is no noted sedimentation to the wetland area. 9/10-9/23/04</p>	<p>- The stone berm around the perimeter of the yard continues to prevent sedimentation and water from leaving the site and getting to the wetland edge, even with the recent high rain levels 9/23/04</p>
<p>State species of concern, threatened and endangered species</p>	<p>- No species of concern are located in this area of construction.</p>	<p>- N/A</p>
<p>Vegetative clearing limits (including trees to save or danger trees noted)</p>	<p>- No vegetation outside of the substation yard will need to be cleared during the expansion work.</p>	<p>- N/A</p>
<p>Dewatering</p>	<p>- Dewatering activities have continued in order to remove standing water from the excavations. 9/23/04 - The water is being directed to flat, stoned areas within the center of the yard and is being directed away from the stockpiles and excavations. 9/16-9/23/04</p>	<p>- None at this time.</p>

View of the line (lighter color) along the perimeter stone berm where the rain water had reached. The site was muddy but there were no discharges to the adjacent wetlands. 9/23/04
