**Docket No. 217 – Development and Management Plan Inspection**

Northeast Utilities Service Company Certificate of Environmental Compatibility and Public Need for the construction of a 345-kV electric transmission line and reconstruction of an existing 115-kV electric transmission line between Connecticut Light and Power Company's Plumtree Substation in Bethel, through the towns of Redding, Weston, and Wilton, and to the Norwalk Substation in Norwalk, Connecticut.

**Norwalk Substation**

**Date:** September 29, 2006

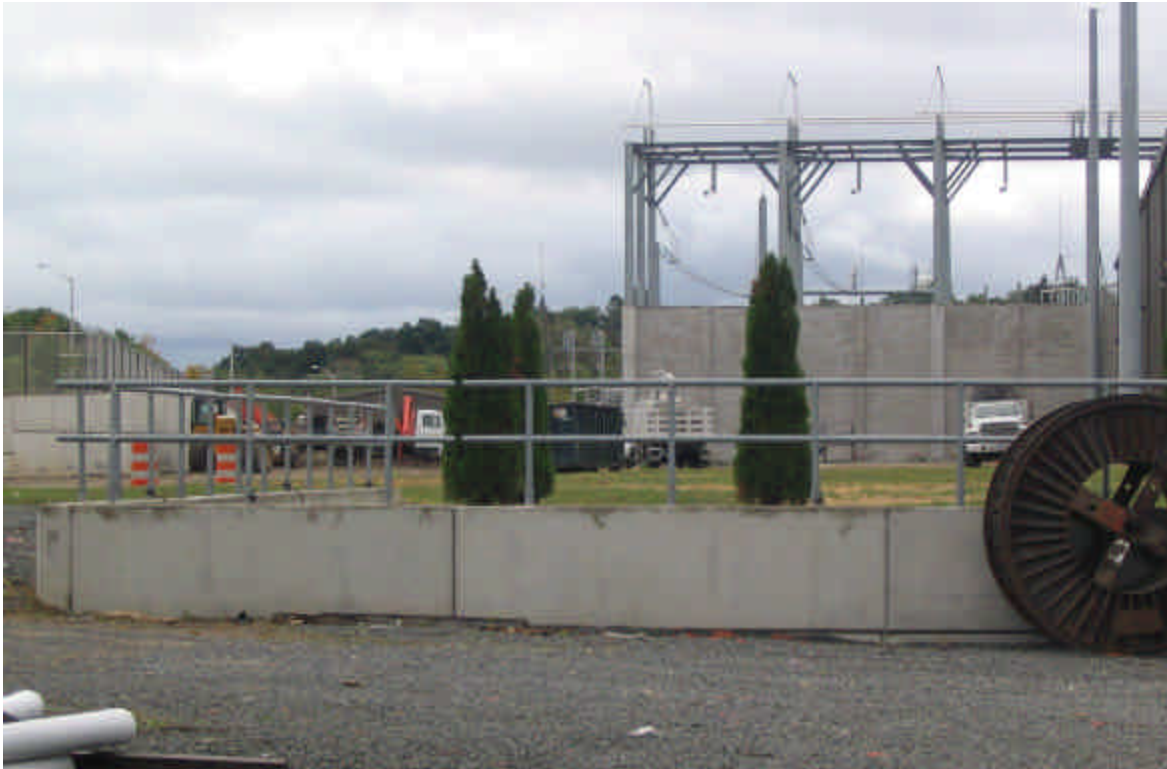
(Norwalk Substation): Photo shows a view of the yard. Some restoration was noted in the grassed area near the GIS building, likely as a repair to vehicle tracking here. 9/29/06
