Docket No. 217 – Development and Management Plan Inspection

Date: October 5, 2005

Location: Norwalk Substation Expansion

Location: Plumtree Substation Expansion, Bethel

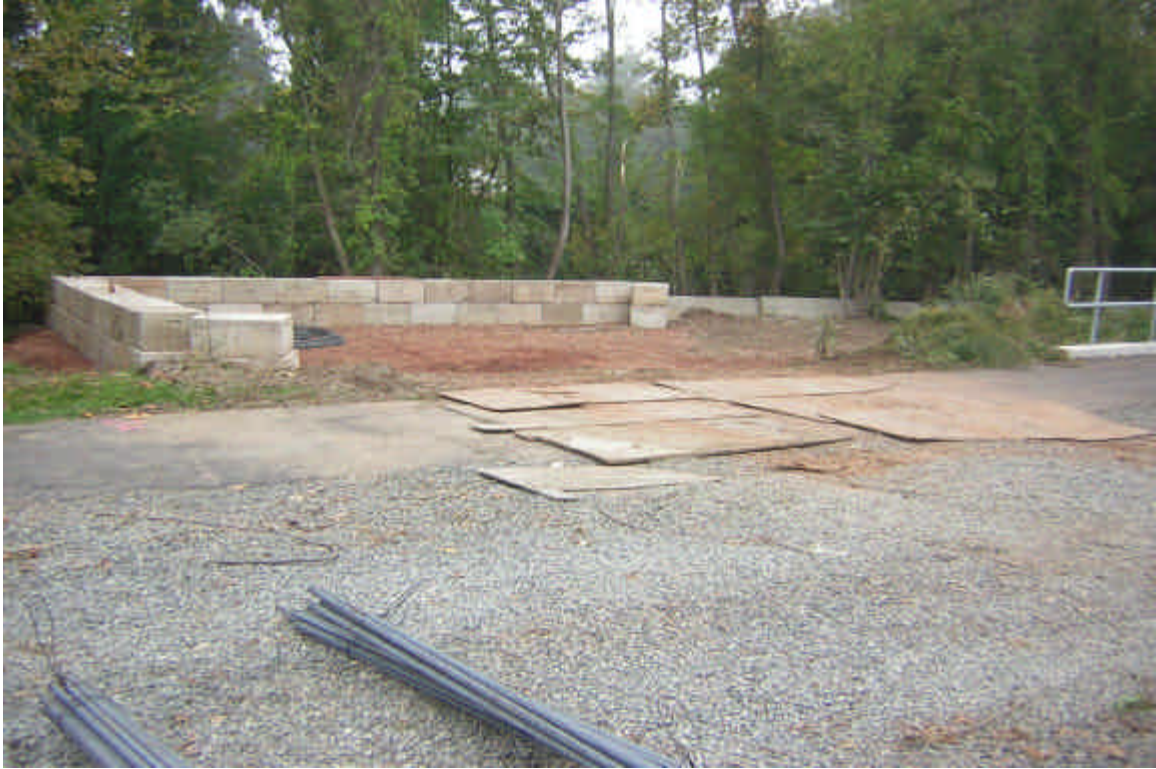
<p>Inland Wetland and Watercourse encroachment and mitigation</p>	<p>-The work on the 345 kV Turning Structure located adjacent to the river and the overflow channel is ongoing. Approximately 200 yards of approved, temporary fill was placed in the natural overflow portion of the channel as a temporary access road and work area. 10/5/05</p> <p>- Sheet piling was installed at the channel entrance as a temporary, partial dam for the work. 10/5/05</p>	<p>- Continue to monitor for erosion controls and access. At completion of the caisson drilling, all temporary fill should be removed and the site restored to its original condition. 10/5/05</p>
<p>State species of concern, threatened and endangered species</p>	<p>- No species of concern are located in this area of construction.</p>	<p>- N/A</p>

Norwalk Substation: View of the temporary, approved fill placed in the natural overflow area to create a work area and temporary access to the 345kV Turning Structure. 10/5/05

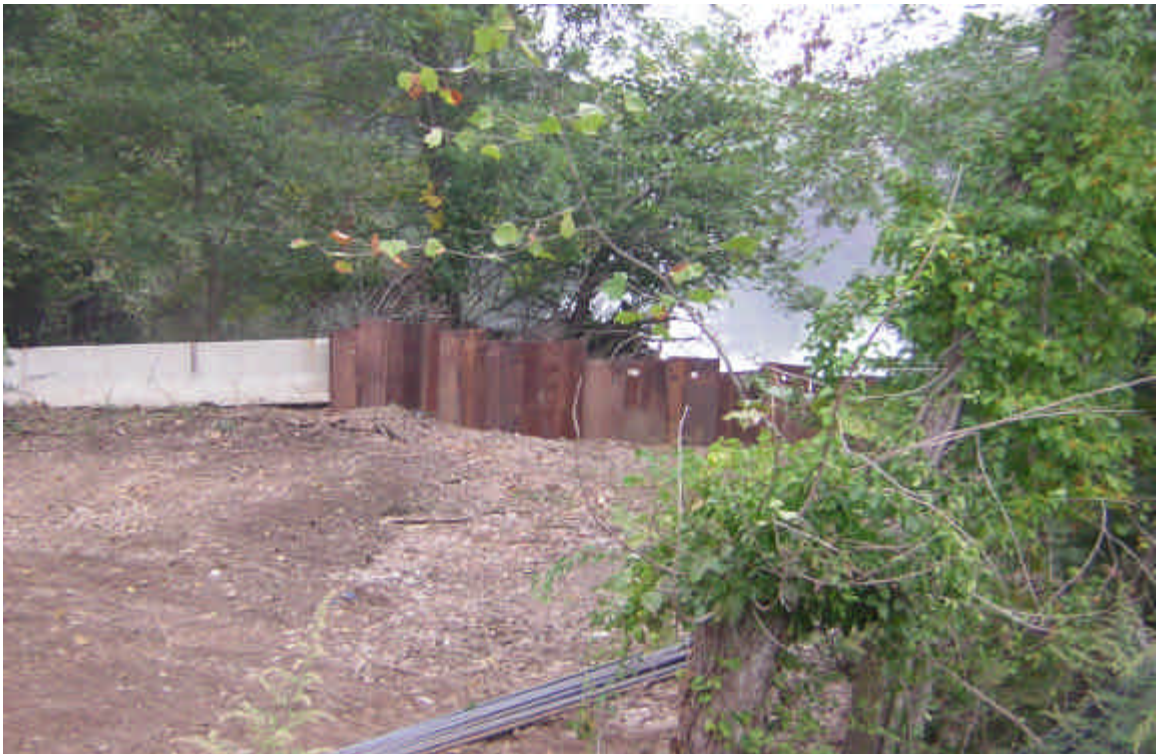
A view of the sheet piling installed as a temporary, partial cofferdam at the northern portion of the temporary work area. 10/5/05

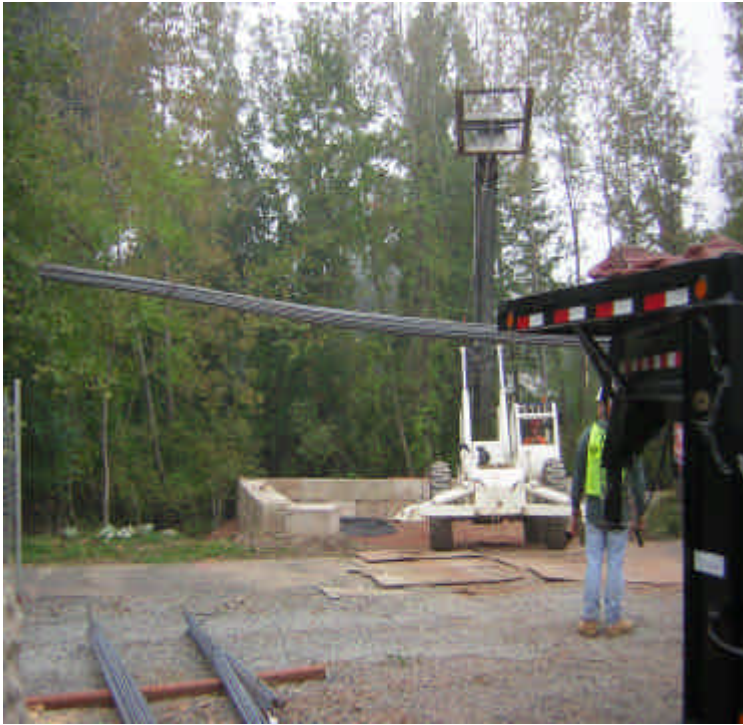
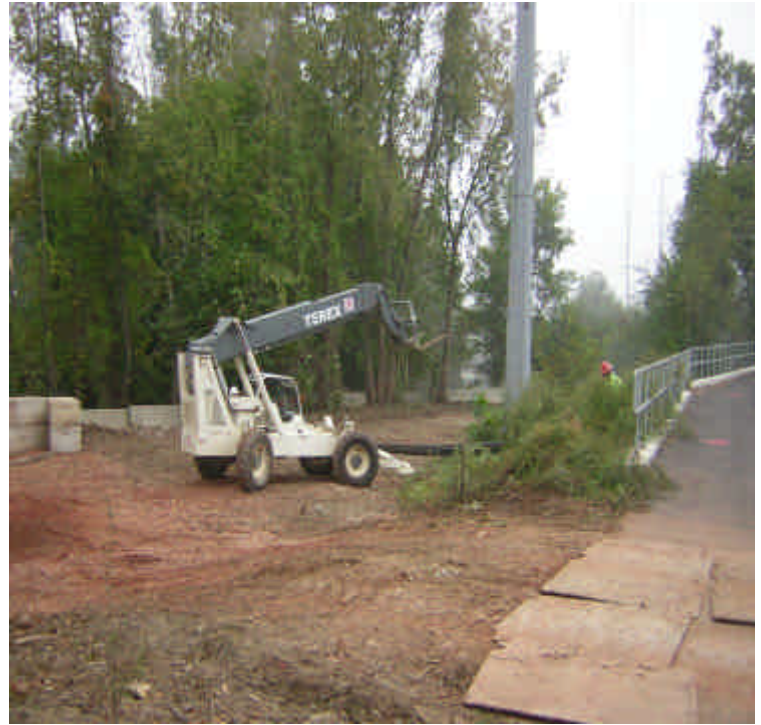
Additional photographs of the work associated with the 345 kV Turning Structure: Photo on the left shows rebar being transported to work area. Photo on the right shows approximate location of caisson drilling. 10/5/05

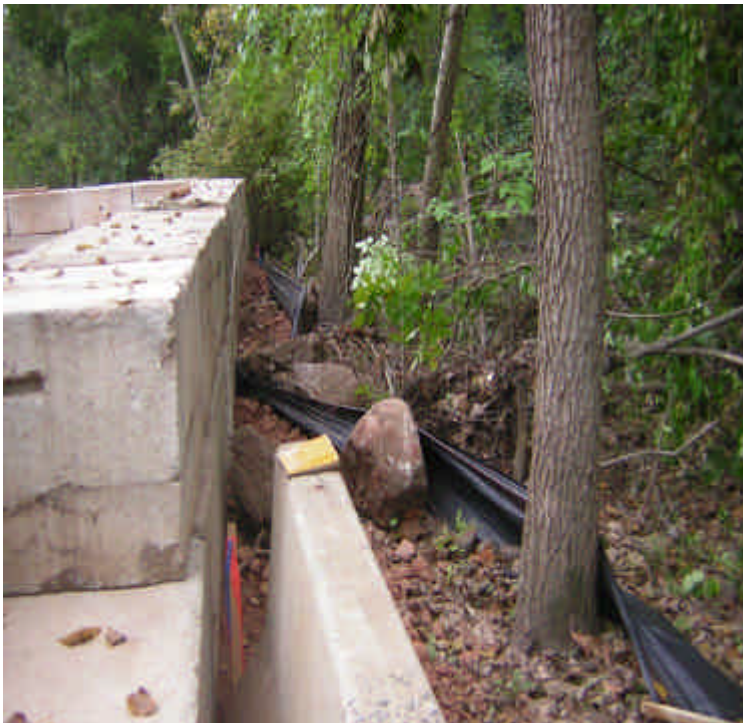
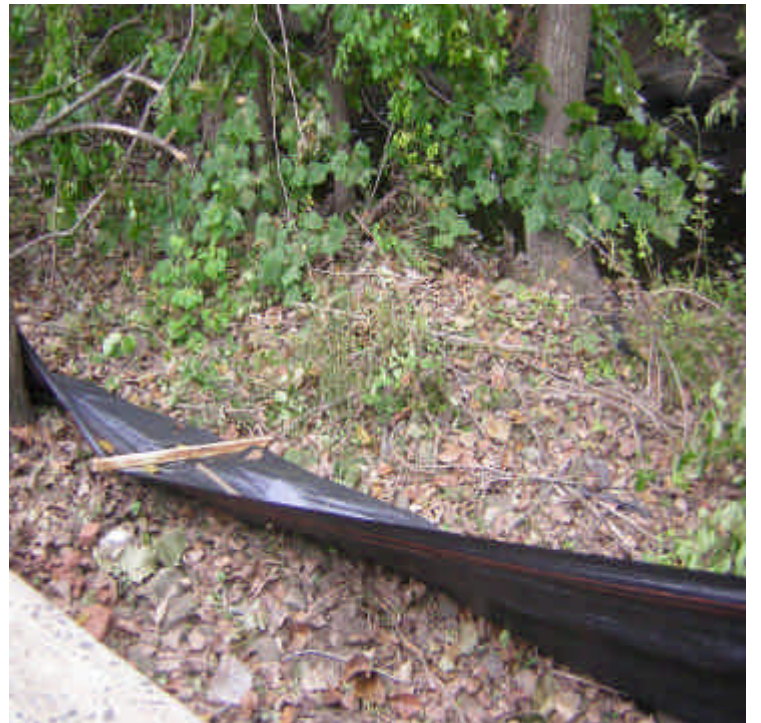
Areas of Inspection	Observation	Recommended Action
<p>Erosion and Sediment Controls</p> <p>(includes inspection within 24 hours of a storm event)</p>	<p>-The channel slopes have recently been reseeded and have some increased growth. 10/05/05.</p> <p>- Sedimentation from the access road off the Rt. 7 ramp was noted in the vegetated perimeter swale but it did not leave the site. 9/21/05-10/5/05</p> <p>- Large amounts of stormwater from the Rt. 7 ramp as well as portions of the perimeter of the site continue to flow to the inlet but the vegetation and stone aid filtration. 8/19-10/05/05</p> <p>- Work on the turning structure across the overflow channel was ongoing. Silt fence was installed behind the jersey barriers and immediately adjacent to the river, but was in need of repair. 10/5/05</p>	<p>-The remaining bare soil areas from the original attempt to revegetate will be monitored for growth and cover. 10/5/05</p> <p>- Sedimentation and gravel remain contained within the swale. The access road will be paved eventually which will remove the problem. Continue to monitor area until final stabilization. 9/21/05-10/5/05</p> <p>- Continue to monitor the area and the silt fence could be removed as the stone is now in place. 10/05/05</p> <p>- Contractors were aware of the damaged silt fence and were preparing for repairs. All silt fence should remain in tact until the area is stabilized. 10/05/05</p>

The silt fence behind the jersey barriers and adjacent to the river was in need of repair. Contractors were aware of the damage and were preparing for repairs. 10/5/05

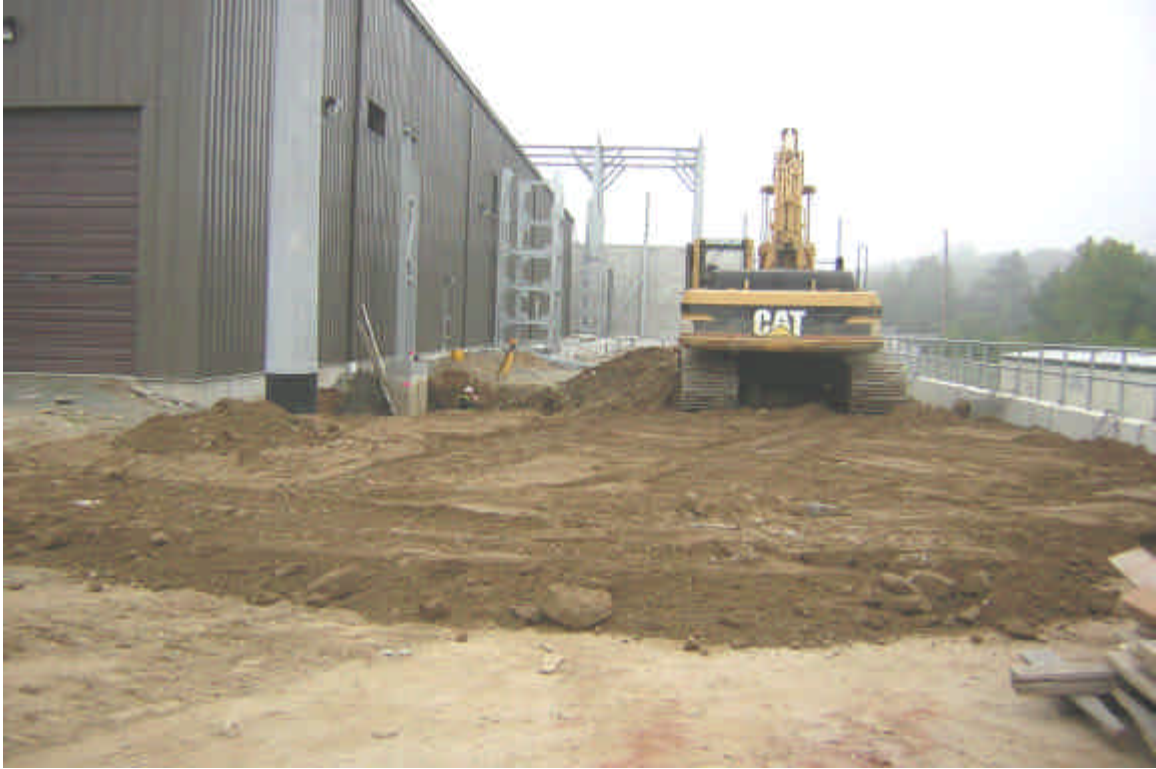
Additional Observations	-Trenching for the Gas Insulated Transmission Line (GITL) was occurring on the western side of the GIS building. 10/5/05	-This excavation and backfill work is well within the yard and areas are contained. 10/5/05

Trenching for the Gas Insulated Transmission Line was occurring on the western side of the GIS building. 10/5/05

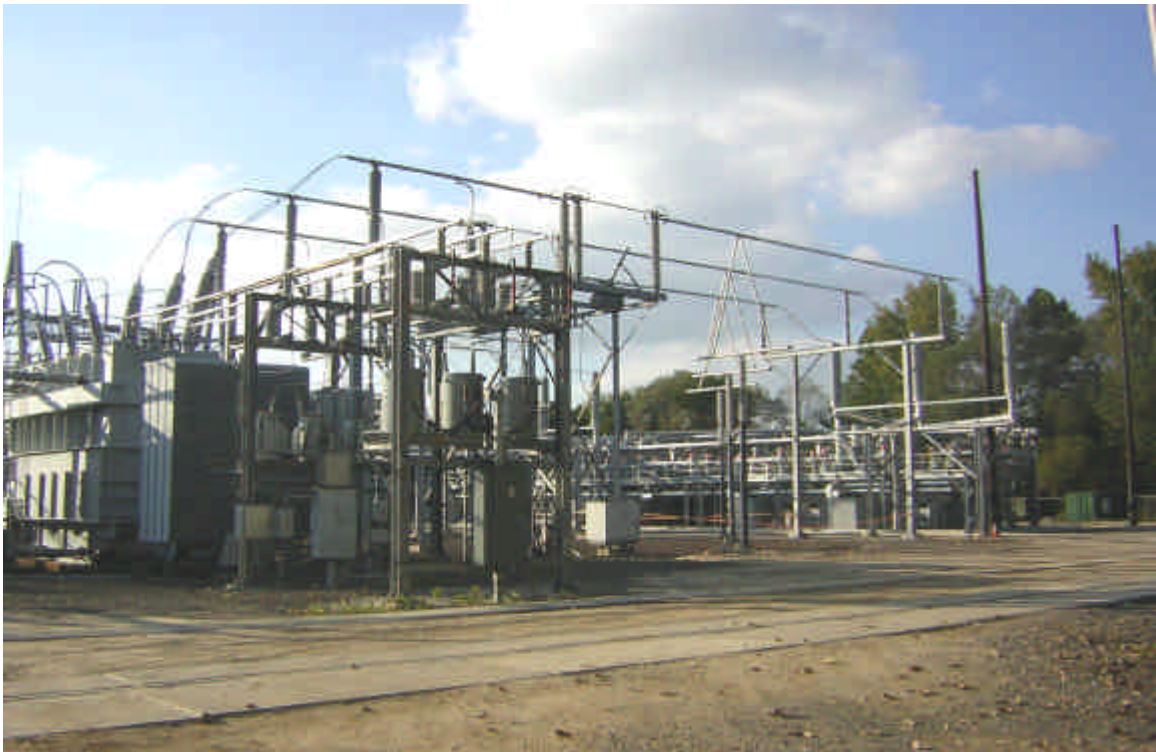
Plumtree Substation: Work continues on structures connecting to the equipment on the concrete pad. 10/5/05
