**Docket No. 217 – Development and Management Plan Inspection**

**Date:** December 22, 2005

**Location:** Norwalk Substation Expansion

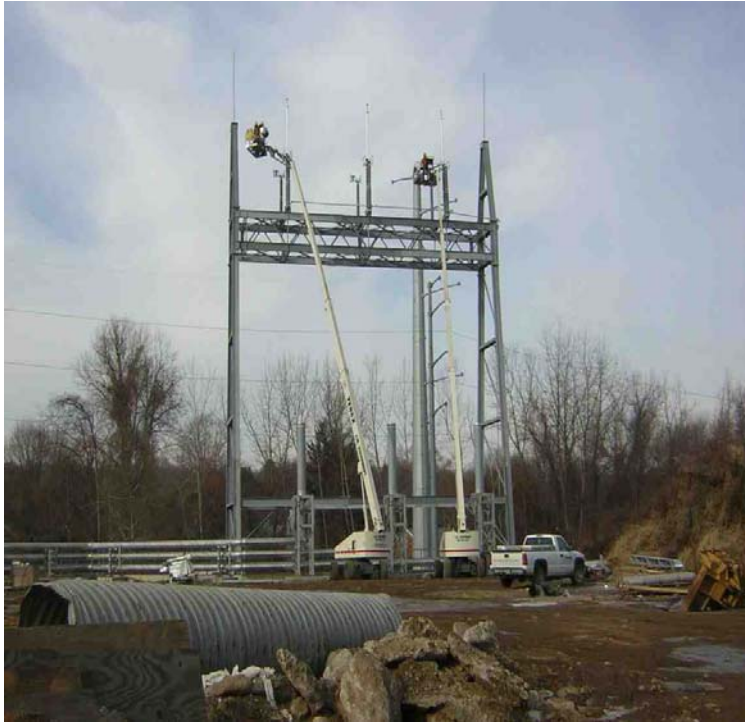
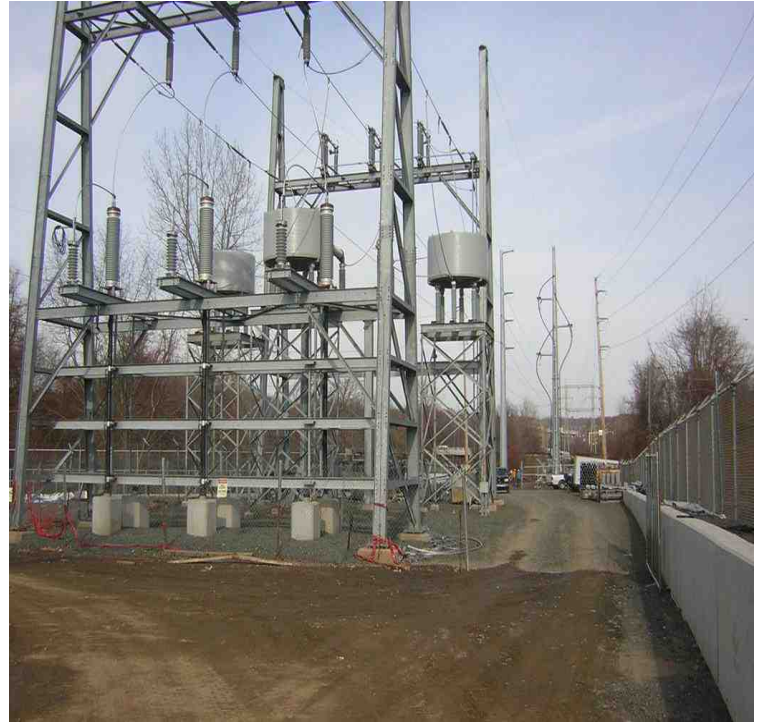
| Areas of Inspection | Observation | Recommended Action |
|---|---|---|
| Foundation construction | -Crane/bucket work was occurring at the steel structures to the north and northwest of the yard between the retaining wall and the bike path.12/22/05<br><br>- Scaffolding work was noted on the tower near the ROW. 12/22/05<br><br>- Work in the area of the cable trenches and manholes adjacent to the GIS building was occurring. 12/22/05<br><br>-The 345kV turning structure work is complete. | -None at this time. 12/1-12/22/05.<br><br>- None at this time. 12/22/05.<br><br>- The area remains contained to the site. 12/22/05<br><br>-We just need confirmation that all proposed grades were met here. 11/10-12/22/05. |

Norwalk Substation: Photo on the left shows work on the recently installed structures northwest of the GIS building. View towards the ROW where some scaffolding work is occurring. 12/22/05.

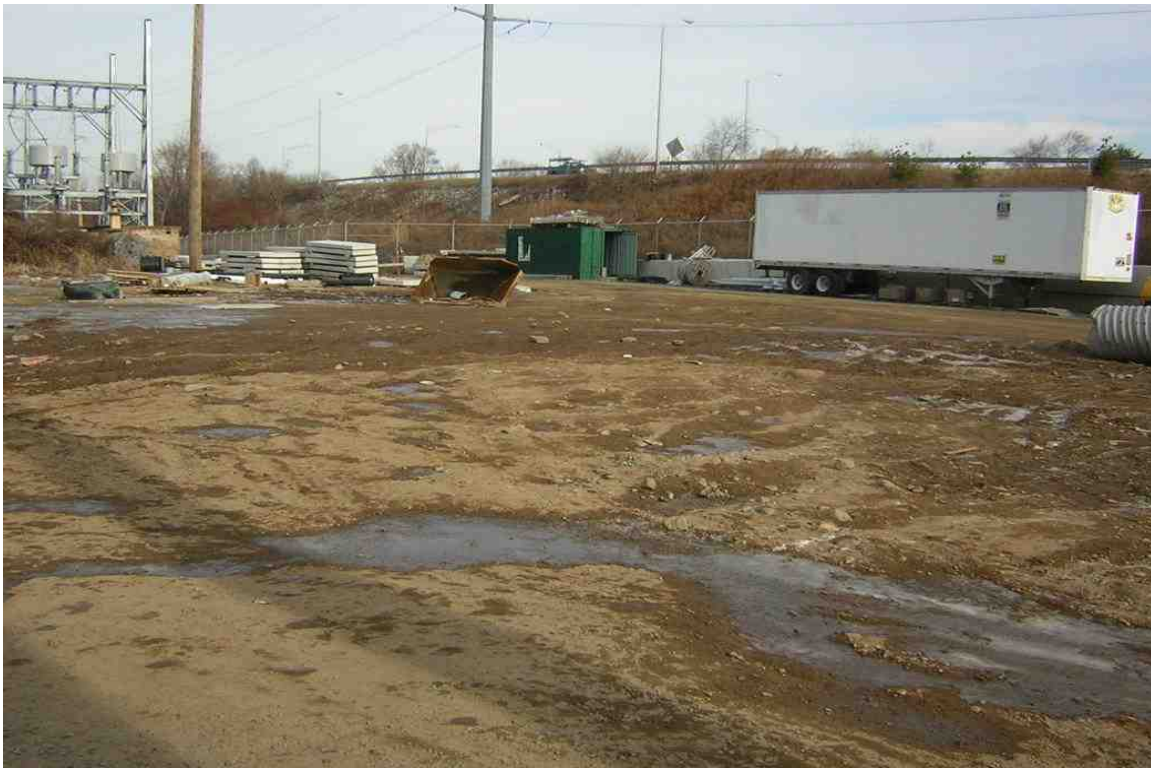
Overview of the yard adjacent to the GIS building. 12/22/05.

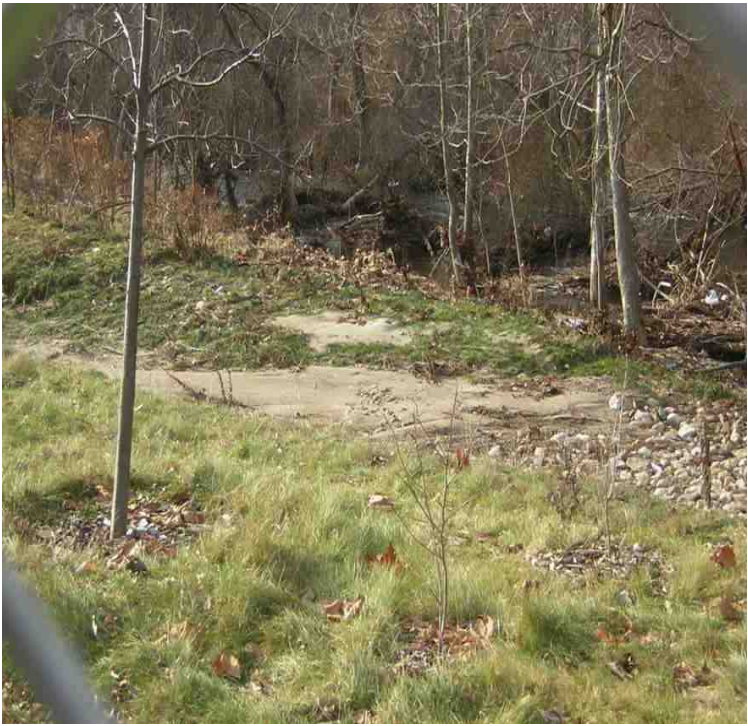
| Areas of Inspection | Observation | Recommended Action |
|---|---|---|
| Erosion and Sediment Controls continued<br>(includes inspection within 24 hours of a storm event) | <ul style="list-style-type: none"> <li>- Piles of sediment were noticeable in the constructed overflow channel and natural overflow area. 12/8-12/22/05.</li> <li>- The topsoil stockpile remains well contained on site. 12/22/05.</li> <li>- All access drive areas were paved, eliminating some potential sources of sediment. 12/1-12/22/05.</li> </ul> | <ul style="list-style-type: none"> <li>- It should be confirmed that the channel is at original grades and whether the source of the sedimentation is project related. 12/22/05.</li> <li>- None at this time. 12/22/05</li> <li>- Monitor stormwater flow and drainage patterns on the pavement when possible. Watch for any erosive flows off site. 12/1-12/22/05</li> </ul> |
| Inland Wetland and Watercourse encroachment and mitigation | -Water has been flowing clear in both the natural and constructed overflow channel, but additional small sediment/sand piles were noted here when the water recedes. 12/8-12/22/05. | - Try to determine whether the loose sediment noted is project related. This may be natural deposition by the river. 12/22/05. |

Photo on the left shows a view of the sediment deposited near the constructed overflow channel as a result of the river flood events. Photo on the right is an overview of the 345kV turning structure area. 12/22/05.

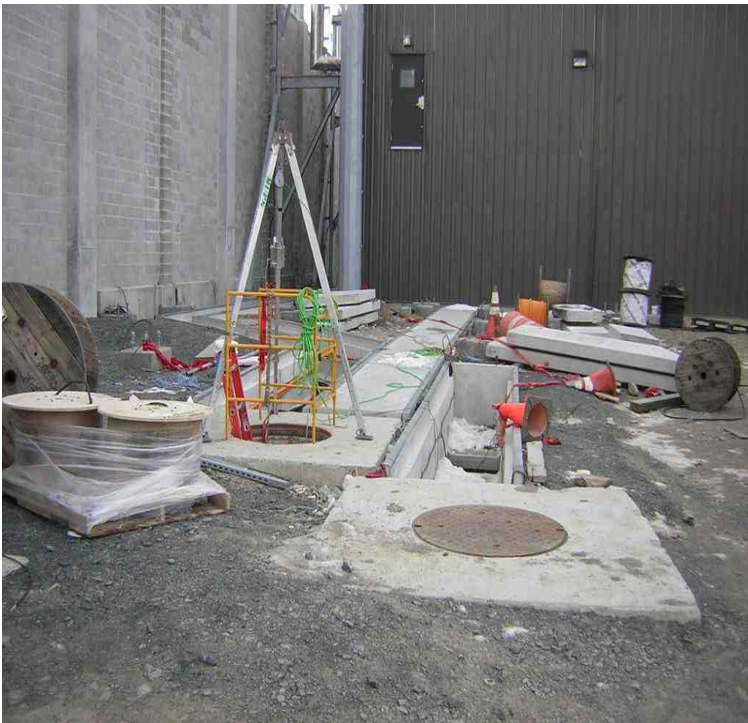
Photo on the left is a view of some work internal to the manholes and cable trenches. Photo on the right is a view of some of the

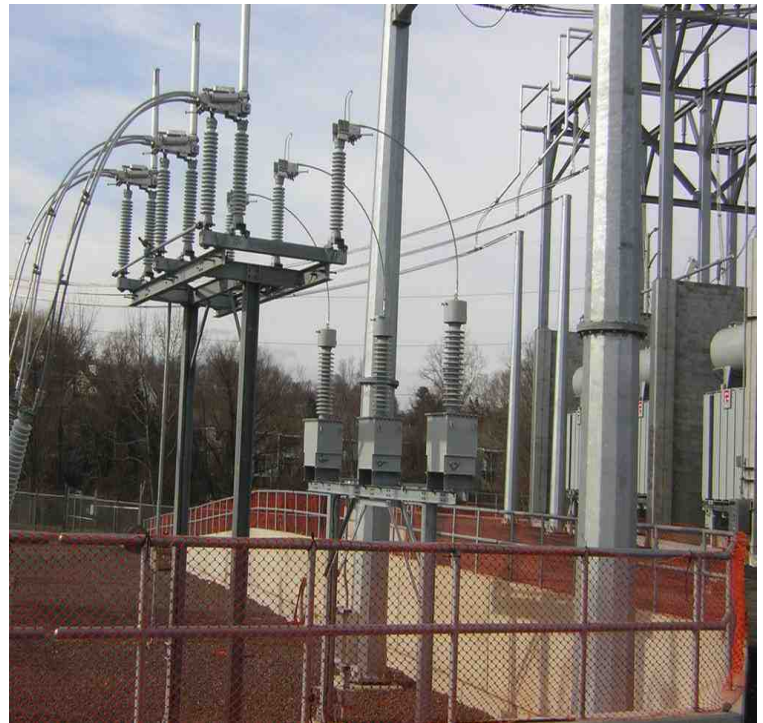
overhead structure work in the yard 12/22/05.
