**Docket No. 217 – Development and Management Plan Inspection**

Northeast Utilities Service Company Certificate of Environmental Compatibility and Public Need for the construction of a 345-kV electric transmission line and reconstruction of an existing 115-kV electric transmission line between Connecticut Light and Power Company's Plumtree Substation in Bethel, through the towns of Redding, Weston, and Wilton, and to the Norwalk Substation in Norwalk, Connecticut.

**Date:** July 26, 2006

**Location:** Transition Stations: Hoyts Hill, Archers Lane, Norwalk Junction

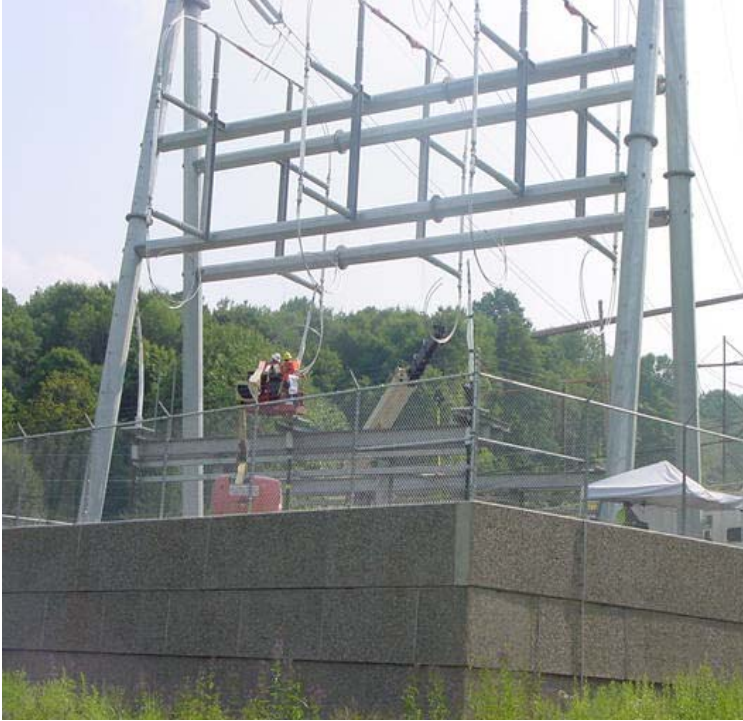
Hoyts Hill Transition Station: Photo on the left shows a view of the electrical work at the station pad. Photo on the right shows a view of a few bare spots remaining in the restored area. 7/26/06

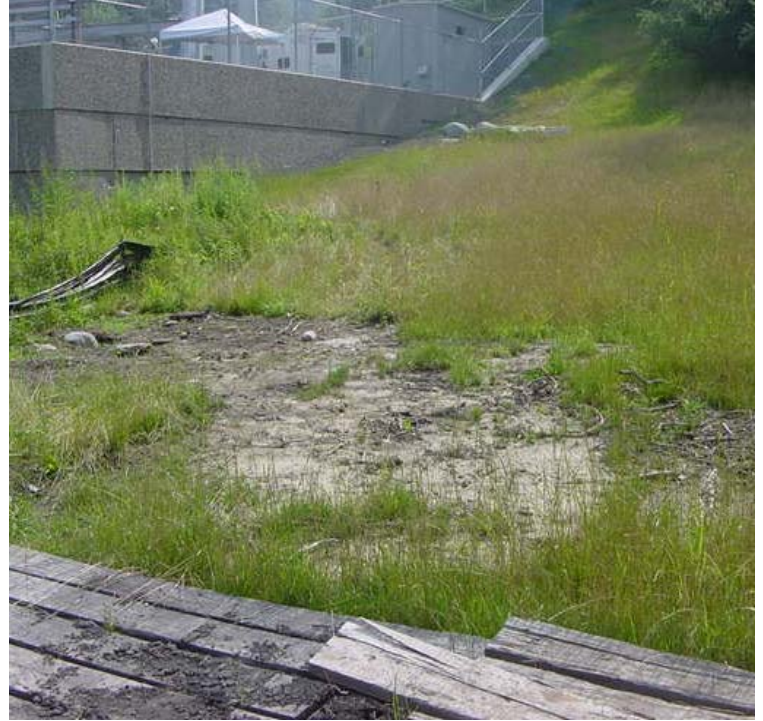
| Areas of Inspection | Observation | Recommended Action | Corrected Actions |
|---|---|---|---|
| Erosion and Sediment Controls | <p>-<b>Hoyts Hill:</b> The perimeter silt fence along the wetlands at the rear of the station remains in good shape. 4/6-7/26/06.</p> <p>- The areas where the</p> | <p>-Monitor and maintain the fence as necessary. 4/6-7/26/06 Vegetation is growing very well in the adjacent wetland 7/26/06</p> <p>- Consider seeding to</p> | <p>- N/A</p> <p>- Needs evaluation</p> |

| Areas of Inspection | Observation | Recommended Action | Corrected Actions |
|---|---|---|---|
| Erosion and Sediment Controls continued | <p>filter bags were removed remains bare with some accumulated sand. 7/5-7/26/06</p> <p>-One gully in the southern slope remains along the stone pad. The rest of the repaired slope is revegetating fairly well. 6/28-7/26/06.</p> <p>- <b>Archers Lane:</b> Silt fence along the access road at the 1<sup>st</sup> wetland was repaired but accumulated sediment remains in the wetland. 7/5-7/26/06</p> <p>- Silt fence on the access drive in the ROW was also repaired adjacent to the 2<sup>nd</sup> wetland crossing. 7/26/06</p> <p>- Turbid run-off from the access road continues to pool at the stonewall near Diamond Hill. Silt fence is partially filtering the water. 7/5-7/26/06</p> <p>- The silt fence where the process stockpile used to be was also washed down. 7/12-7/26/06</p> | <p>revegetate if this does not occur naturally soon. 7/5-7/26/06</p> <p>-The gully will be repaired and the slope reshaped to promote sheet flow. 6/28-7/26/06.</p> <p>-Continue to remove sediment carefully by hand. 7/5-7/26/06<br/>This area will need more final stabilization measures as this is an on-going problem. 7/19-7/26/06</p> <p>- Continue to pull back stone and remove sediment as needed. 7/26/06</p> <p>- Repair fence or replace with haybales or a gravel berm (or similar control) here if ponding is a problem. 7/5-7/26/06</p> <p>- Repair silt fence and install haybales to reinforce the area. 7/12-7/26/06</p> | <p>- Needs attention when feasible</p> <p>- Silt fence was being repaired, sediment still needs attention.</p> <p>- Silt fence was being repaired but sediment still needs attention</p> <p>- Needs attention</p> <p>-Needs attention if feasible</p> |

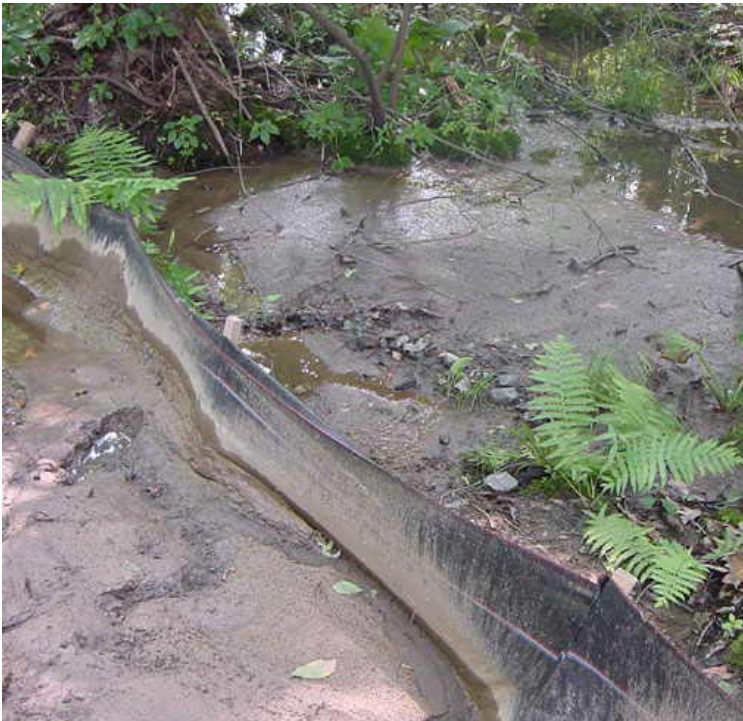
| Areas of Inspection | Observation | Recommended Action | Corrected Actions |
|---|---|---|---|
| | - The silt fence along the access road was repaired but accumulated sediment will still need to be removed from the wetland 7/26/06 | - Sediment needs to be removed carefully by hand in these spots. This area will also need some final stabilization measures as this is an ongoing problem. 7/26/06 | - Fence was repaired but sediment will still need attention<br>- Needs evaluation |

Archers Lane: Photo on the left shows the area along the silt fence at the 1<sup>st</sup> wetland crossing where accumulated sediment remains in the wetland. Contractors are being scheduled to remove this but more final stabilization measures will be needed. Photo on the right shows an overview of the work and structures in the station yard. 7/26/06.

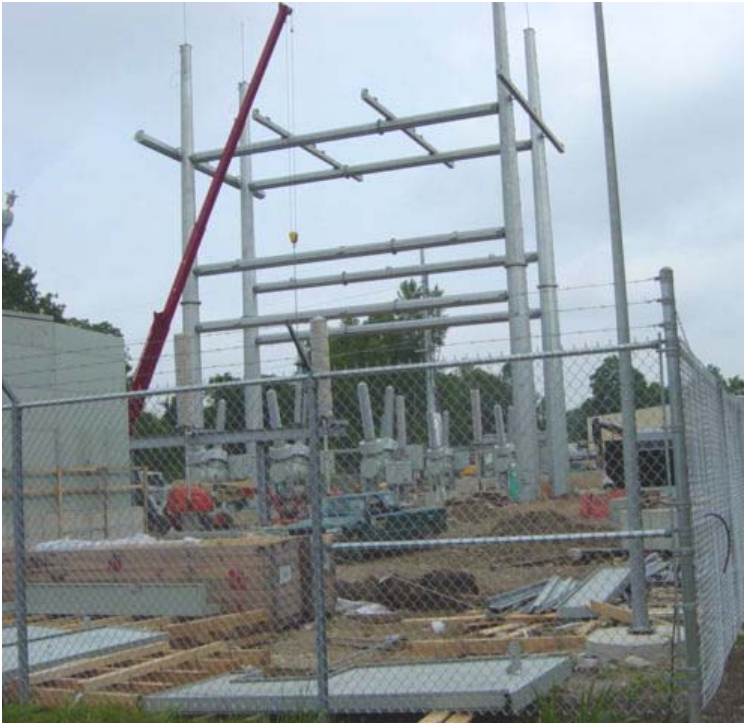
Norwalk Junction: Photo on the left shows the ongoing work on foundations and structures at the station yard. Photo on the right shows sediment accumulation remaining in the swales on site. This should be removed and the haybales need to be replaced. 7/26/06

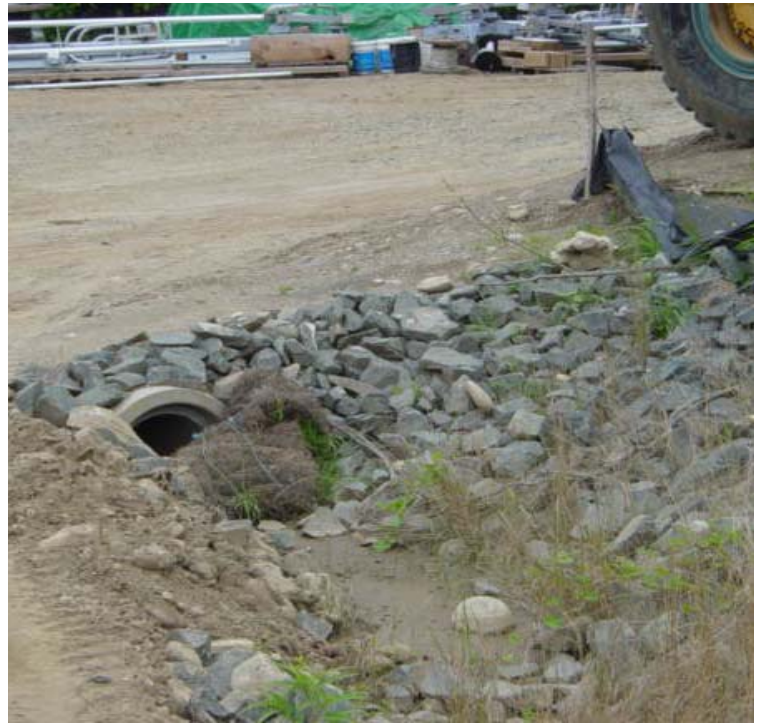
| Areas of Inspection | Observation | Recommended Action | Corrected Actions |
|---|---|---|---|
| Erosion and Sediment Controls continued | <p>- All the haybales in the swale culverts remain degraded. 6/28-7/26/06</p> <p>-Significant sediment accumulation also remains in the swale. 6/7-7/26/06<br/>Adjacent areas on site are not stable or have soil disturbance leading to additional sediment in the swale. 7/19-7/26/06</p> <p>- Significant ruts from equipment were noted adjacent to the perimeter fence. 7/26/06</p> <p>-Trench plates remain over the swale for access. 7/12-7/26/06</p> | <p>-Place new haybales or additional controls at all the culverts for filtration. 6/28/-7/26/06</p> <p>- Continue to improve water quality to the swale by restoring areas wherever feasible. Also remove accumulated sediment from the swale 6/1-7/26/06.</p> <p>- Repair ruts and consider using mats or plates in this area to reduce disturbance. 7/26/06</p> <p>- The swale is intact at this time but if access causes any damage to the swale it should be repaired. 7/26/06</p> | <p>- Needs attention</p> <p>- Needs attention</p> <p>- Needs attention</p> <p>- N/A at this time</p> |

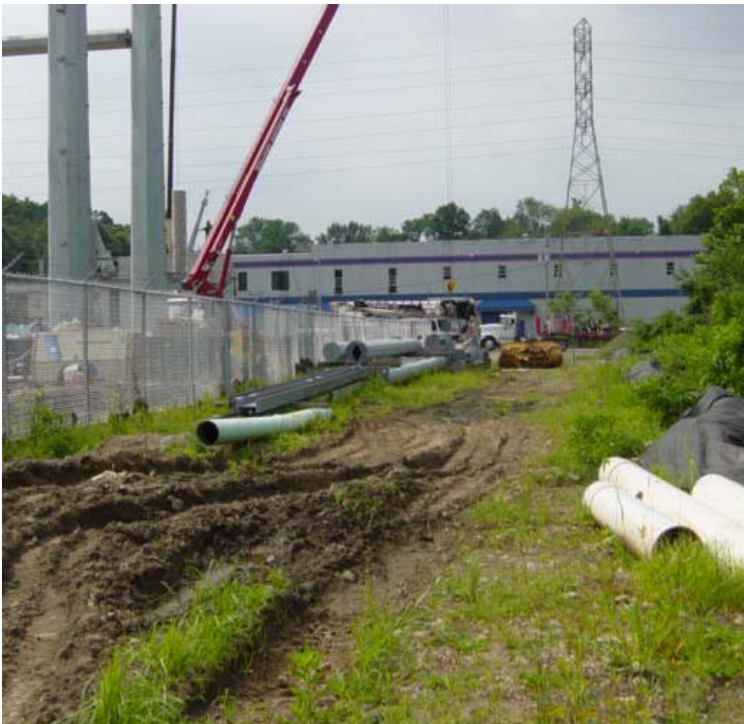
| Areas of Inspection | Observation | Recommended Action | Corrected Actions |
|---|---|---|---|
| Access Roads and Adjacent Roadways continued | <p>occurred. 4/26-7/26/06</p> <p>- Turbid run-off water had pooled up in the access road near the stone wall. 7/5-7/26/06</p> <p>- <b>Norwalk Junction:</b> Sediment tracking did not appear to be an issue at this time. 5/25-7/26/06.</p> <p>- Significant ruts were noted along the perimeter fence. 7/26/06</p> | <p>7/26/06</p> <p>- Controls here need maintenance. If the ponding is an issue, replace fence with haybales or gravel berms 7/19-7/26/06</p> <p>- Continue to monitor Rt. 7 at the main access pad. Silt fence remains at the 345kV stockpiles. 7/26/06</p> <p>- Restore soil ruts to reduce disturbance and consider using plates or mats in this area. 7/26/06</p> | <p>-Needs attention</p> <p>-N/A</p> <p>- Needs attention</p> |

Norwalk Junction: Photo on the left shows where some vehicle traffic caused significant ruts in the soil. This area needs to be smoothed out/restored and mats or plates should be used here to reduce disturbance. Photo on the right shows the plate in place across the swale for vehicle access. 7/26/06.
