Docket No. 272 – Development and Management Plan Inspection

Beseck Switching Station Inspection

Date: November 27, 2007

Location: Beseck Switching Station

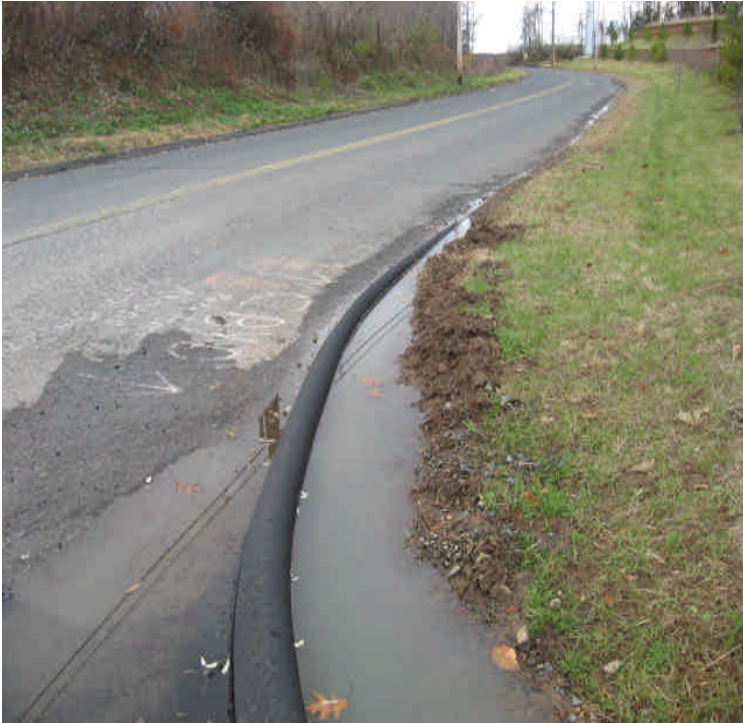
Eastern side of the site, view along Carpenter Lane. New curbing has been installed and turbid run-off from the site is now pooling here and settling before reaching the roadway.

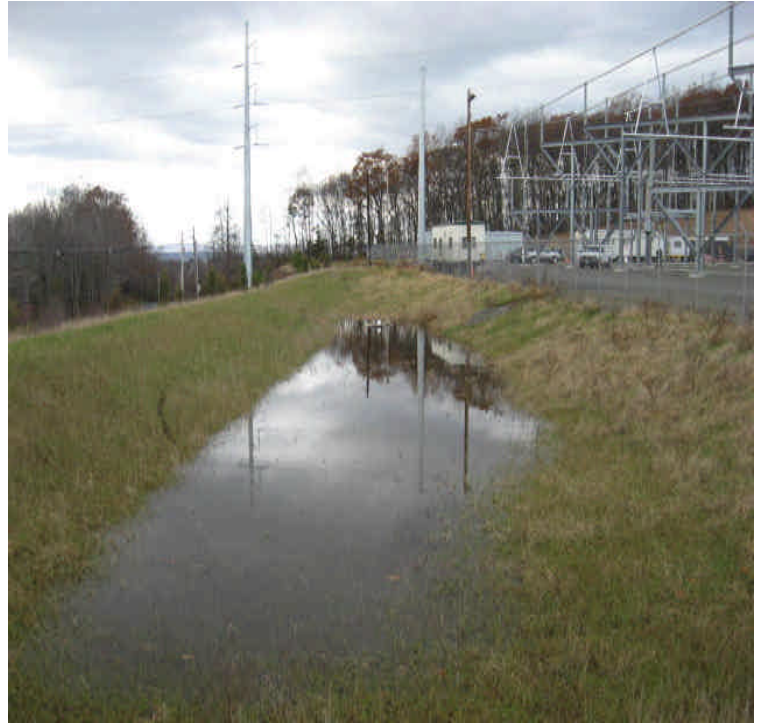
Clear standing water noted at the drain inlets within the detention basin.

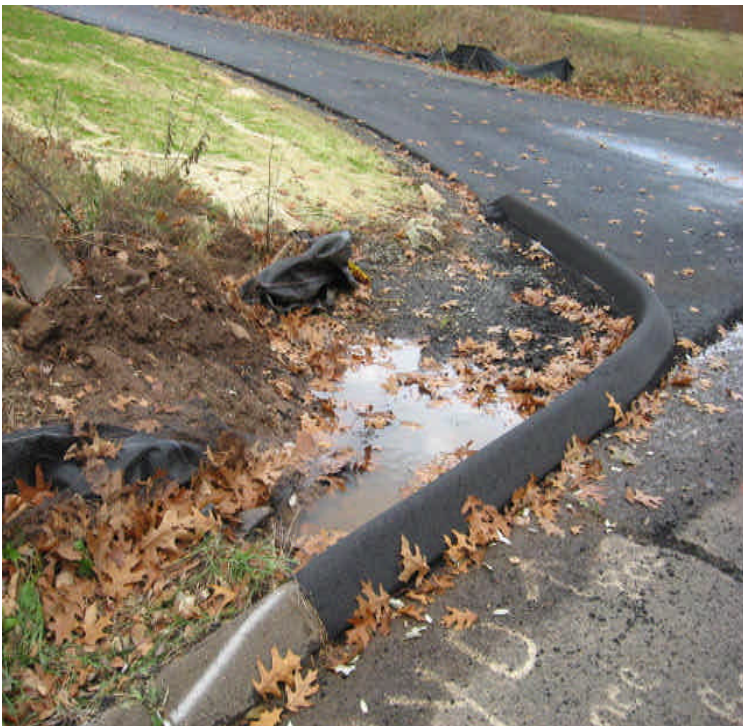
View of the western site access drive which also has newly installed curbing. Clear run-off was noted pooling here.

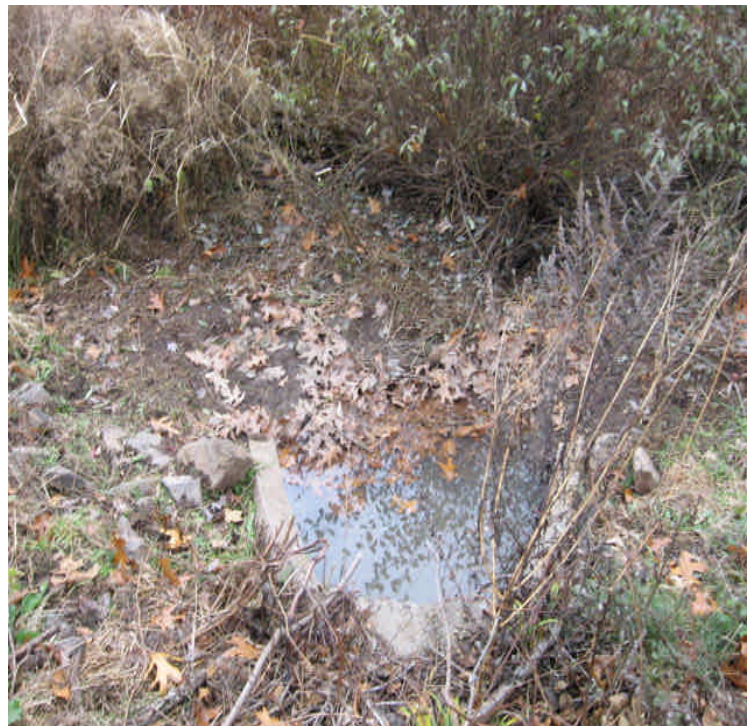
View of the outlet across Carpenter Lane where slightly turbid water was noted in the wetlands following a small rain event. Efforts should be made to remove all visible, settled sediment at the outlet and within the pipe. Seed the disturbed area with wetland mix.
