Docket No. 272 – Development and Management Plan Inspection

Beseck Switching Station Inspection

Date: December 18, 2007

Location: Beseck Switching Station

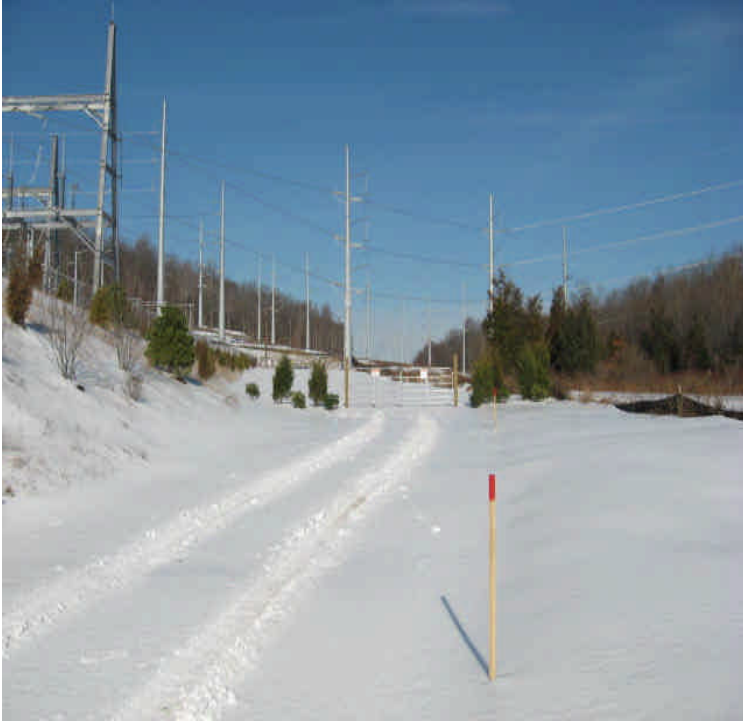
View along the eastern site access from Carpenter Lane. The site is under snow cover and largely inactive.

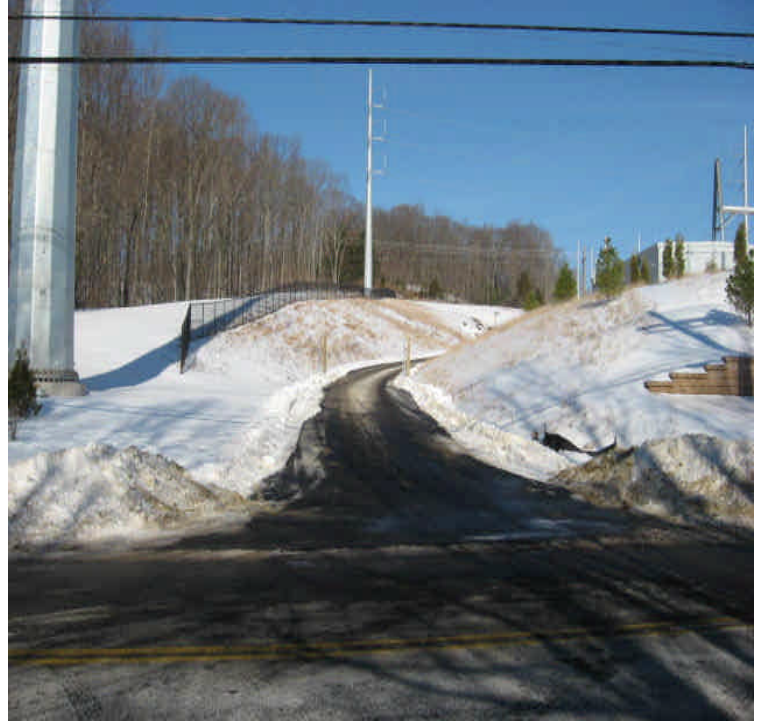
Western site access, view looking from Carpenter Lane.

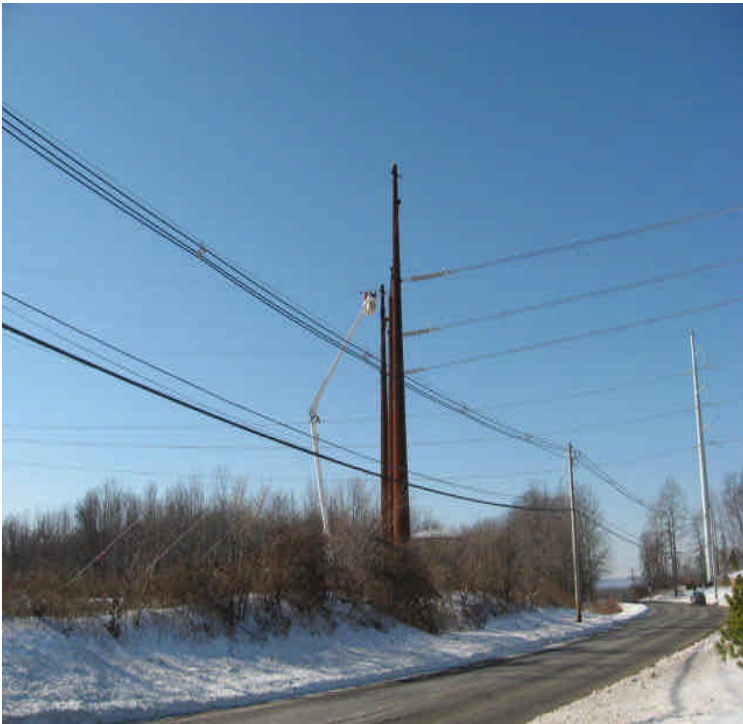
Line work from Segment 2A into the switching station.

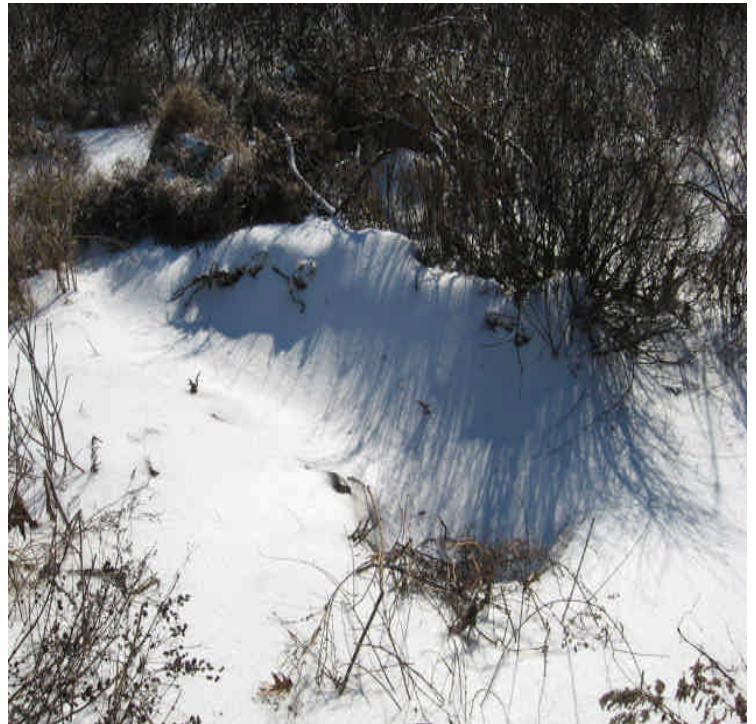
Areas of Inspection	Observation	Recommended Action	Corrected Action
	<p>Sediment accumulation was noted within and around the outlet where the haybales had been. 10/23-12/18/07</p> <p>Contractors have made several attempts to remove sediment, including the creation of the small drainage channel but sediment accumulation likely remains under the snow cover. 12/18/07</p>	<p>feasible from within the pipe). Seed the area with a wetland seed mix for final stabilization. The edges of the access roads are not fully stabilized, therefore haybales should be replaced during heavy rain. 10/23-12/18/07</p> <p>Continue to attend to this. Provide oversight so that the task is completed appropriately. 12/18/07</p>	<p>Sediment needs some additional attention.</p>
<p>State species of concern, threatened and endangered species.</p>	<p>According to the D&M plan, state-listed species are not located in this work area. 12/18/07</p> <p>Several different species of frogs, turtles, and salamanders have been noted in wetlands south of Carpenter Ln. and east of Beseck this spring and last year. 12/18/07</p>	<p>None. 12/18/07</p> <p>Although these species were not state-listed, it indicates good habitat. Continue to make good efforts to reduce impacts to these wetlands to the extent possible. 12/18/07</p>	<p>NA</p> <p>NA</p>

A small channel appears to have been created to allow drainage into the wetlands across Carpenter Lane. Sediment removal is likely still needed in this area when snow cover is gone.

<p>Inland Wetland and Watercourse encroachment and mitigation</p>	<p>Haybales have been removed from the outlet and the wetlands across Carpenter Lane (10/23).</p>	<p>Continue to remove all visible sediment from within and around the outlet (and whatever is</p>	<p>Sediment needs some additional attention.</p>
