Docket No. 272 – Development and Management Plan Inspection

Beseck Switching Station Inspection

Date: December 31, 2007

Location: Beseck Switching Station

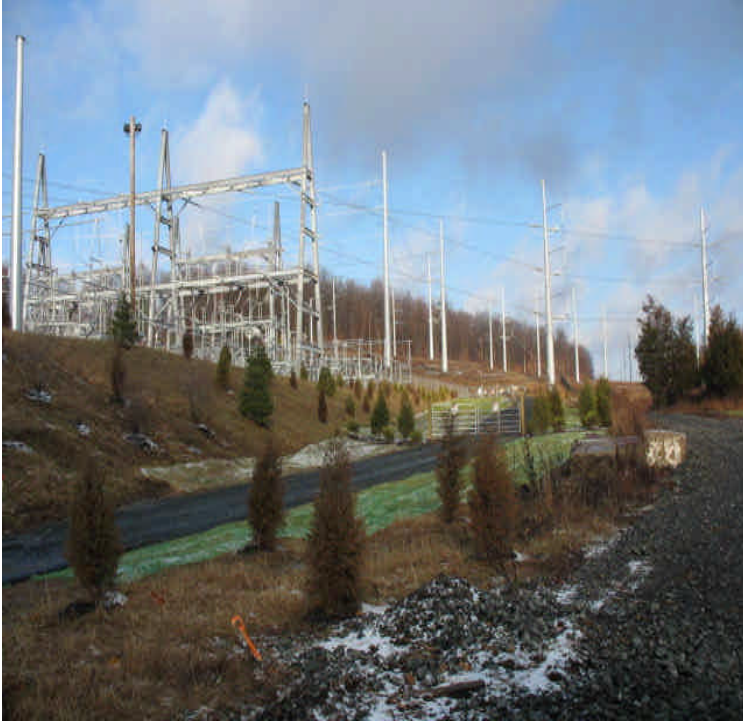
View along the eastern site access from Carpenter Lane.

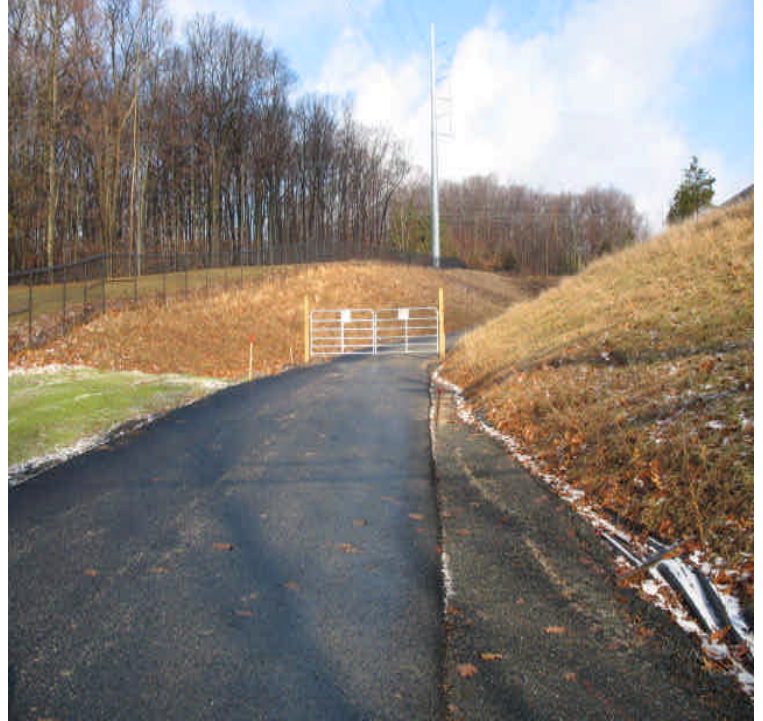
View along the western site access from Carpenter Lane.

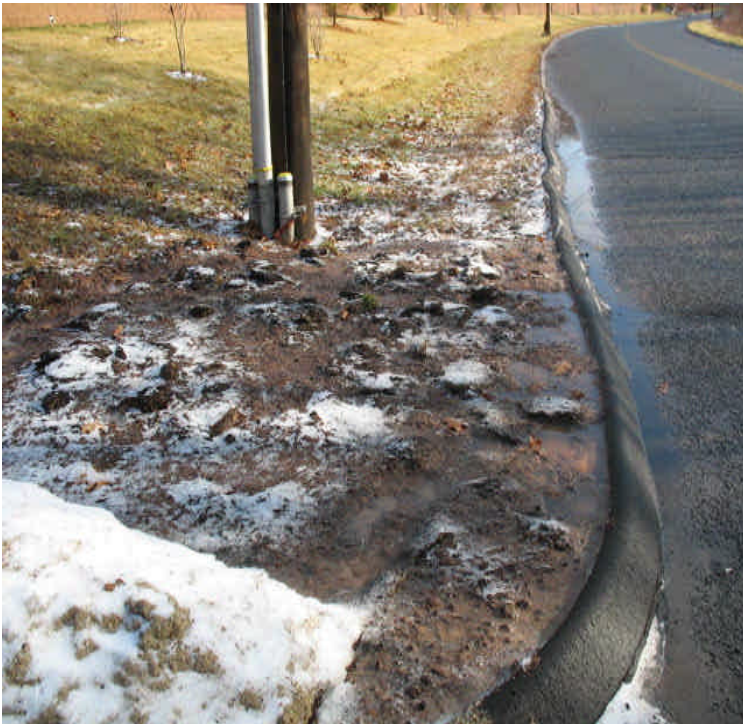
A small disturbed area was noted at the western access curb, likely as a result of plowing.

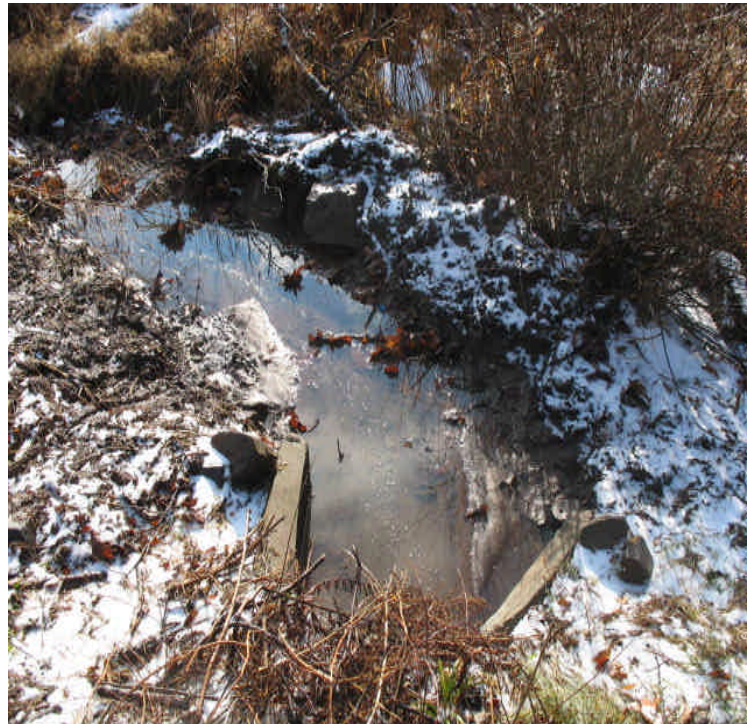
The small channel appears to have widened, possibly from snow melt combined with stormwater. Attention is still needed in this area. When crews return from break, they should remove the sediment prior to the next storm or frozen conditions.
