**Docket No. 272 – Development and Management Plan Inspection**

**East Devon Substation Inspection**

**Date:** November 20, 2007

**Location:** East Devon Substation

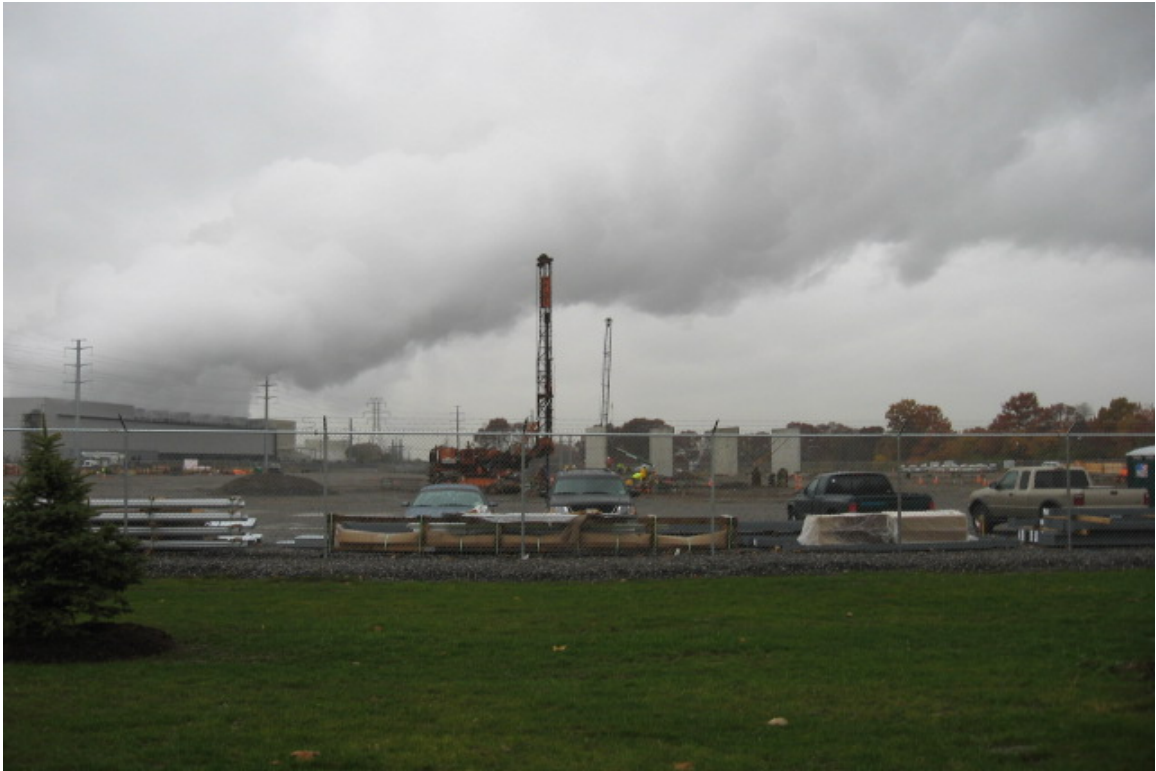
East Devon Subststion (Milford): A general view of construction at the substation.

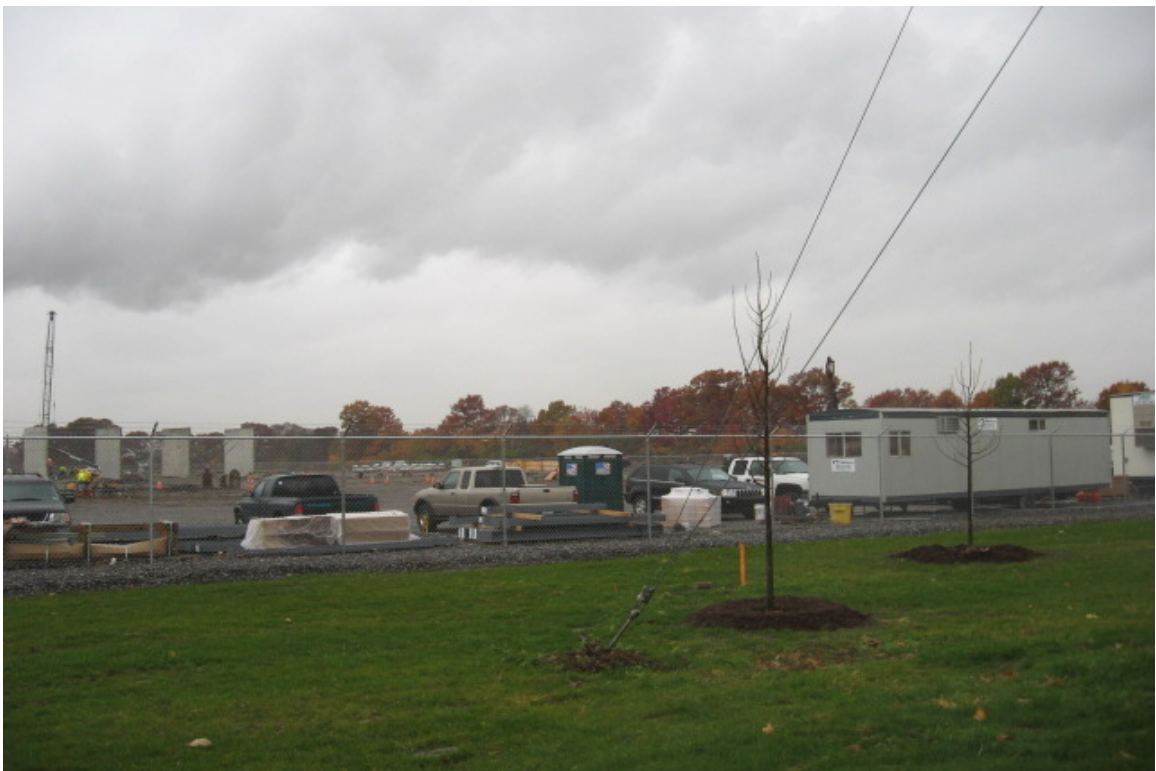
East Devon Substation: An additional view of the construction at the substation.
