Docket No. 272 – Development and Management Plan Inspection

East Devon Substation Inspection

Date: November 30, 2007

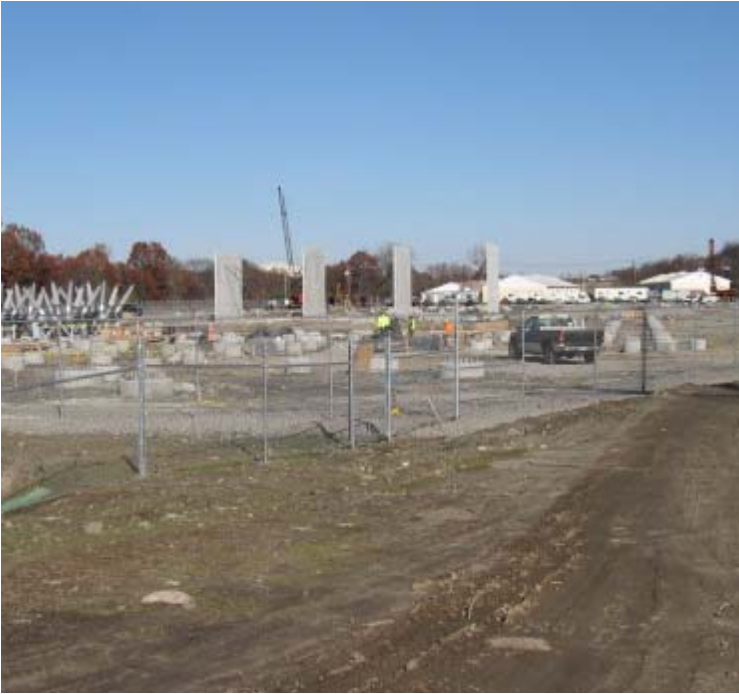
East Devon Substation (Milford): A general view of construction at the substation.

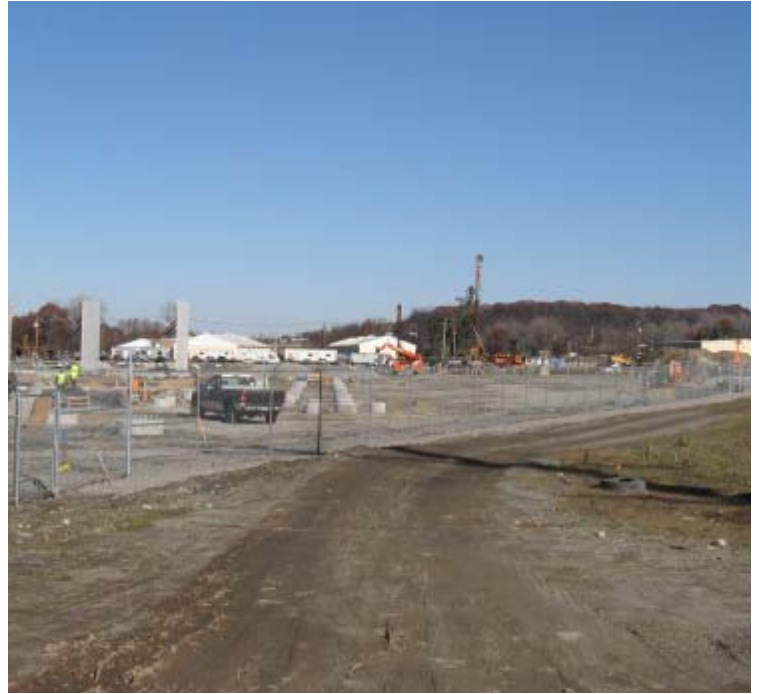
East Devon Substation: An additional view of the construction at the substation.

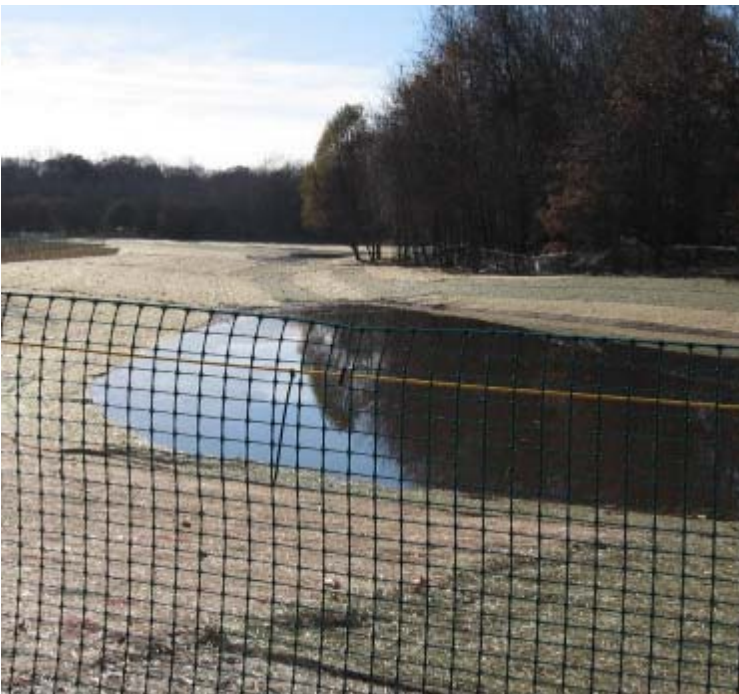
Eisenhower Park (Milford): Erosin blankets have been installed to stabilize soils around the wetland mitigation area.

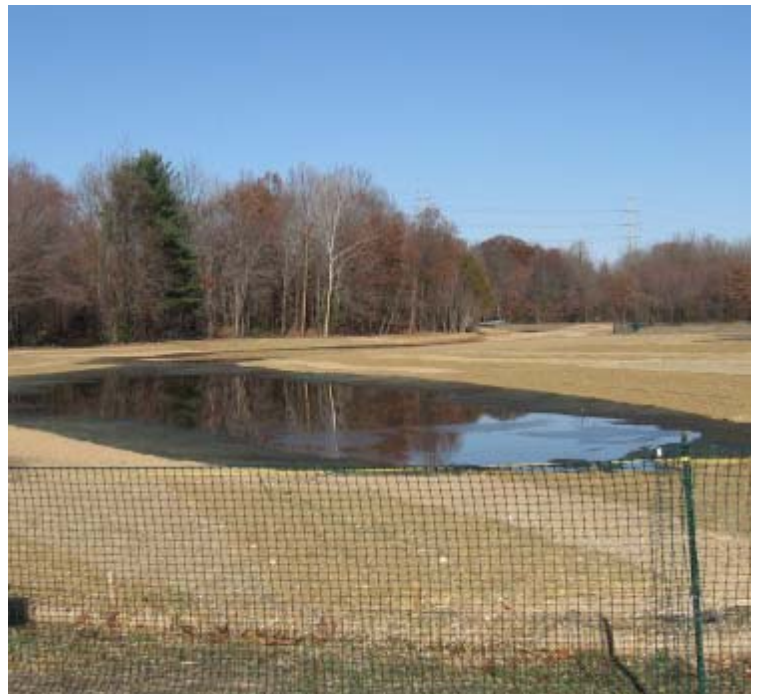
Eisenhower Park (Milford): An additional view of the wetland mitigation area.
