Docket No. 272 – Development and Management Plan Inspection

East Devon Substation Inspection

Date: December 7, 2007

Location: East Devon Substation

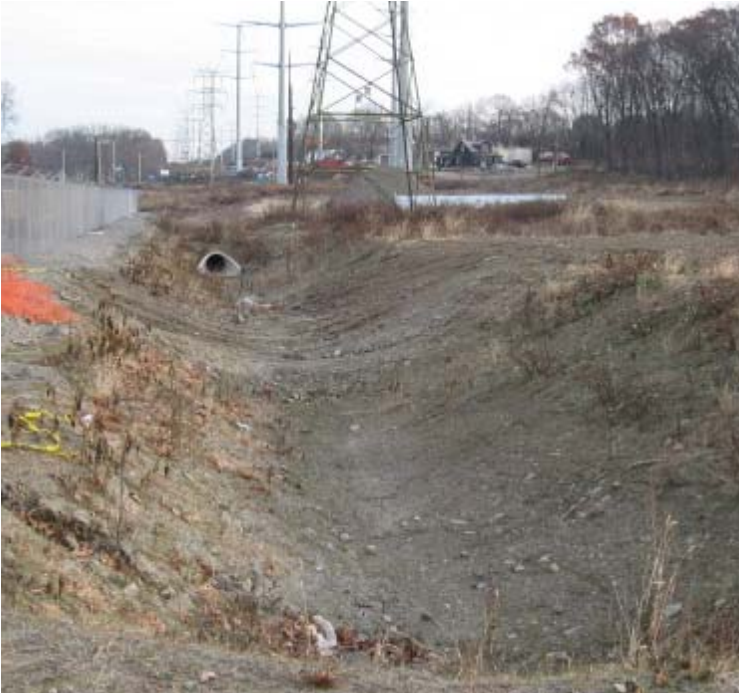
East Devon Substion (Milford): Exposed soils remain in the drainage swale located along the eastern site boundary.

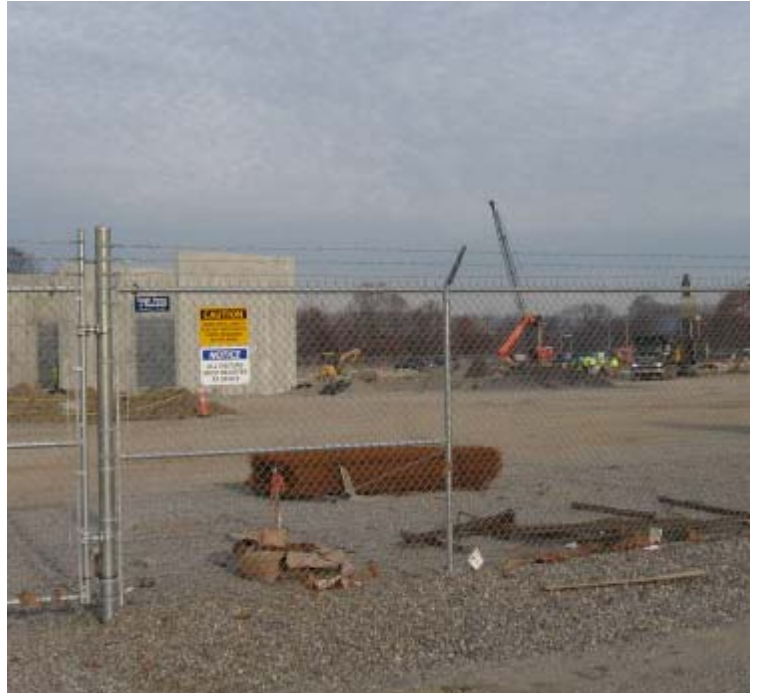
East Devon Substation: A general view of the construction at the substation.

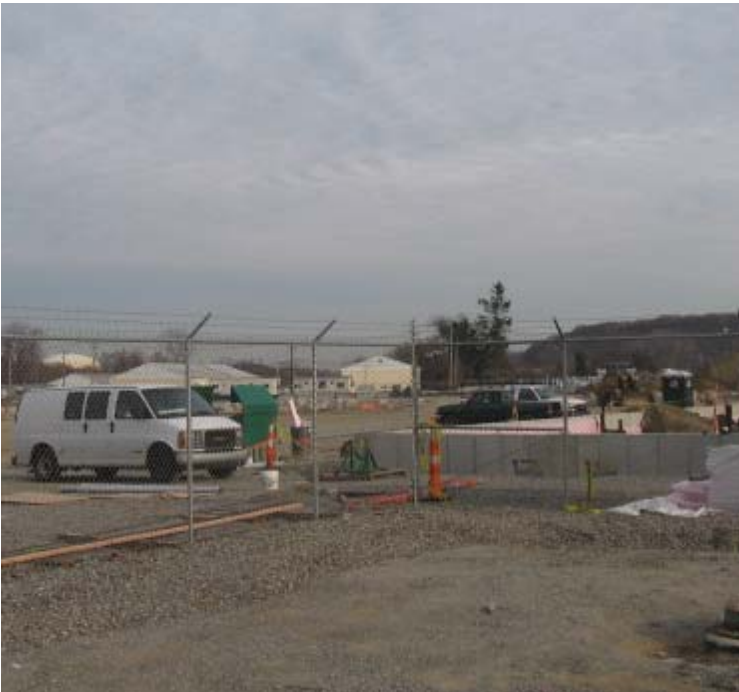
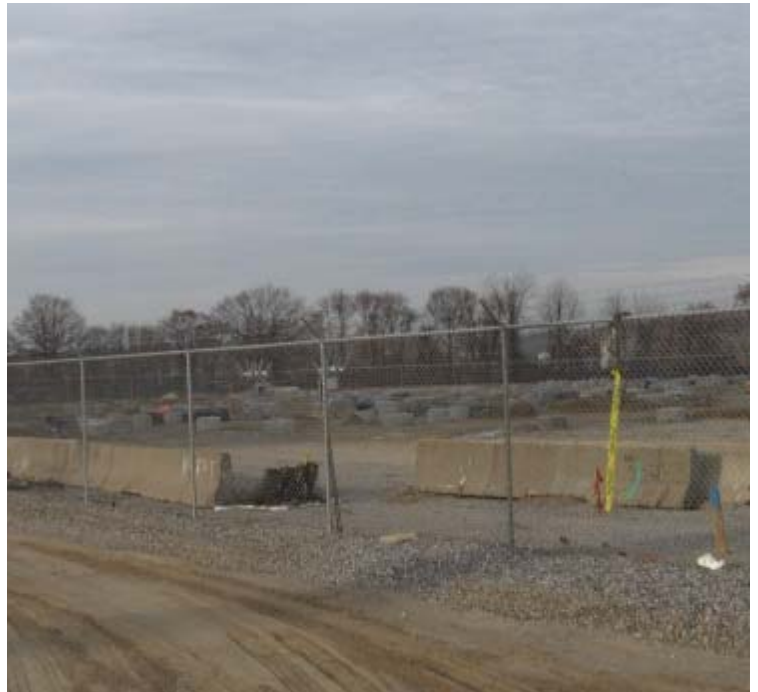
East Devon Substation: Additional views of the construction at the substation.
